# **APPENDIX E**

## **OTHER REPORTS**

# Adams County Exempt Property Profile

7225 BRADBURN BLVD

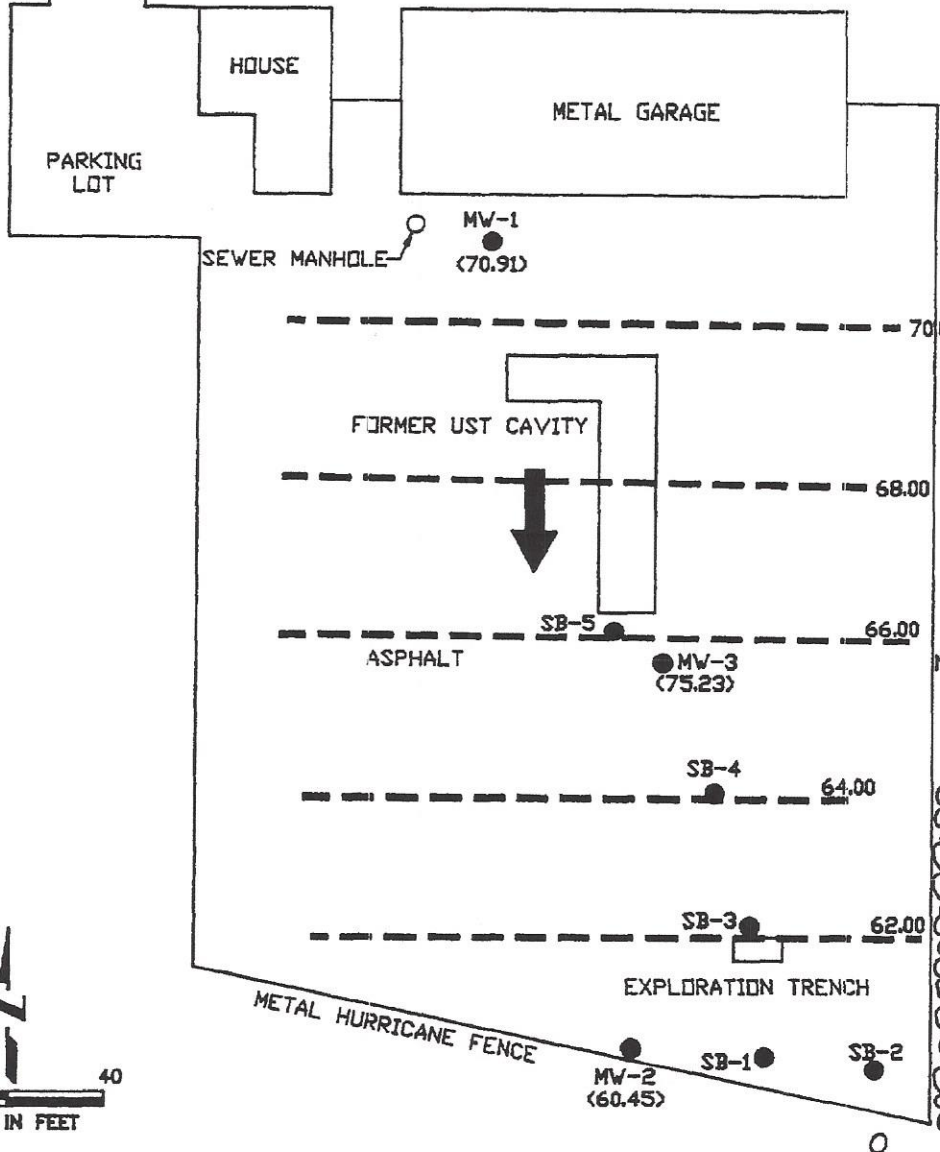
NOTE: THE WELL SEAL WAS NOT IN TACT ON MW-3 DURING THE RECENT SITE VISIT. THE WATER LEVEL IS CONSIDERED AN ANOMALLY.

Based on the current and historical analytical data, Delta recommends that no further remedial actions are completed and that site closure be granted.

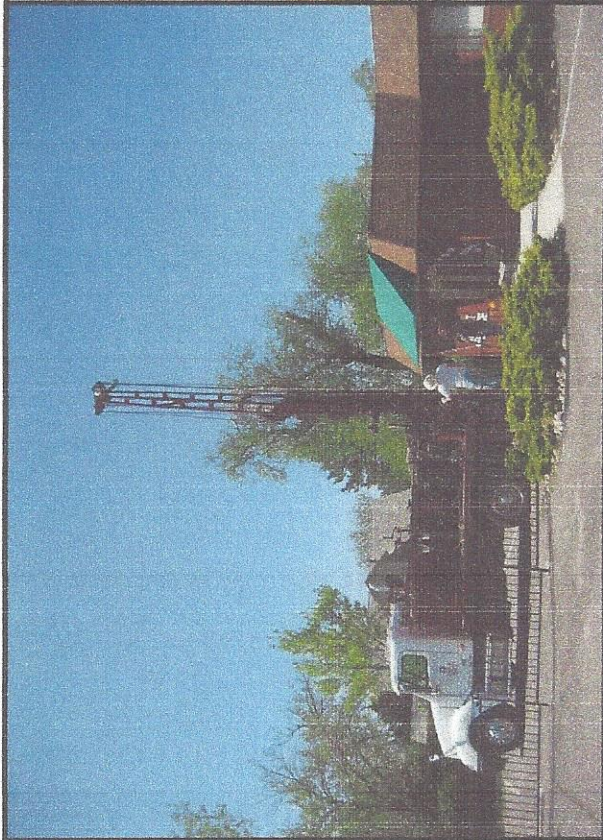
Photo 1:  
Drilling Borehole BS-1

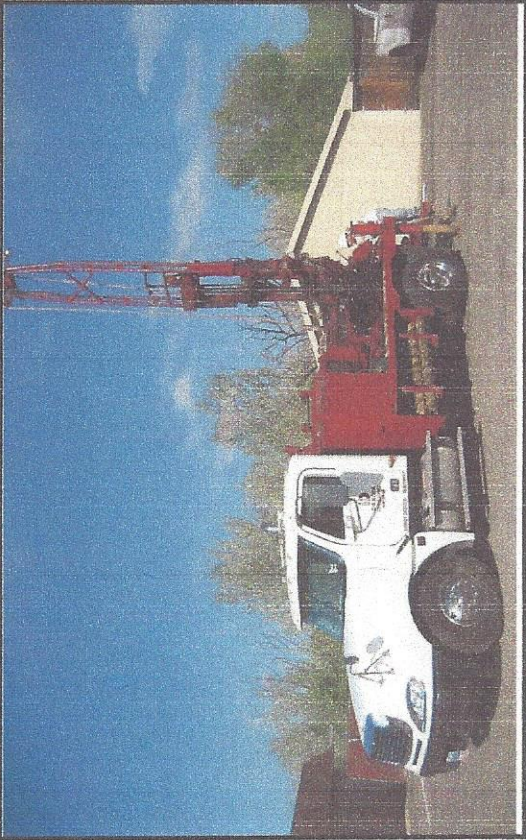
Photo 2:  
Drilling to 28 feet before taking split spoon samples at Borehole BS-1

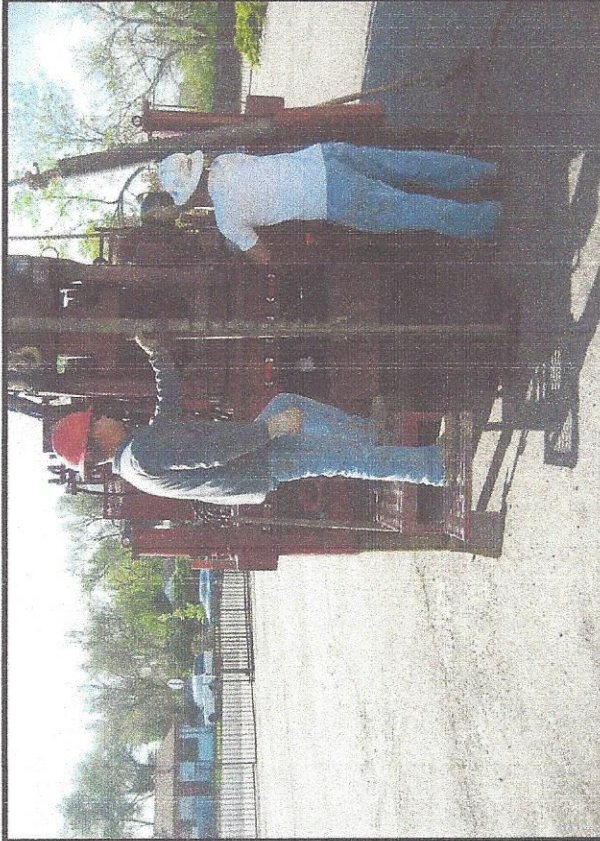
Photo 4:  
Taking Split Spoon Samples  
in Borehole BW-1

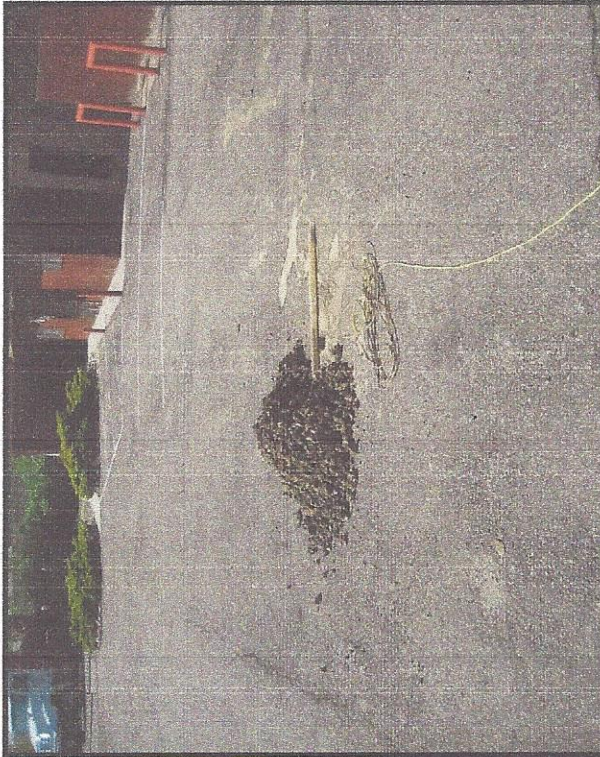
Photo 5:  
Water Sampling at Borehole BW-1

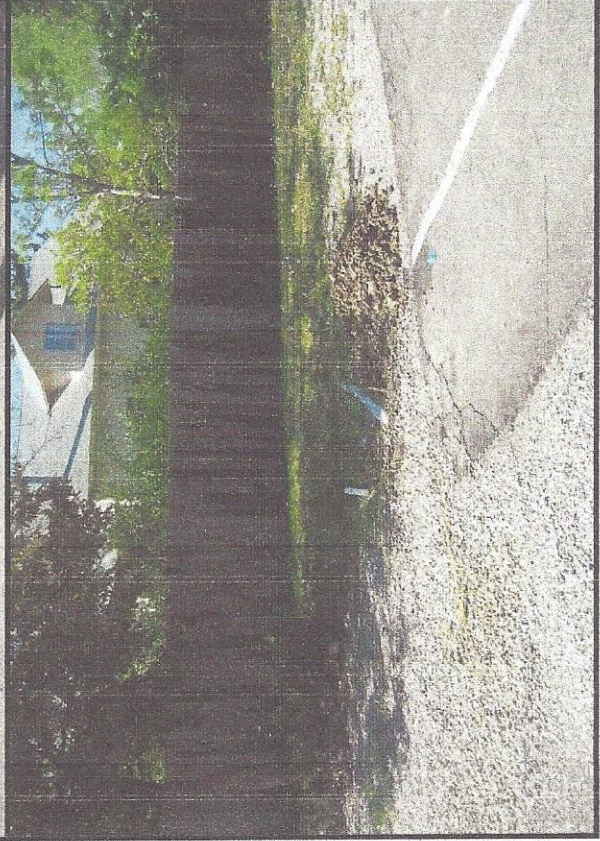
Photo 6:  
Borehole BW-2

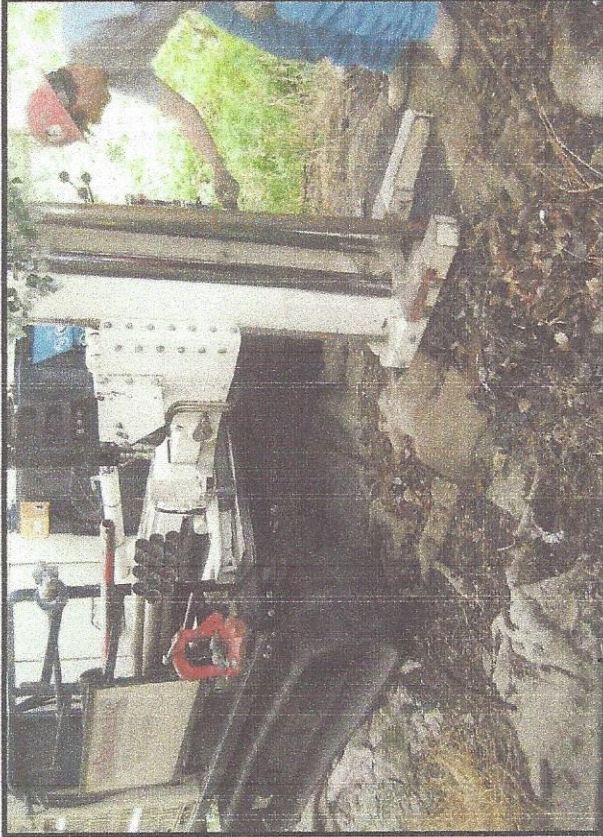
Photo 1:  
Drilling Borehole BW-5

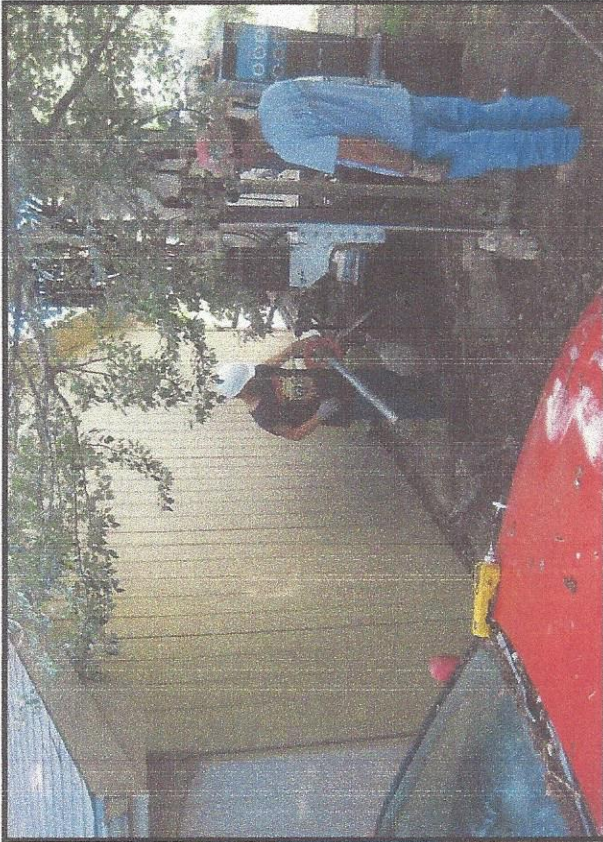
Photo 2:  
Drilling Borehole BW-5

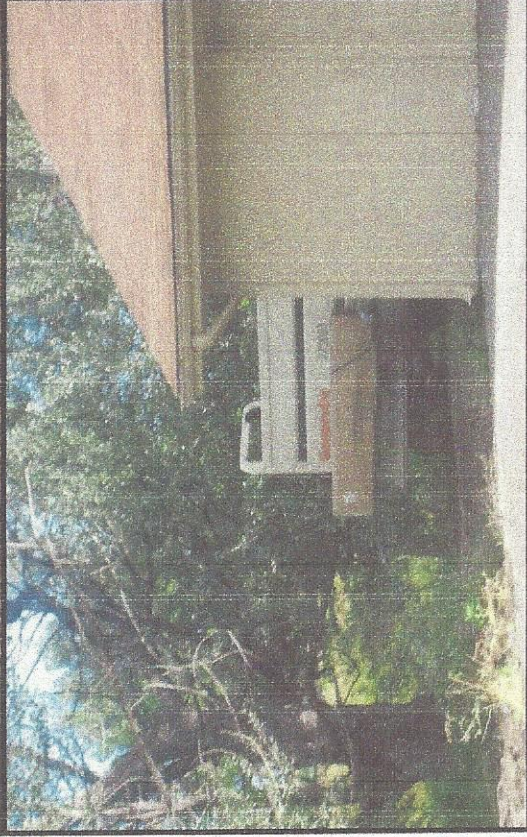
Photo 3:  
Geoprobe on west side of garage at  
Borehole BW-5

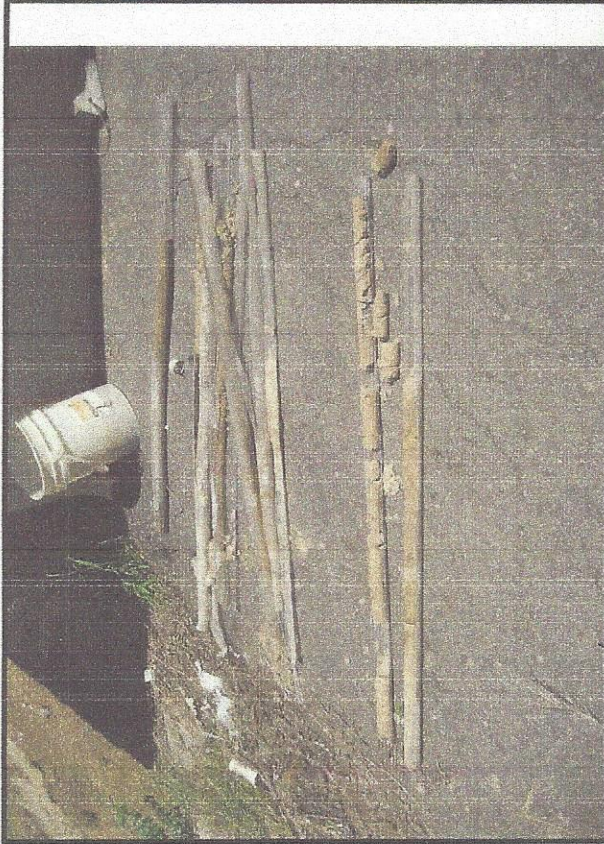
Photo 4:  
Borehole BW-5 cores

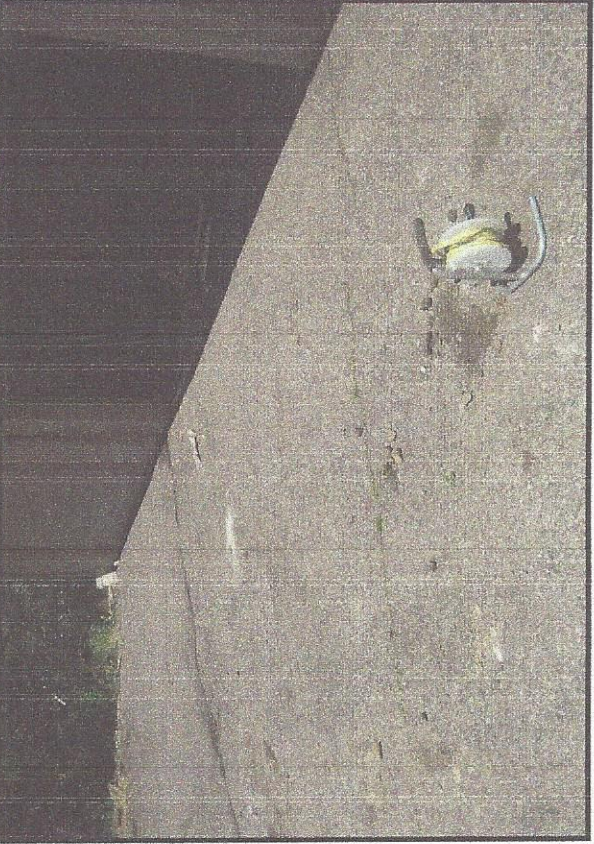
Photo 5:  
PID meter reading at 0.0 ppm with core from Borehole BW-4

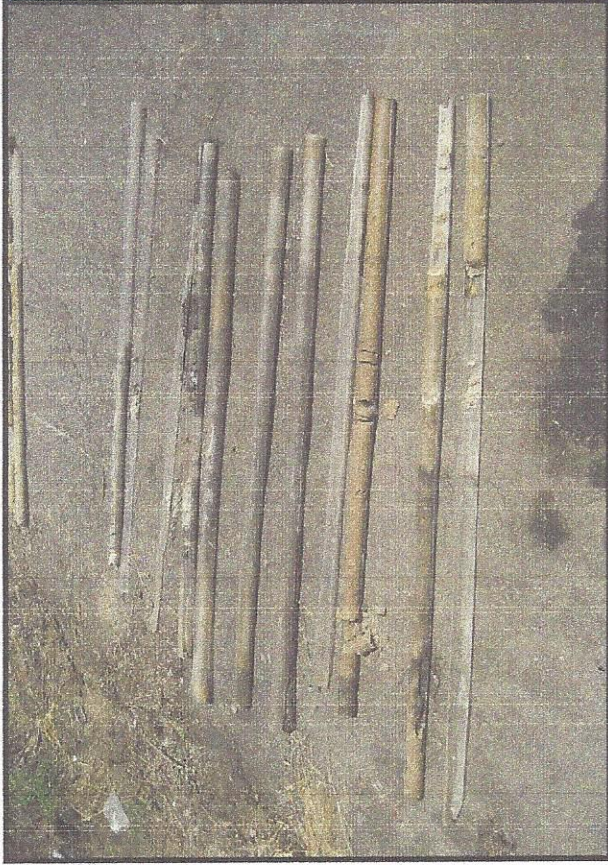
Photo 7:  
Borehole BW-4 cores

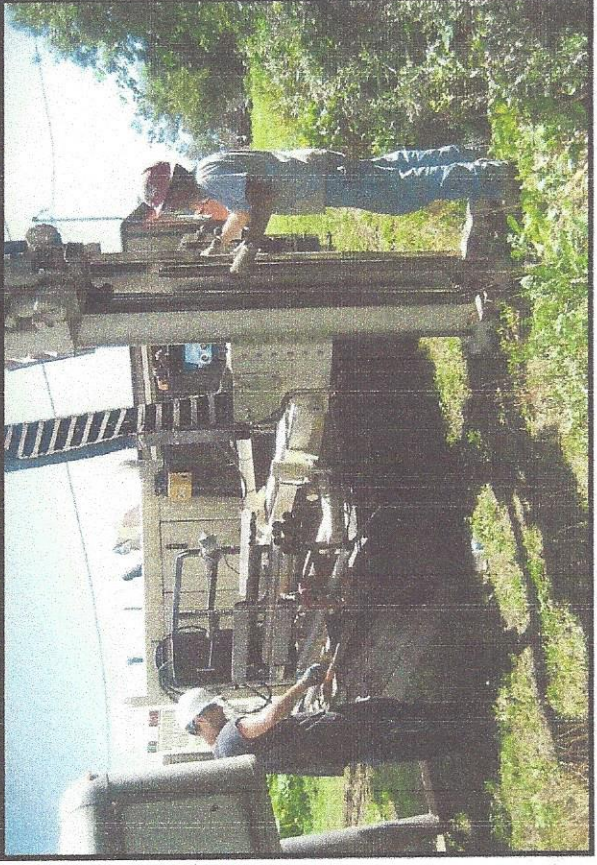
Photo 8:  
Drilling Borehole BW-3
