ASBESTOS SURVEY REPORT

ASBESTOS SURVEY & SAMPLING REPORT

**7225 BRADBURN BOULEVARD
WESTMINSTER, COLORADO**

February 28, 2017

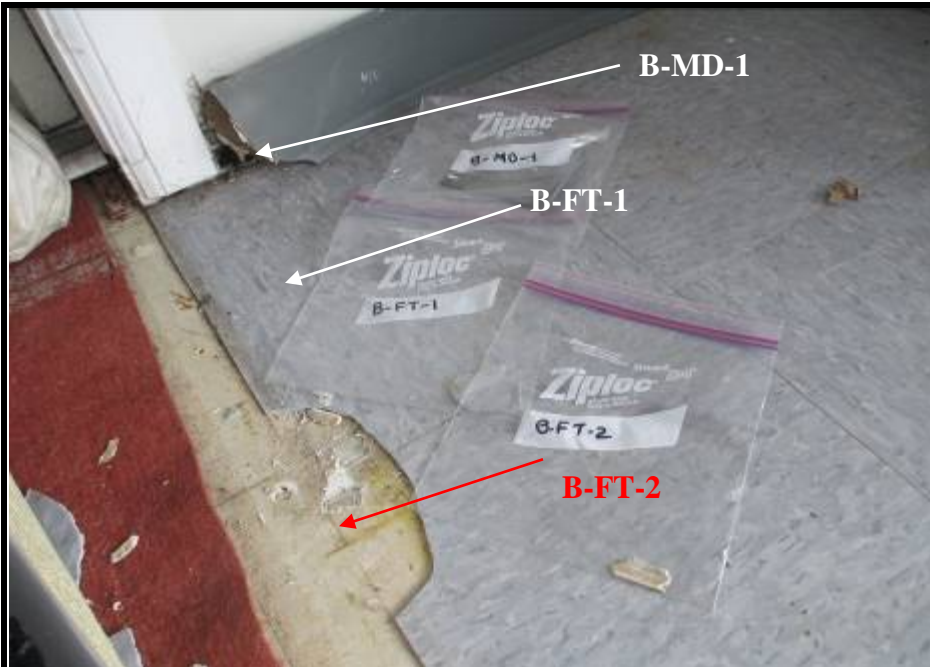
Photo 1:
North Unit

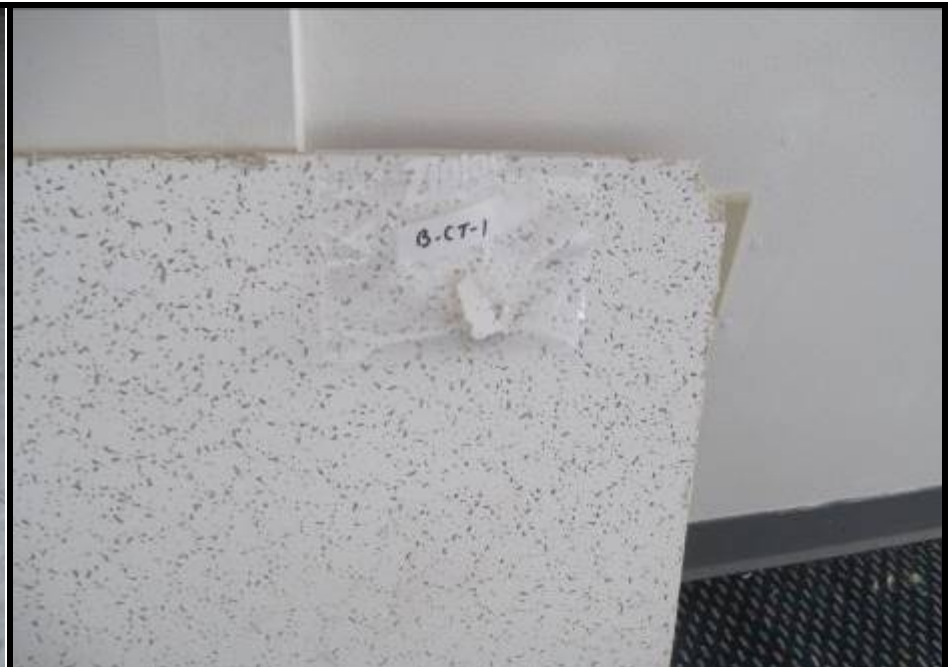
Photo 2:
North Unit Ceiling Tile

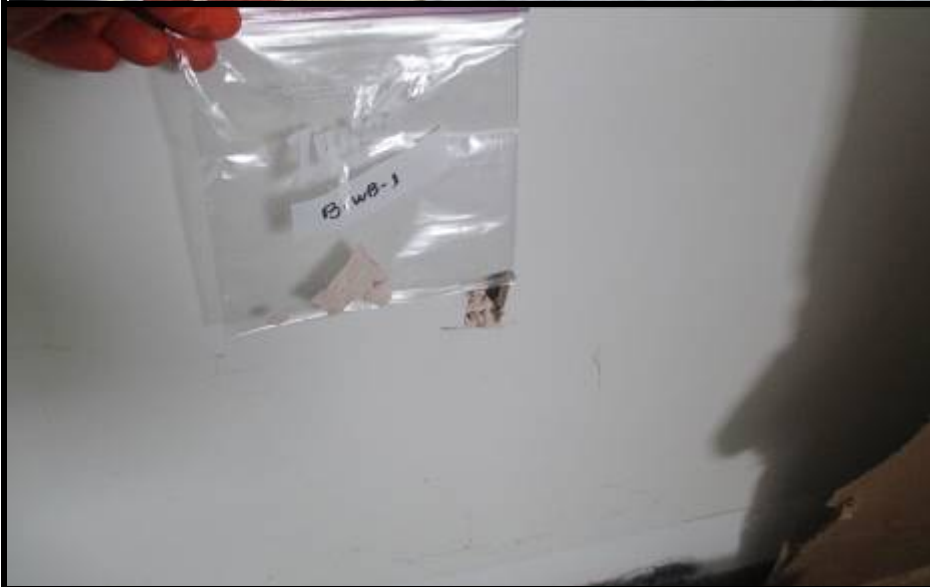
Photo 3:
North Unit Drywall

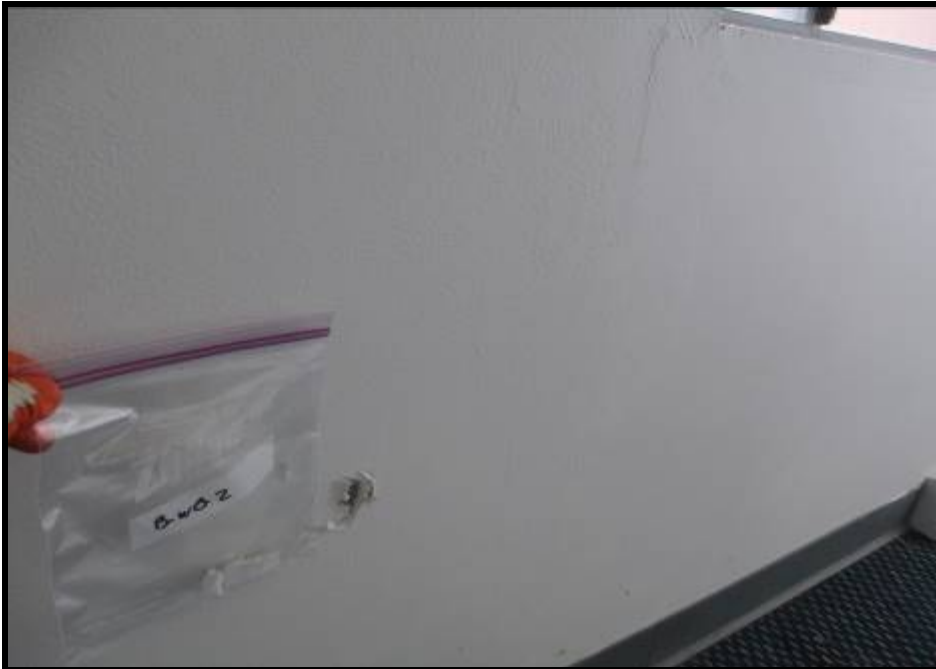
Photo 4:
North Unit Drywall

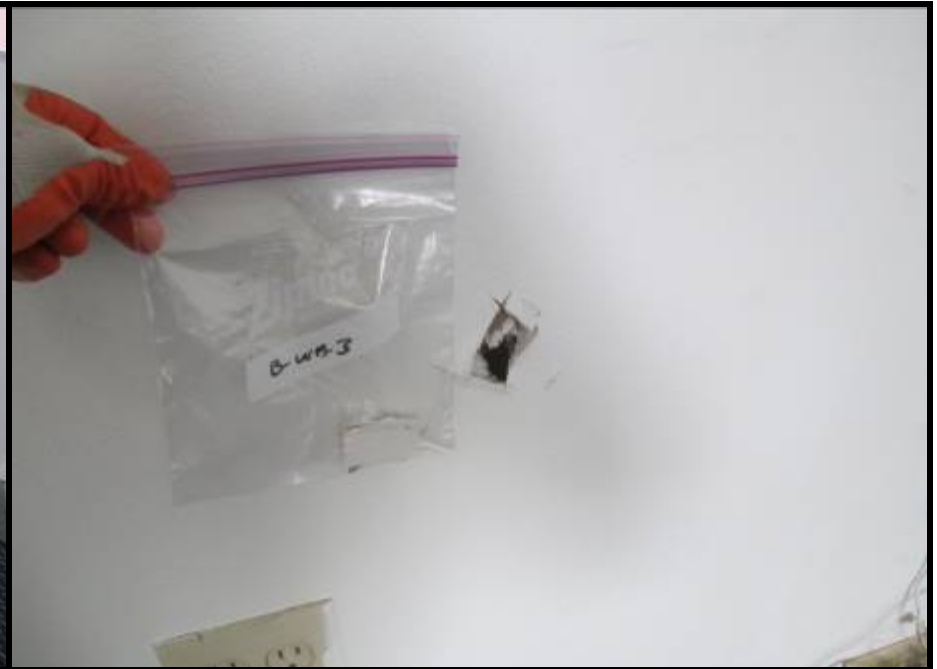
Photo 5:
North Unit Drywall

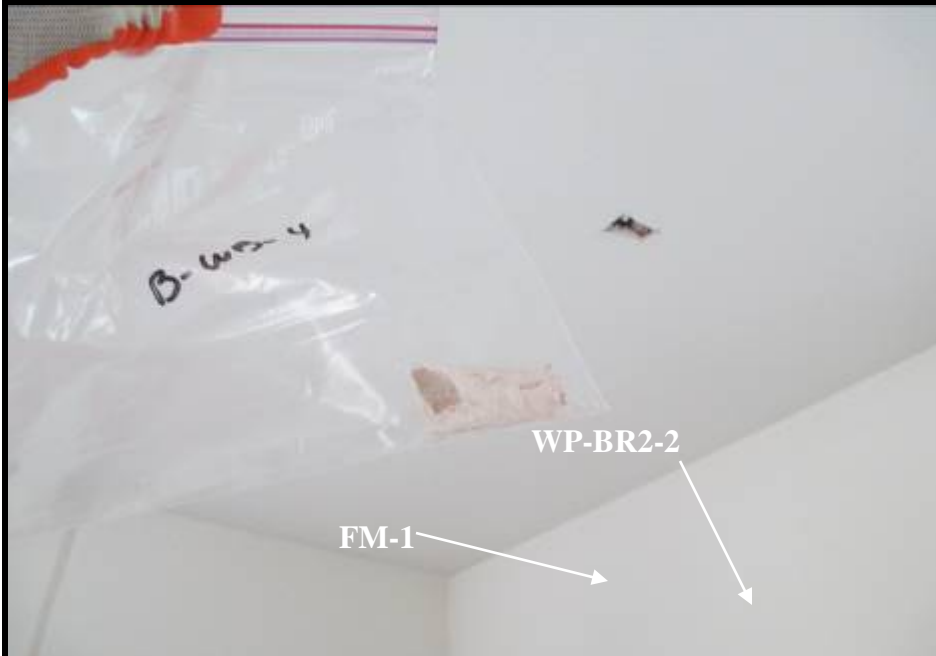
Photo 6:
South Unit Drywall Ceiling

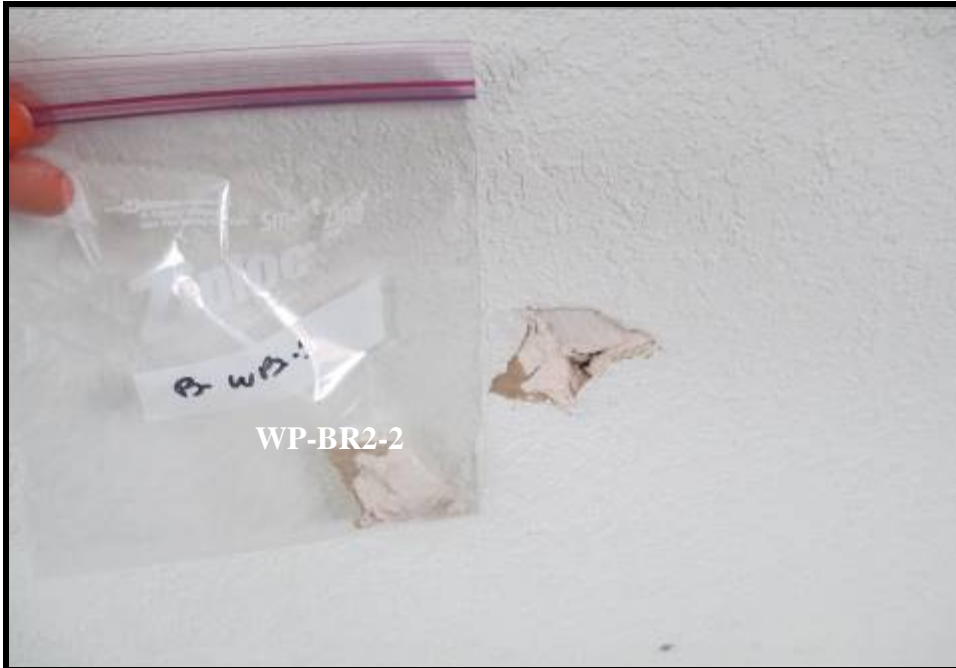
Photo 7:
South Unit Drywall

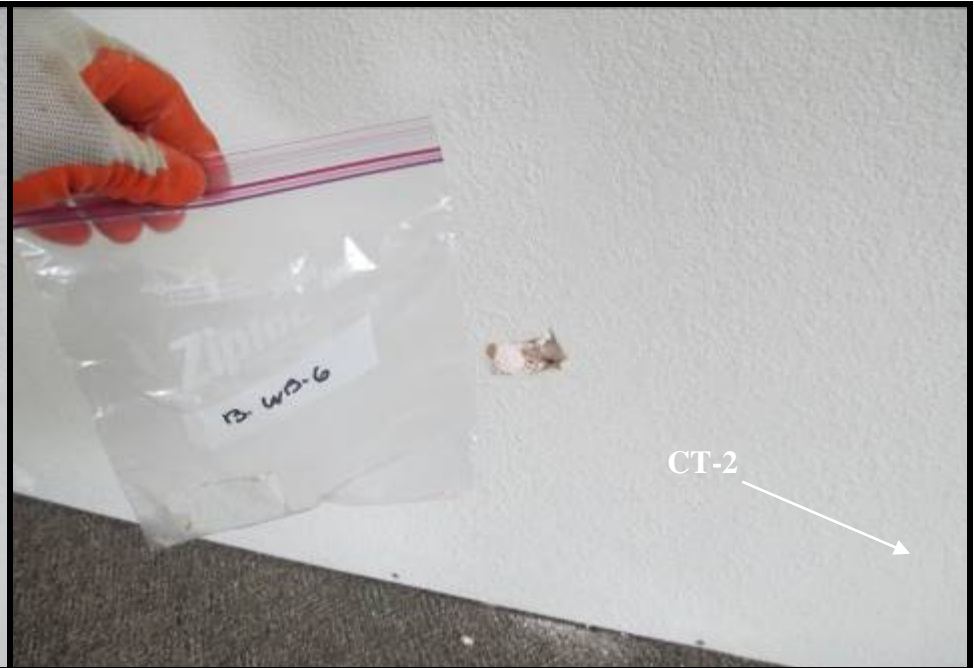
Photo 8:
South Unit Drywall

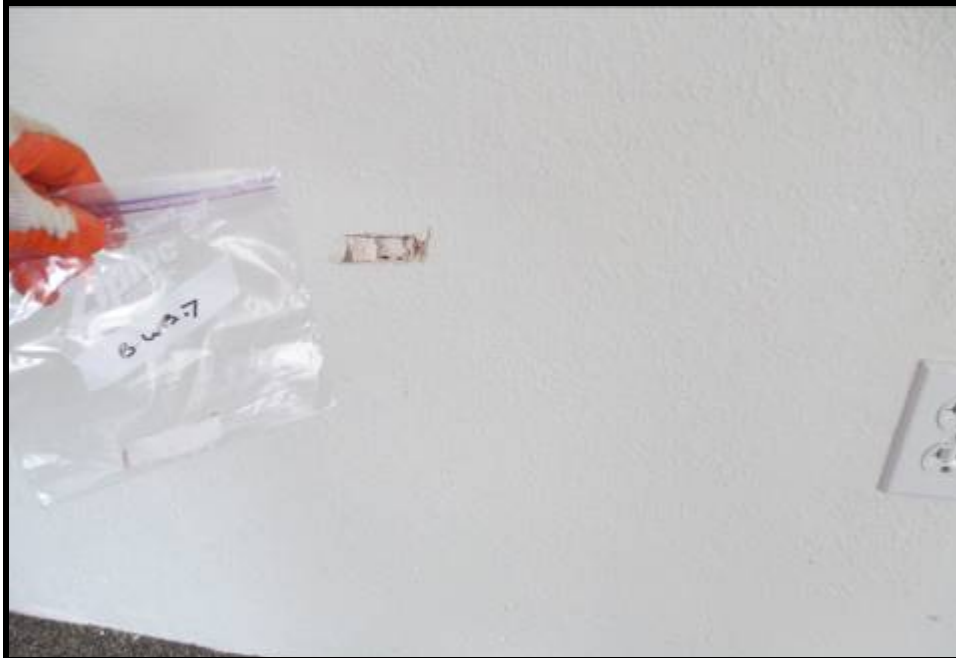
Photo 9:
South Unit Drywall

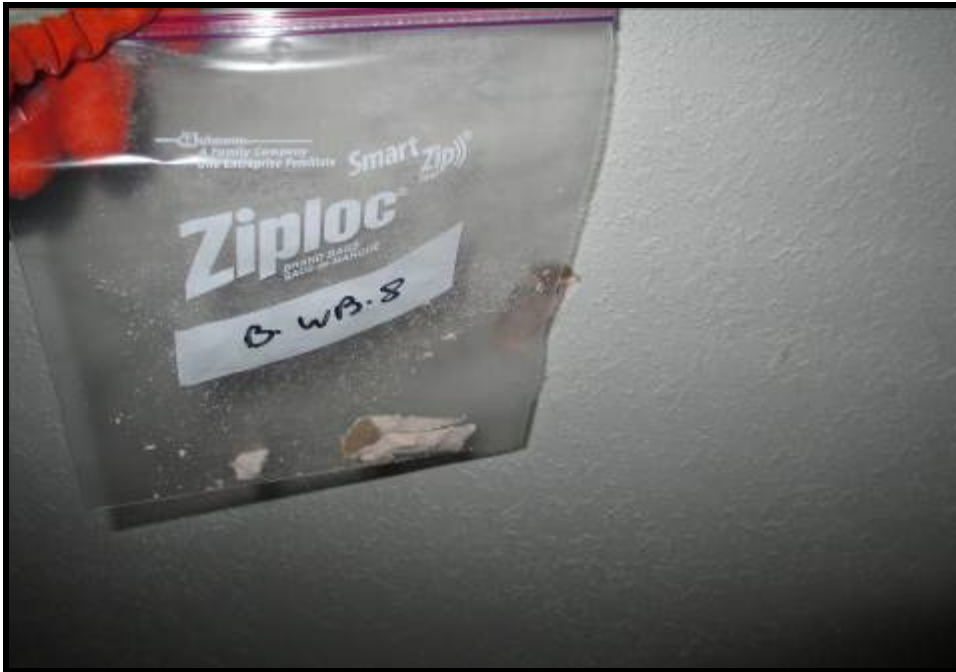
Photo 10:
South Unit Bath Drywall

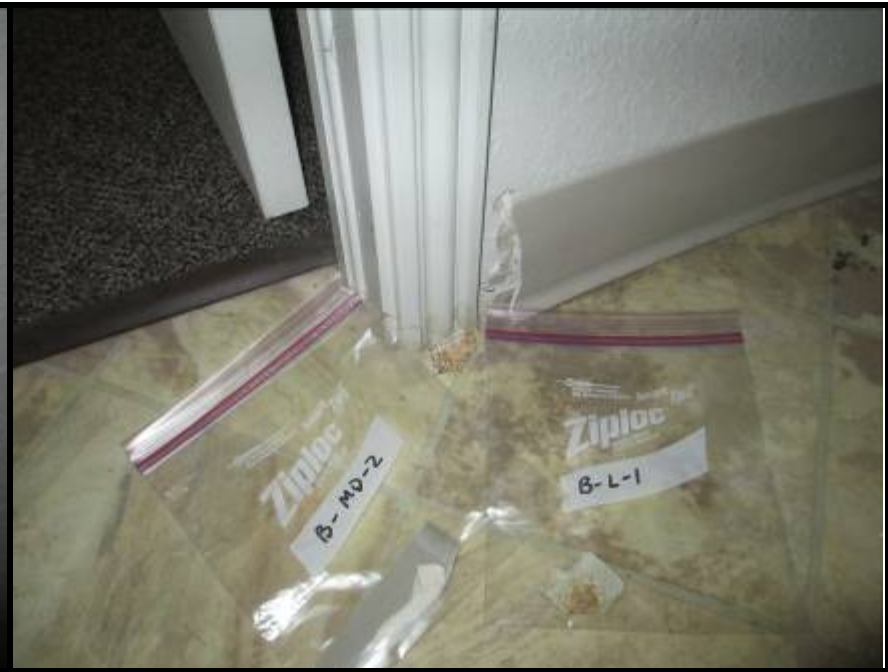
Photo 11:
South Unit Linoleum and Molding
