Shoenberg Farm

Historic Structures Assessment Project #2007-M2-011 March 14, 2008

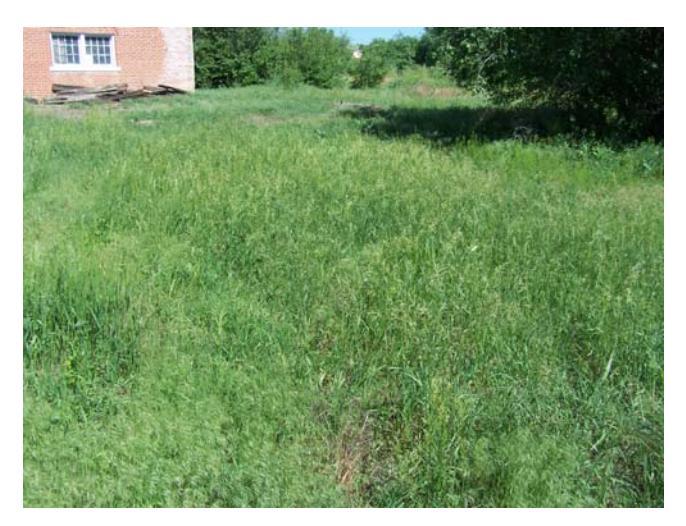
Overgrown grasses at northern boundary of 1911 Brick Bungalow

RECOMMENDATED TREATMENT:	Trim the overgrown grasses and shrubbery surrounding all the existing structures at the site. Remove the volunteer groves of trees adjacent to the structures so as to provide clear access paths and diminish damage to the foundations.
	Repair the concrete sidewalks and driveway as necessary for possible future tenant use. Slope the sidewalks away from the

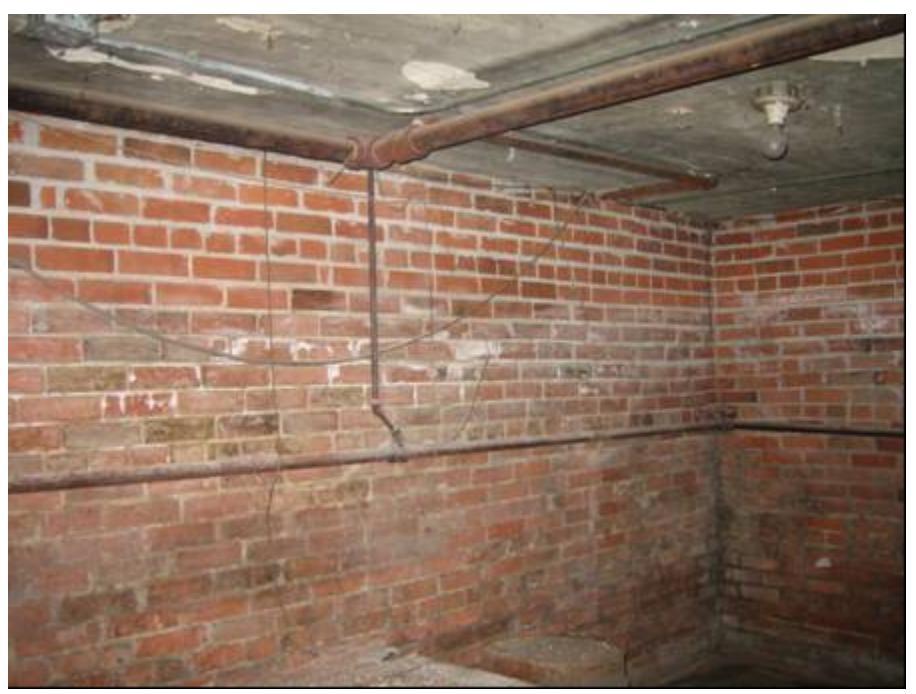
Southeast corner of Bungalow basement

Mortar is in good condition except in the northeast corner of the basement in the lower brick courses where the mortar is degraded badly. It is assumed that this worsened state of deterioration is the result of the boiler located in this area, its historic use and the associated high levels of moisture. As both the current use and proposed adaptive reuse of the building do not include operation of the boiler, the damage is no longer ongoing.

Stair step cracking is visible in the brick walls above grade. These cracks are likely a result of foundation movement.

Overall, the slab-on-grade is in fair condition. Much of the slab-on-grade is covered in dirt, but in cleaner areas large cracks were visible. There is also a 3 foot diameter hole near the partition wall doors. The three wood partition wall doors at the bottom of the stairs are all stuck partially open: the bottom of the doors in contact with the slab. Also, a gap is visible between the top of the wood partition wall south of the stair and the ceiling. Finally the stairs are noticeably out of level. It is clear that the slab is moving relative to the building's walls, particularly on the western portion of the building. Consequently, the interior walls founded on the slab-ongrade are moving along with the slab.

The four brick pilasters supporting the porch are in poor condition. The pilasters have twisted and are out of plumb due to movement of the underlying foundation elements. The pilasters' mortar and brick deterioration can be characterized as severe.

RECOMMENDED TREATMENT: The foundation should be underpinned to prevent further movement.

After the perimeter foundation system is stabilized, portions of the slab that have settled relative to the perimeter walls should be leveled via pressure grouting and slab cracks should be filled with a suitable cementitious grout.

Some mortar re-pointing and brick replacement is recommended in localized areas where deterioration is severe.

A perimeter drain should be installed to prevent hydrostatic pressure build-up on the basement walls. The walls should be waterproofed with an appropriate membrane waterproofing system over the exterior face to prevent water infiltration and degradation of the walls. Some mortar and brick replacement may be necessary if deterioration of the exterior wythe is discovered during excavation.

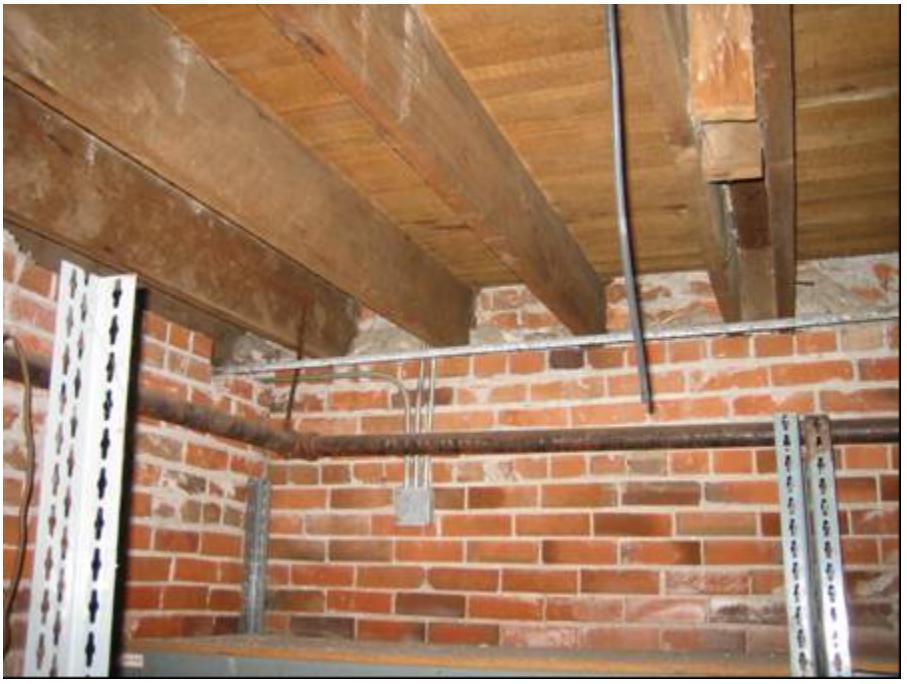
Bungalow first floor framing from below

EVALUATION:	The first floor framing is in fair condition. Distress is evident in the first floor framing. In some locations the first floor deflects noticeably under a person's weight and is out of level.
	On the western portion of the building an approximately 1/2" high north-south running step is visible in the first floor finish, possibly indicating a compromised support condition for the floor joists below. As mentioned in the 'Foundation' section, the interior wood walls on the western third of the building have displaced along with the basement slab. The movement of the support walls is translating to the first floor joists.
	The east-west running brick bearing wall located in the middle section of the building appears to be in good condition.
	The 6x8 supporting the first floor joists on the eastern third of the building is visibly distressed. One of the 6x6 posts has lost engagement with both the beam above and the foundation below and is thus ineffective. The bottom of the post has rotted where in contact with the slab. As a result the 6x8 beam has deflected and developed horizontal cracks near the original location of the post.

The floor joists and the wood bearing wall on the west half of the building will need to be exposed so that their condition can be assessed and their capacities calculated. Given the current condition and performance of the first floor, some reinforcing, repair, or replacement of these elements should be expected.

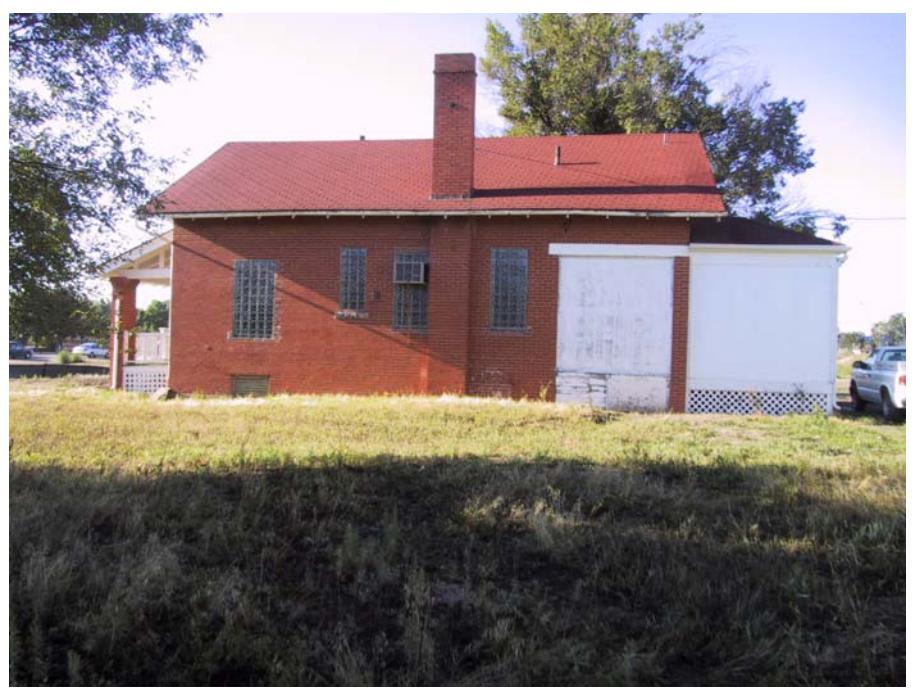
1911 Brick Bungalow. North elevation showing wood infill at northwest corner and west porch reconstruction. Non-historic glass block window infill.

No historic photo documentation exists to determine the original construction at the northwest corner of the Bungalow where the vertical wood infill is currently. It is recommended that further research be done to determine the original construction and configuration.

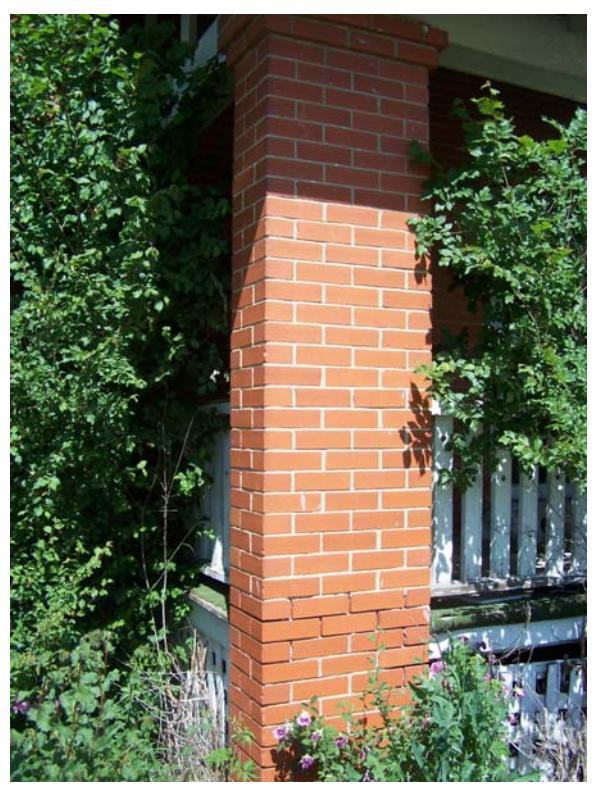
1911 Brick Bungalow. East porch masonry piers supporting the shed roof. Note: mortar deterioration at floor level.

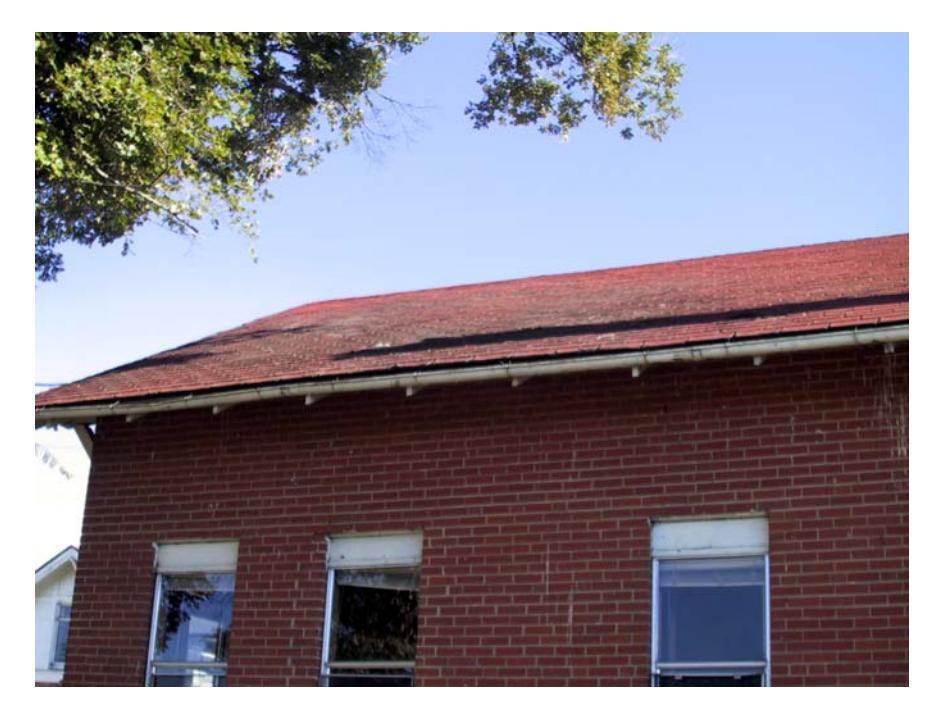
Asphalt shingle roof showing exposed rafter tails at south elevation of 1911 Brick Bungalow.

CATEGORY:	3.5 Envelope - Roofing & Waterproofing
DESCRIPTION:	The roof plan is a simple gabled roof with modern asphalt shingles installed over bead board with 2x6 rafters at 24 inches on center.
	Rafter tails are exposed on the north and south elevations, originally painted. Eave extensions on the east and west elevations are supported by 4x4 wood brackets at the ridgeline and outside walls. Water drainage is contained by continuous half-round metal gutters on the north and south elevations.
EVALUATION:	The roof of the bungalow residence is in fair to poor condition. Several shingles are missing and beginning to delaminate, specifically on the south elevation of the gabled roof where UV degradation is evident.
	The exposed rafter tails are beginning to show early signs of deterioration and paint is flaking and peeling. One 4x4 support bracket is missing at the northwest side of the roofline. Paint is peeling at the support brackets, rafter tails and bargeboards. Gutters are loose and failing. The downspouts often empty into depressions adjacent to the foundation.

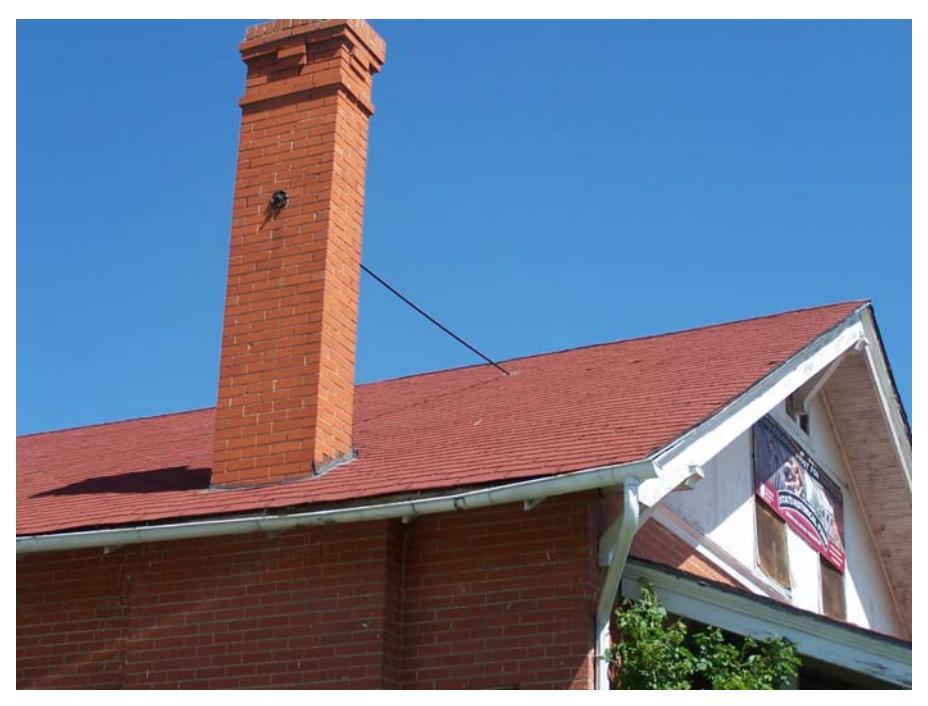
Masonry chimney at the south elevation of Brick Bungalow

CATEGORY:	3.5a Roofing & Waterproofing - Chimneys
DESCRIPTION:	Two brick masonry chimneys rise approximately eight feet above the north and south roof lines. Both chimneys are structurally tied back to the roof with metal tie rods. A metal flue is evident approximately eight inches above the top of the south chimney.
EVALUATION:	In general, the south chimney is in good condition and appears plumb and level.
	The north chimney is in fair condition. Several areas require re-pointing and the chimney is leaning towards the north. Historic photos, dated circa 1920 indicate the south chimney was originally tied back to the roof with a structural tie rod.
RECOMMENDED TREATMENT:	Inspect the leaning chimneys for structural integrity and any visible cracking or distress. Remove roofing but retain stepped flashing at chimney base. Add additional steel rods for support at the north chimney. Re-point both chimneys.

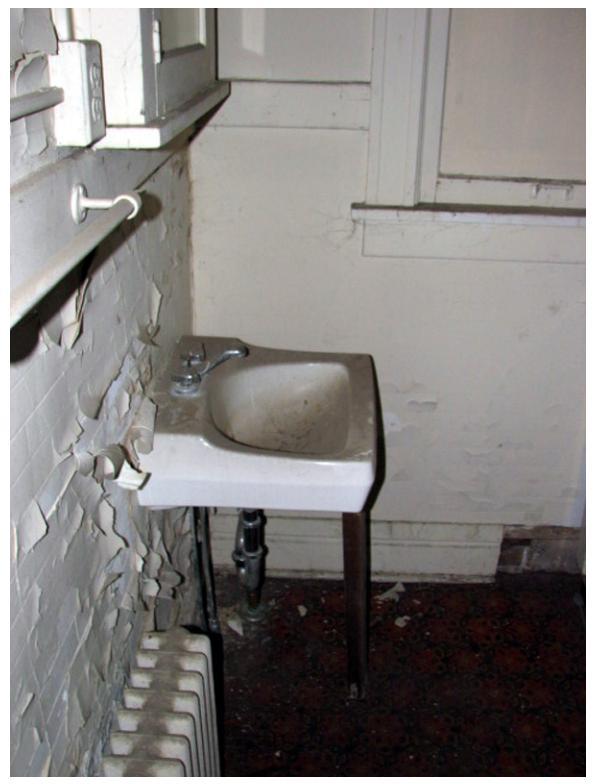
Moisture and humidity damage on the interior walls of Room 108

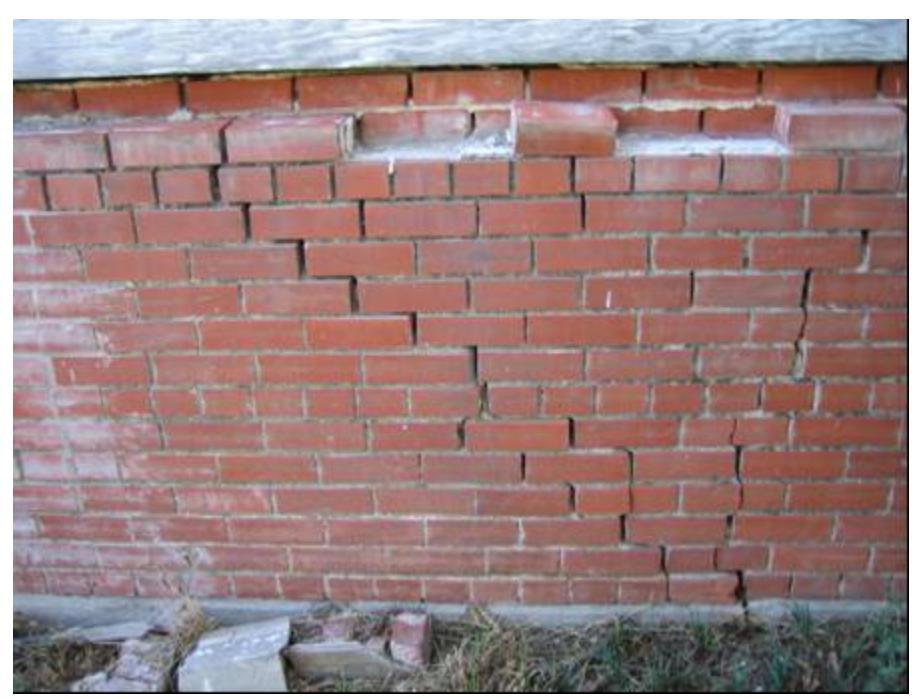
Stair step cracking along north elevation

After the move, the walls would then require further repair. Portions of the perimeter walls with severe cracking will need to be taken down and rebuilt. Less severely damaged wall sections can be restored with selective brick rebuilding and re-pointing of the mortar joints.

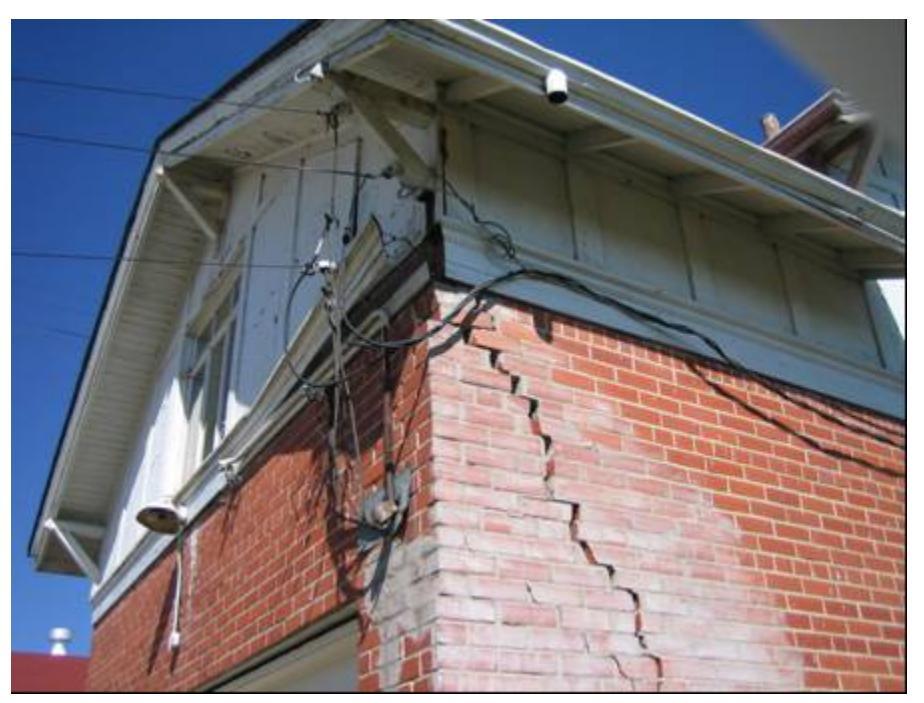
Stair step cracking along east elevation

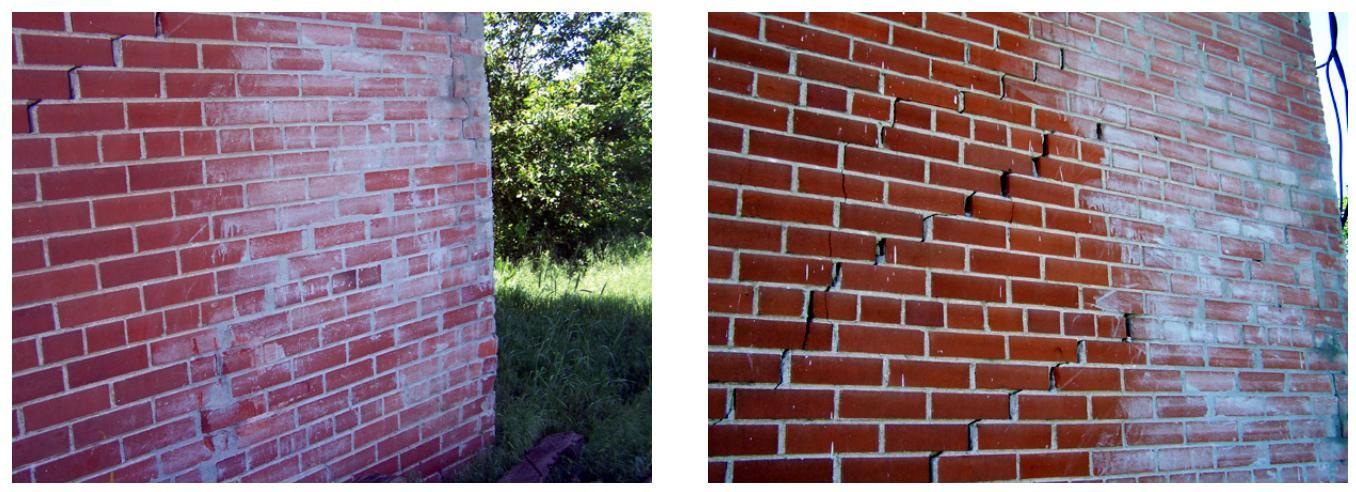
East wall of the Two-Story Garage. Multiple stair-step cracks are visible as well as previous patching attempts with cementitious slurry

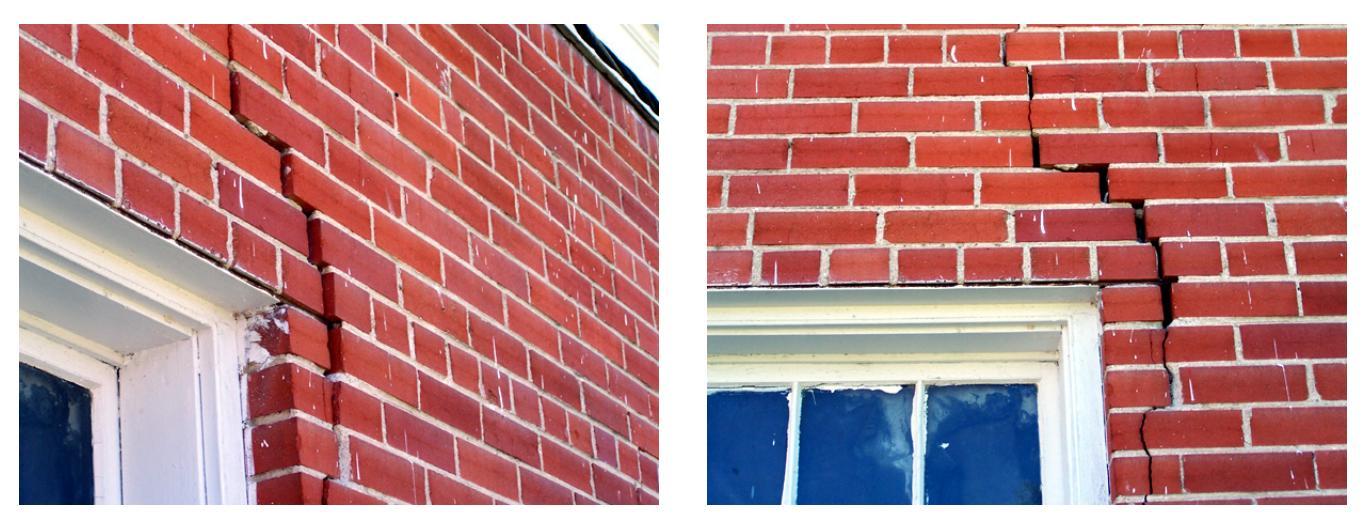
Critical crack above fixed window on the east elevation of the Two-Story Garage

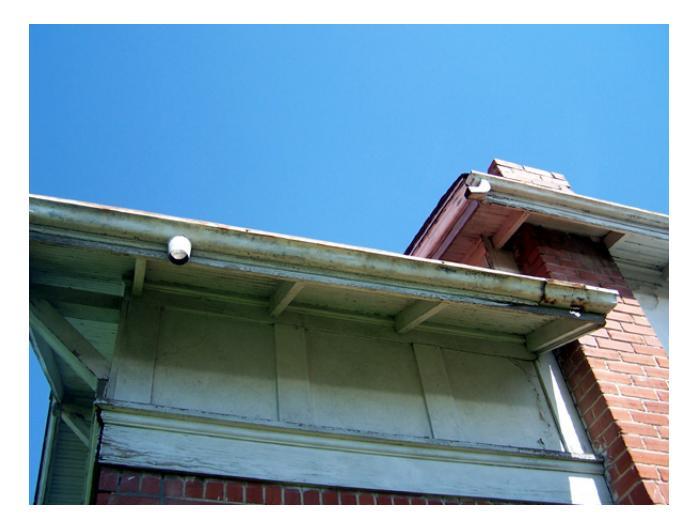
Rusted gutters and missing downspouts

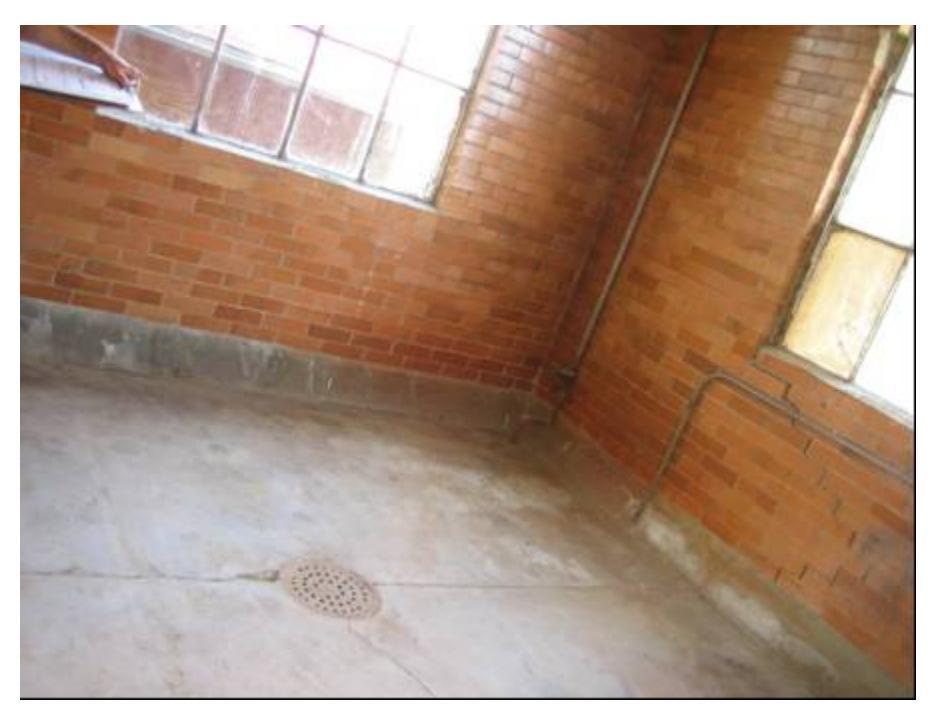
Stair step cracking and slab cracking in northeast corner

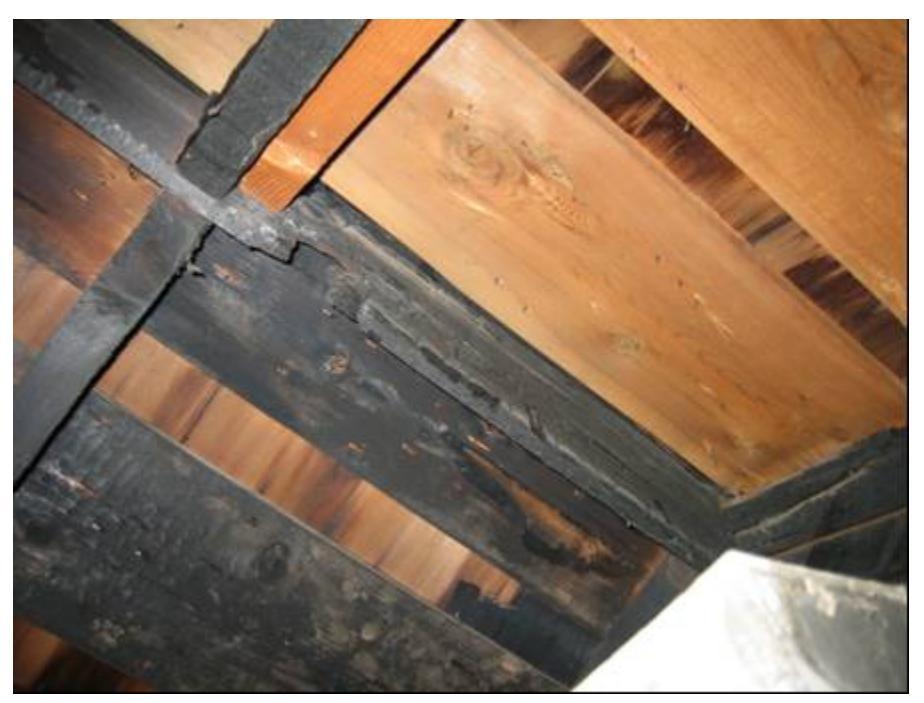
Fire damaged roof framing

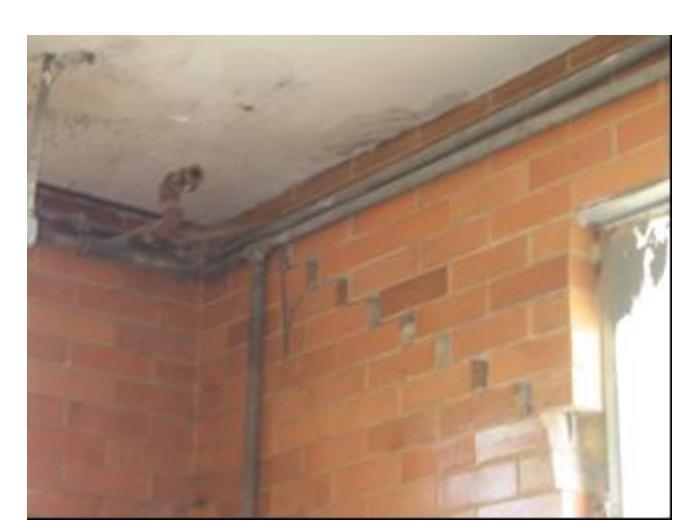
Stair step cracking on north side of east wall

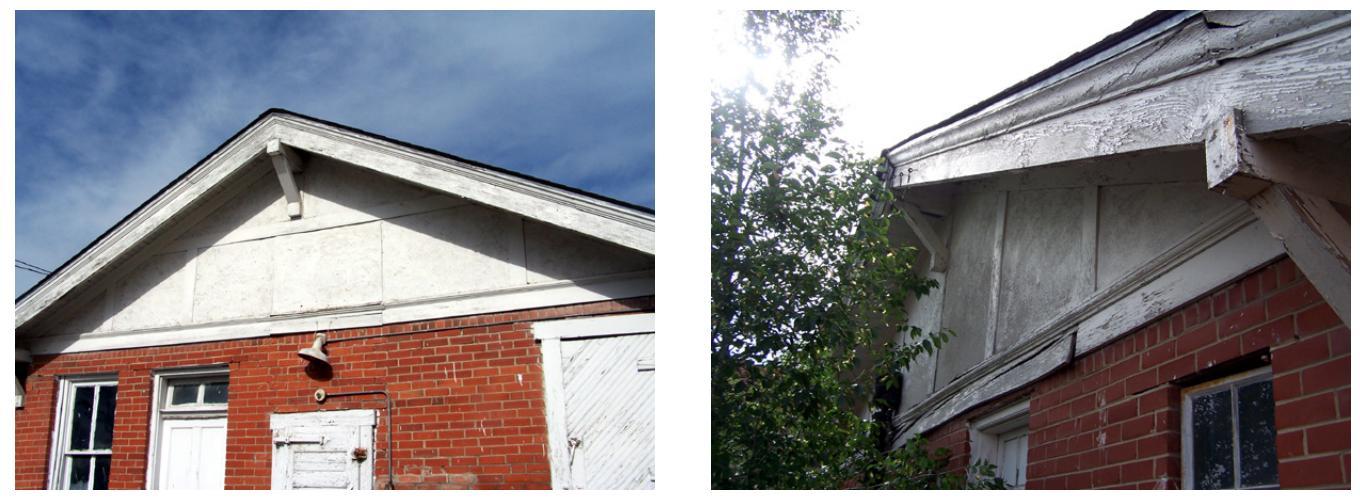
Gable ends infilled with stucco and painted decorative "stickwork" trim on the east and north elevations.

It is recommended a paint analysis be completed to determine the original finish of the decorative "stickwork" at the gable ends. Once determined, the non-historic paint should be removed at the "stickwork" trim areas. Refinish to match per historic photographs. Patch and repair stucco sections between the decorative trim, paint to match original.

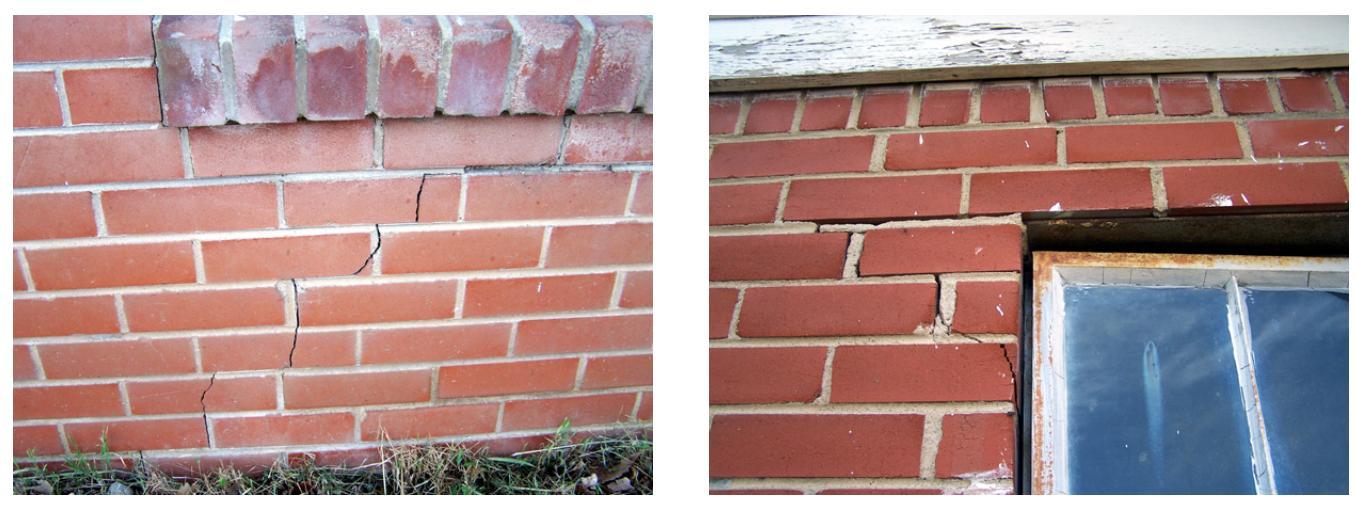
Areas of minor stair-step cracking above and below original windows

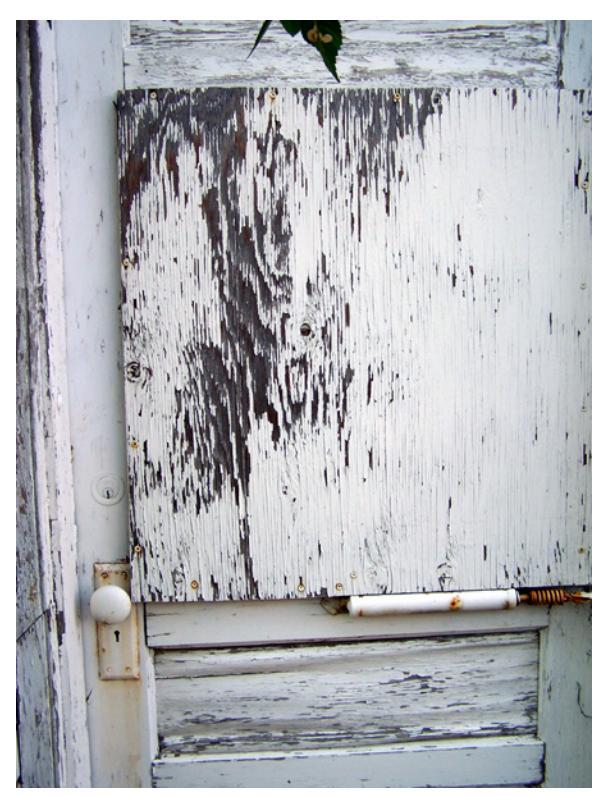
Wood board covering missing window glazing on the north door

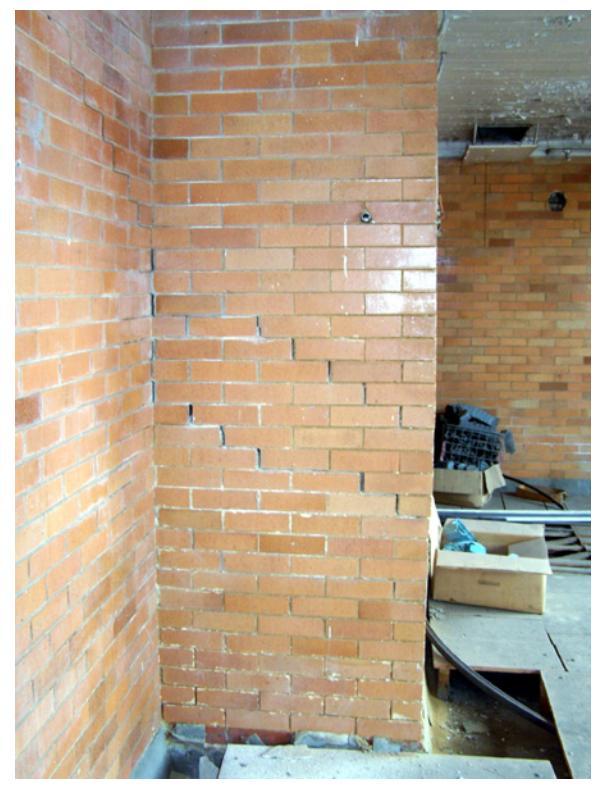
Stair-step crack at bump out wall in Room 104

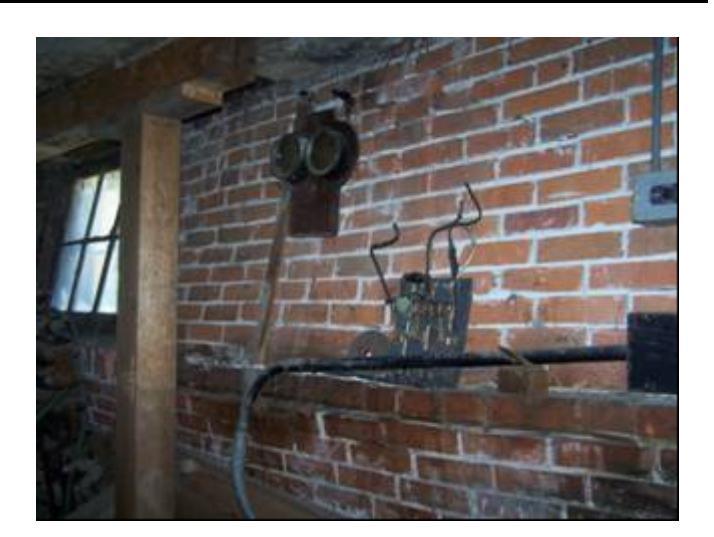
Distressed and deflected north wall from interior

RECOMMENDED TREATMENT:	In the current condition the Pump House is not safe for occupancy. It is recommended that the soil around the perimeter be removed immediately to prevent collapse. A pump or drain system will need to be provided to prevent the excavated area from filling with water.
	If the Pump House is to become occupied in the future, it is recommended that concrete retaining walls and footings be introduced up to the grade elevation and that all of the brick walls be removed and rebuilt. The brick walls can be rebuilt utilizing the salvaged bricks, and be built off the top of or just inside the new concrete retaining walls. But, severely deteriorated bricks are not considered salvageable so some new bricks will need to be introduced. A perimeter drain is also recommended in conjunction with this repair.
	The slab-on-grade is in serviceable condition, but will likely need to be removed in order to rebuild the walls and install competent foundation elements.

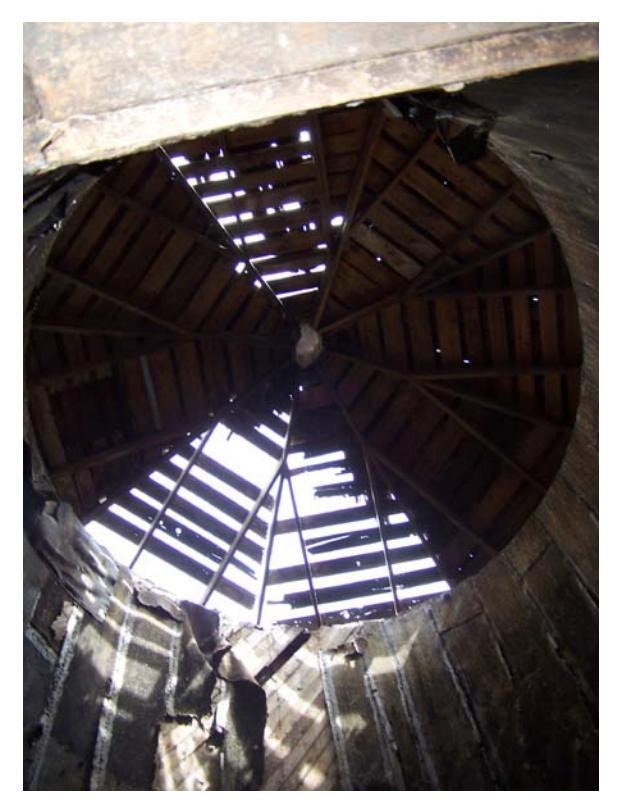
Segmented roof of Wood Silo with missing sheathing and shingles.

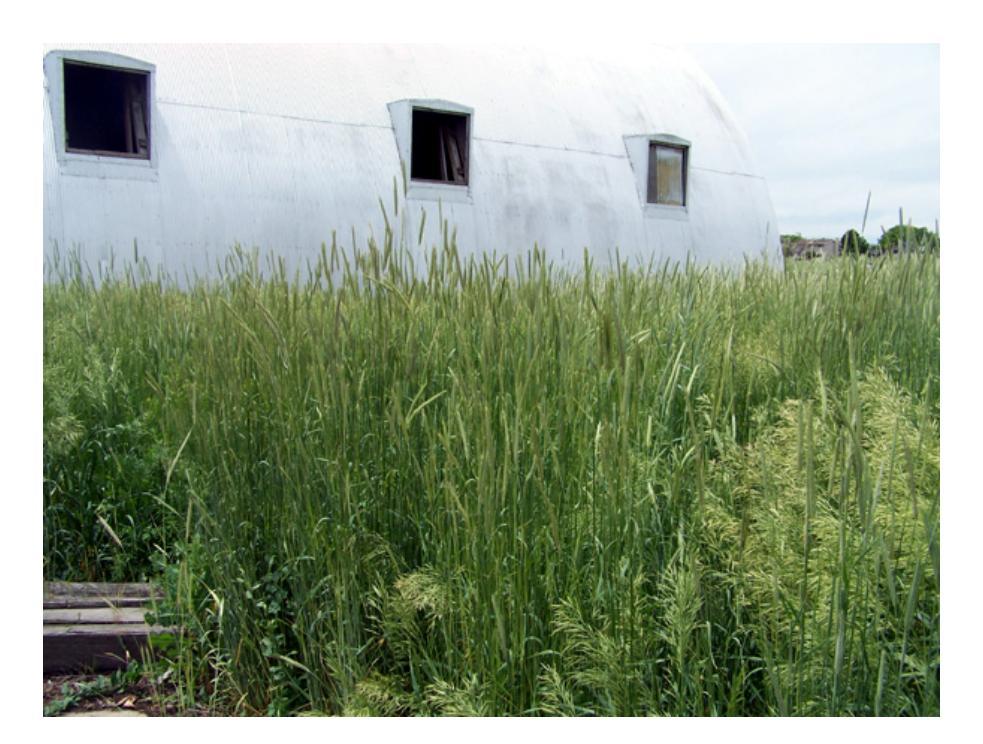
CATEGORY:	3.6b Windows
DESCRIPTION:	Twenty windows exist on the four elevations of the Quonset. They are nine-lite steel windows and are located approximately halfway up the curved side arches and the flat ends of the structure. It is unknown if they are operable.
EVALUATION:	Observations of the windows were limited to those from the building exterior and interior spaces. In general, the windows look to be in fair to poor condition. Several are missing panes of glass and are covered with translucent corrugated plastic.
RECOMMENDED TREATMENT:	All windows need to be restored or replaced in kind with a nine-lite design to match the original size. Further investigation should be conducted to determine the levels of deterioration and rehabilitation of the original design.
