**APPLICATION
For
VOLUNTARY CLEAN UP PLAN**

**3630 WEST 73RD AVE AND 7227 & 7287 LOWELL BOULEVARD
- WESTMINSTER, COLORADO**

March 9, 2020

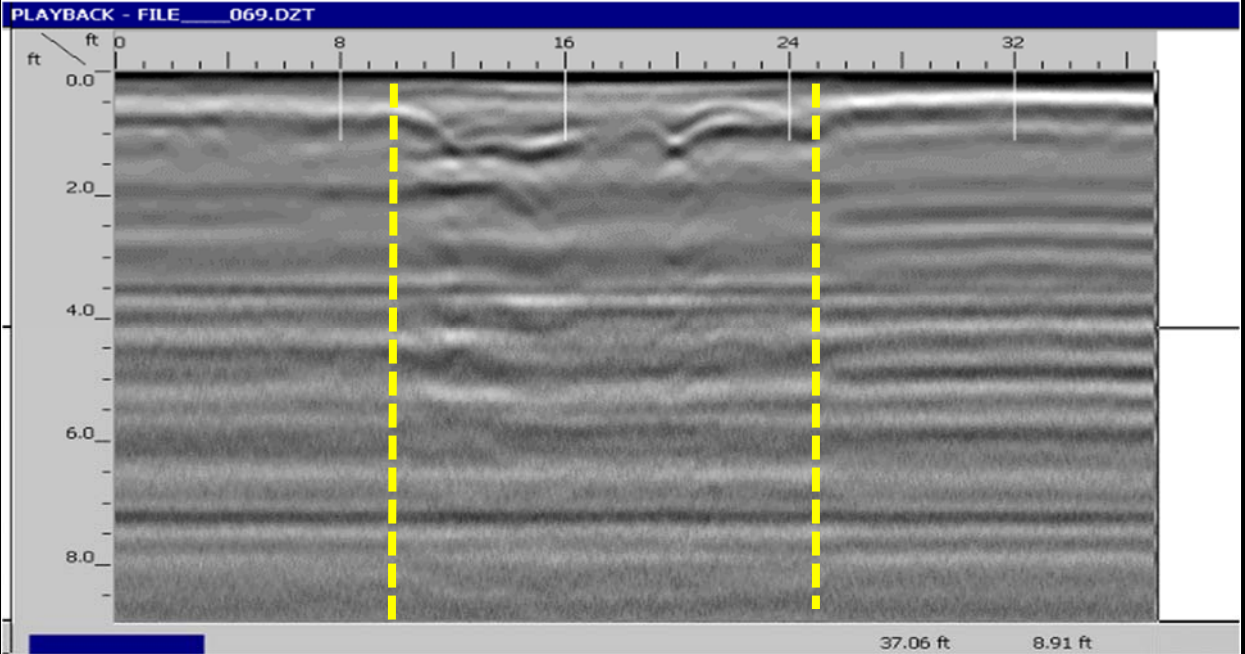
GPR Data Screenshot and Photo of Location

GPR data screenshot. The depth scale is on the left and the distance of the scan is across the top, forming a cross section view of the subsurface. Yellow hash marks indicate the start and finish of the disturbed soil indicating a potential former UST basin.

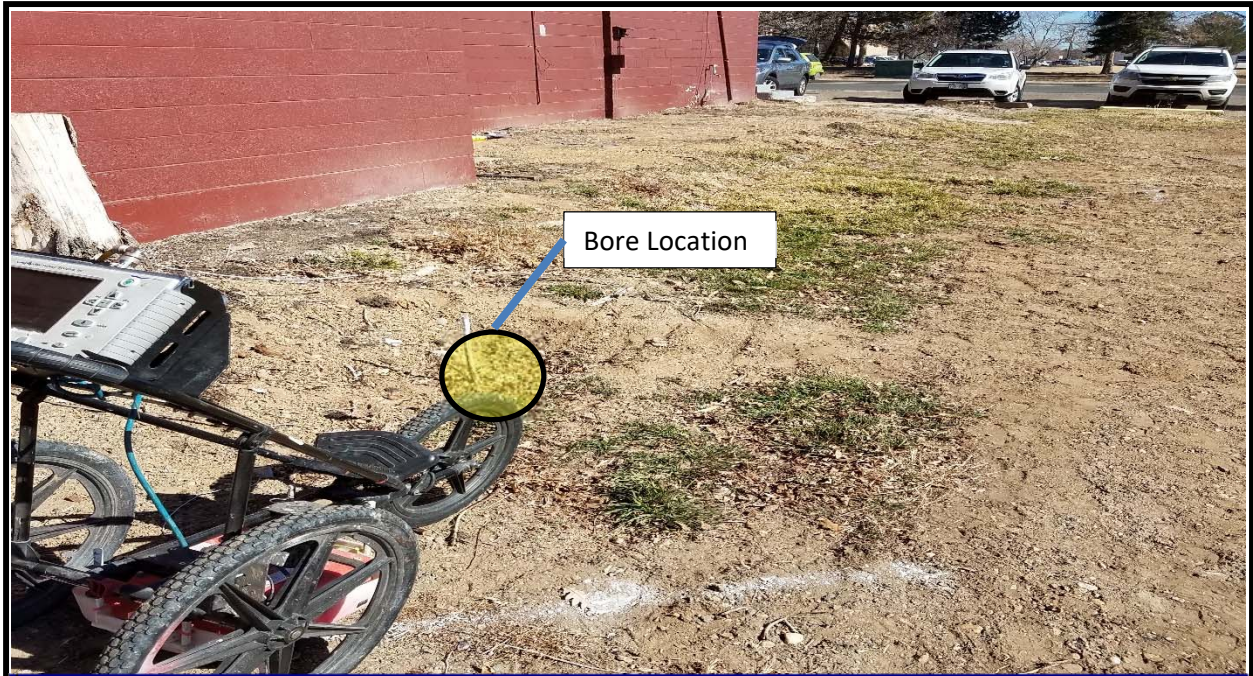
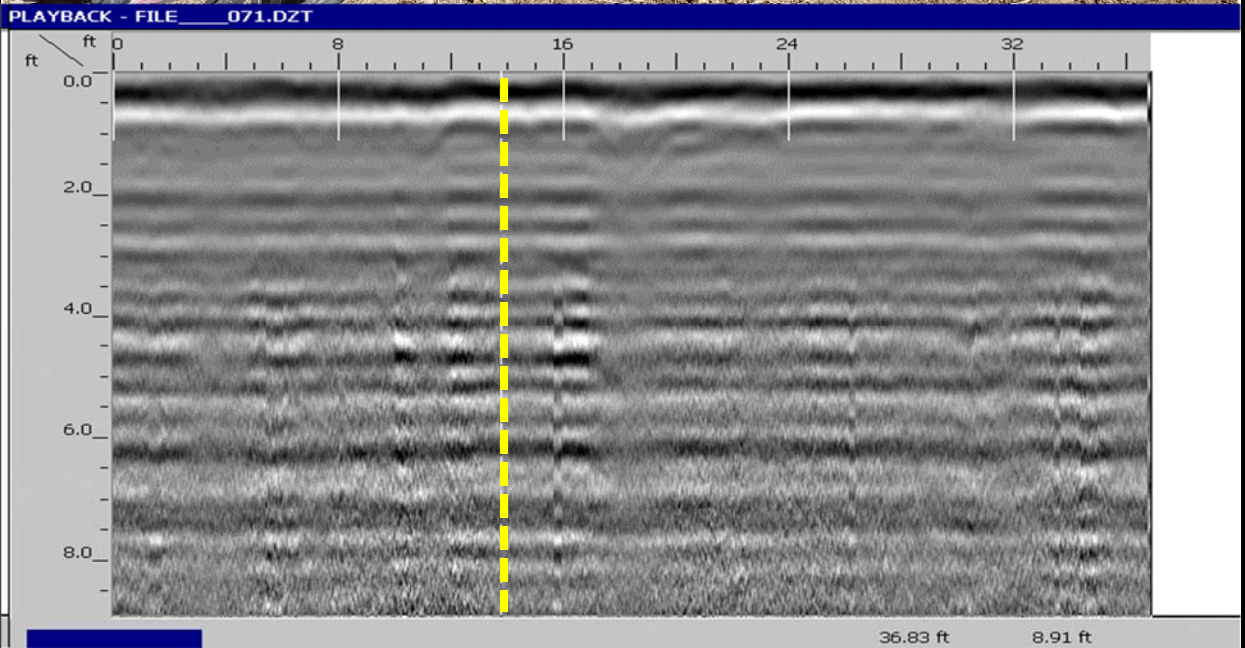
GPR Data Screenshot and Photo of Location

GPR data screenshot of boring location. The depth scale is on the left and the distance of the scan is across the top, forming a cross section view of the subsurface. Yellow hash mark indicates boring location.

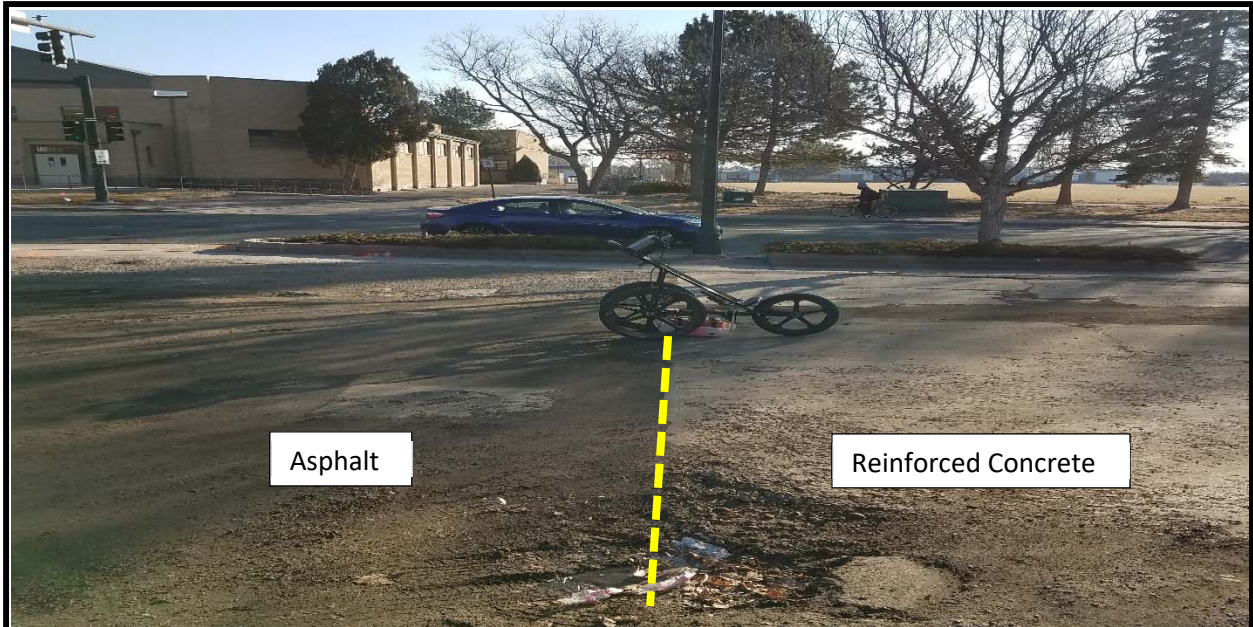
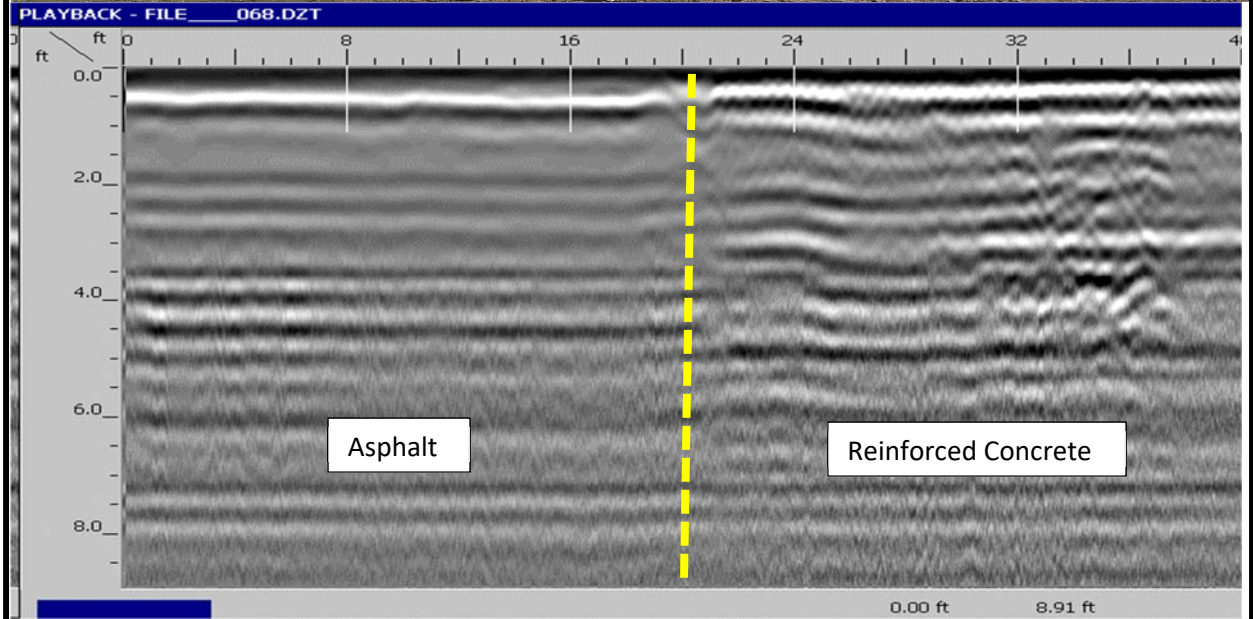
GPR Data Screenshot and Photo of Location

GPR data screenshot of boring Location. The depth scale is on the left and the distance of the scan is across the top, forming a cross section view of the subsurface. Yellow line indicates the line between asphalt and heavily reinforced concrete. Notice the max GPR depth is different between the two due to the heavy reinforcement. Most of these areas around the building varied between asphalt and concrete.

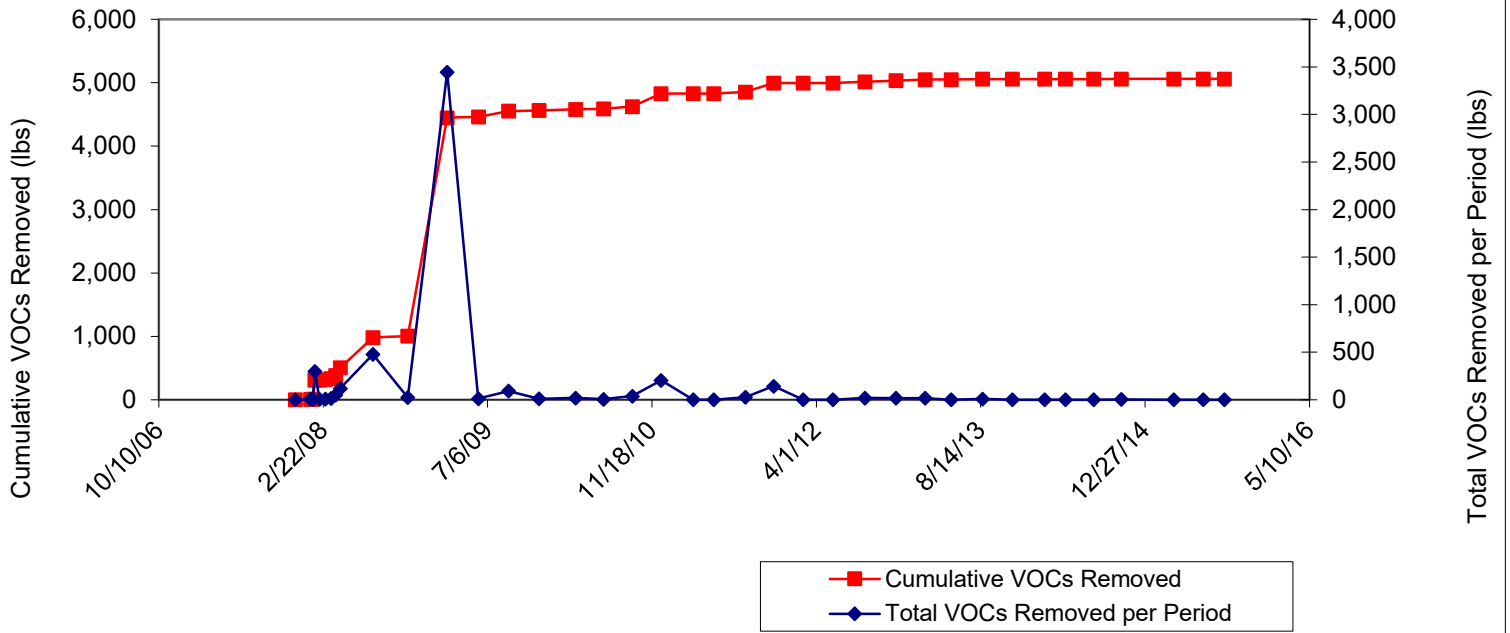
VOCs Removed - Field PID

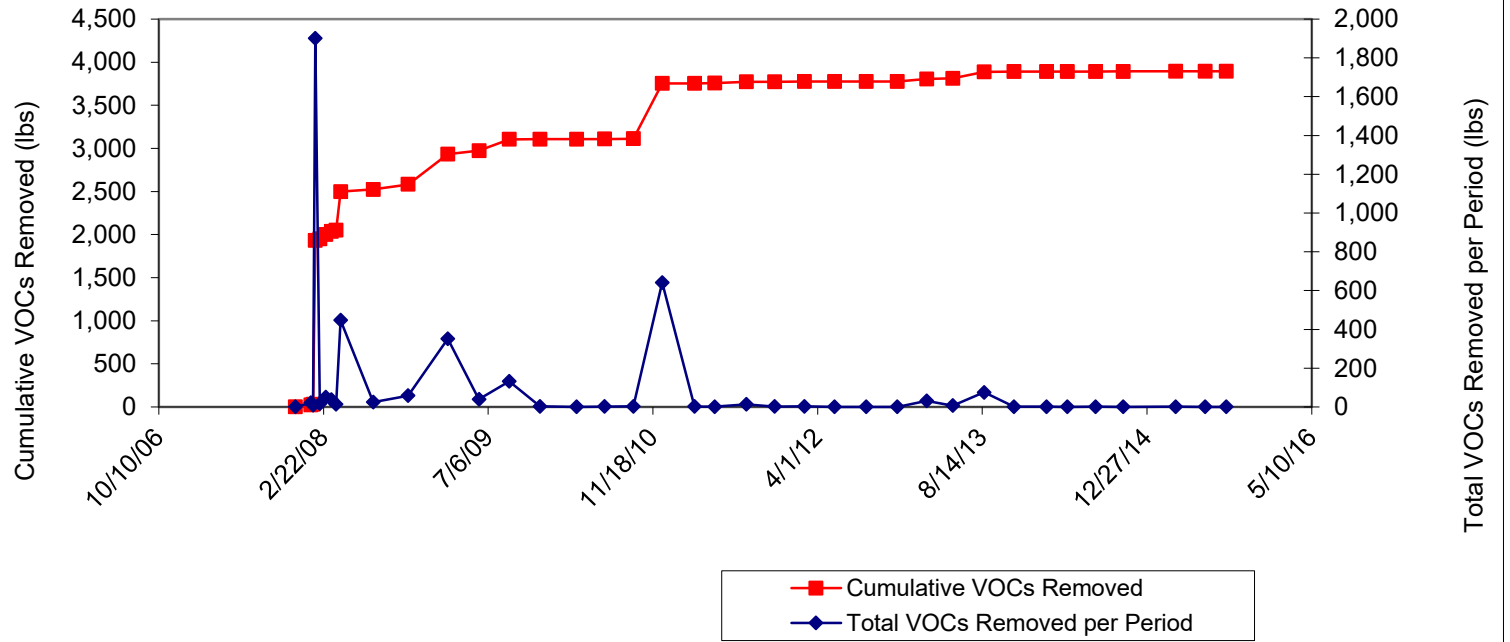
VOCs Removed - Lab Analysis

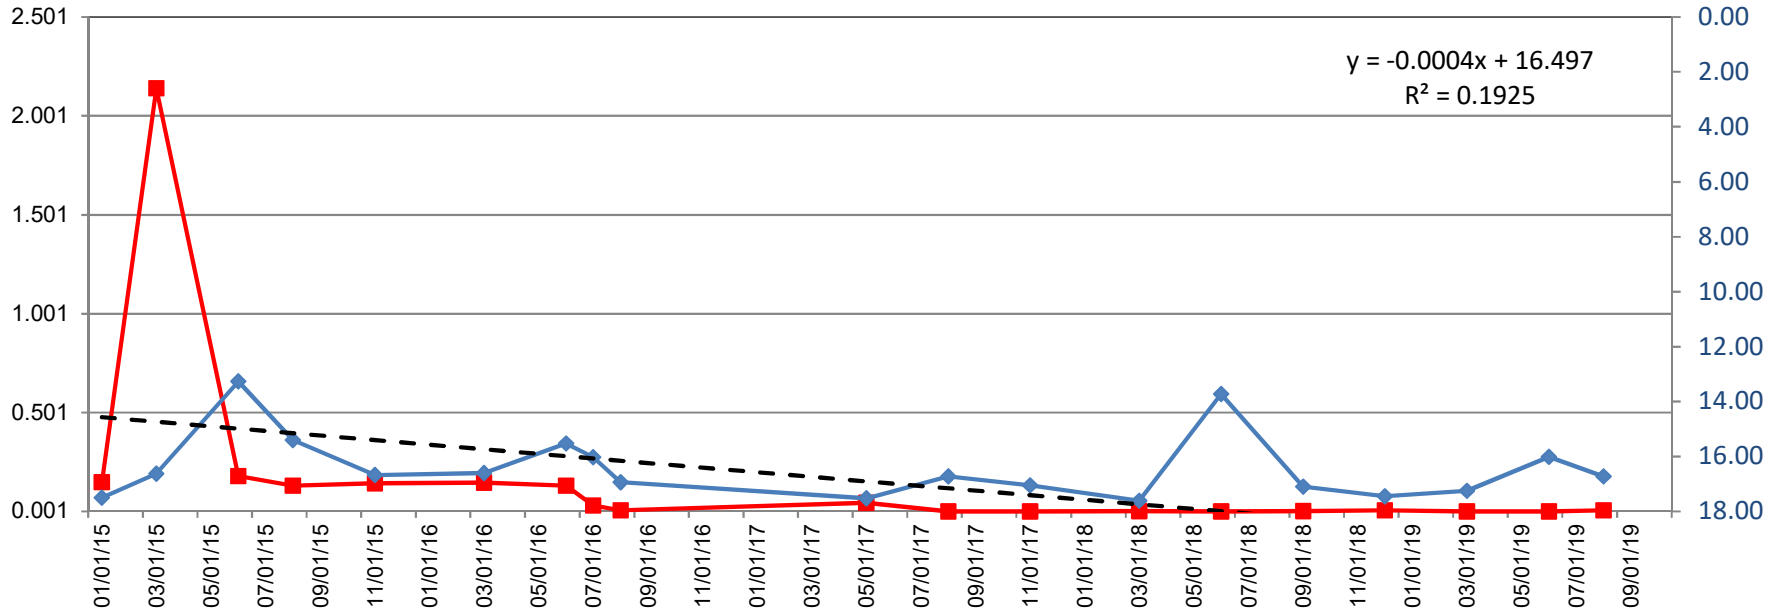
**Former Pik Kwik - OPS Event ID 1989
Benzene Trend - MW-11**

■ MW-11 (mg/L) ◆ Groundwater Depth (ft)
- - - Linear (MW-11 (mg/L))

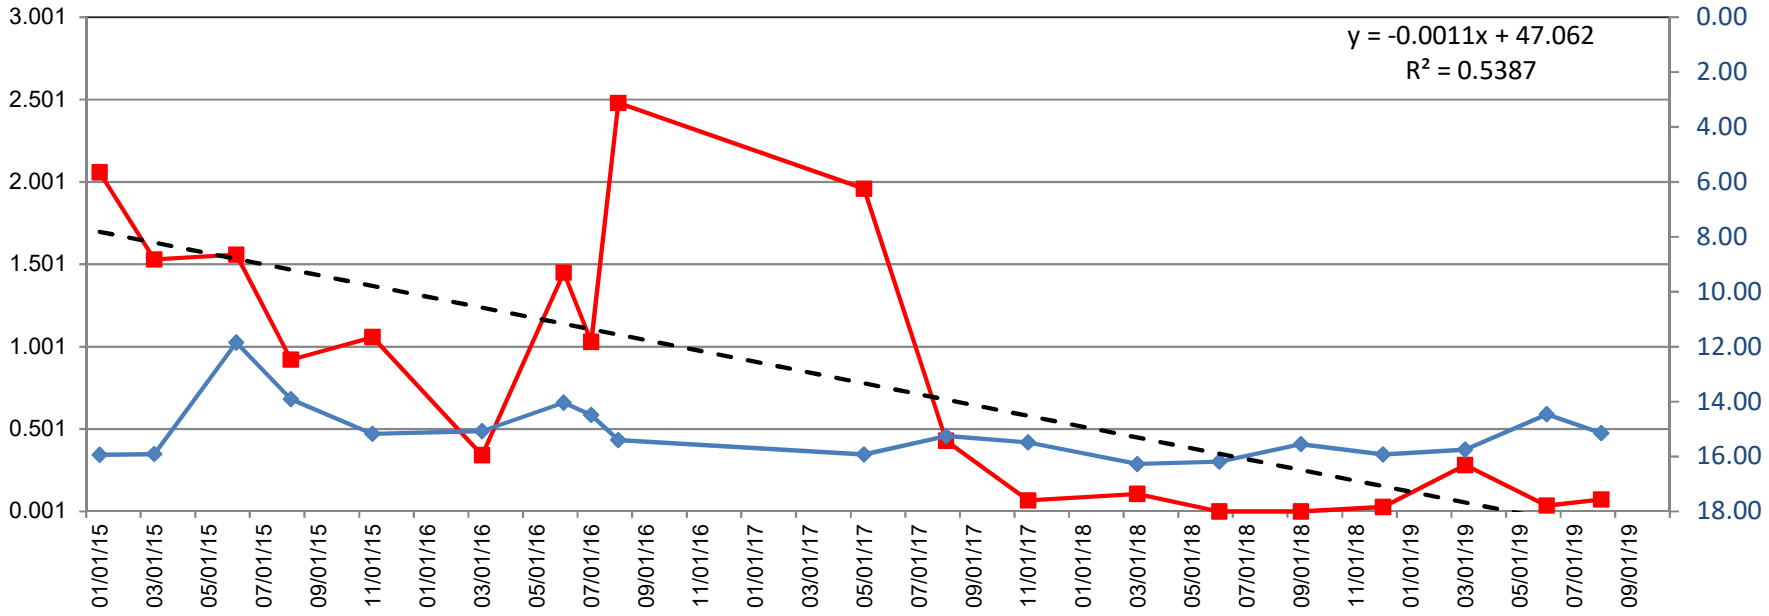
**Former Pik Kwik - OPS Event ID 1989
Benzene Trend - MW-14**

■ MW-14 (mg/L) ◆ Groundwater Depth (ft)
- - - Linear (MW-14 (mg/L))

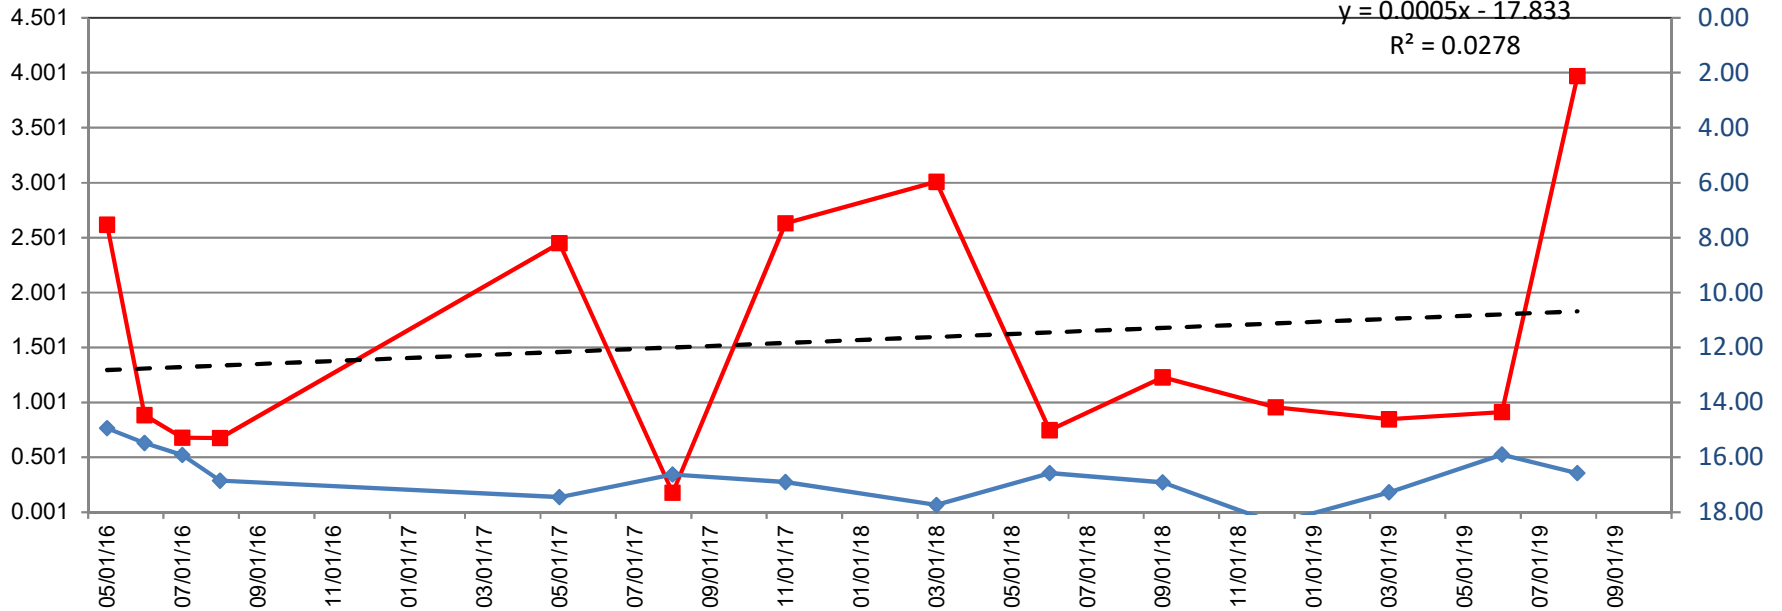
**Former Pik Kwik - OPS Event ID 1989
Benzene Trend - MW-16**

- MW-16 (mg/L)
- ◆ Groundwater Depth (ft)
- - - Linear (MW-16 (mg/L))

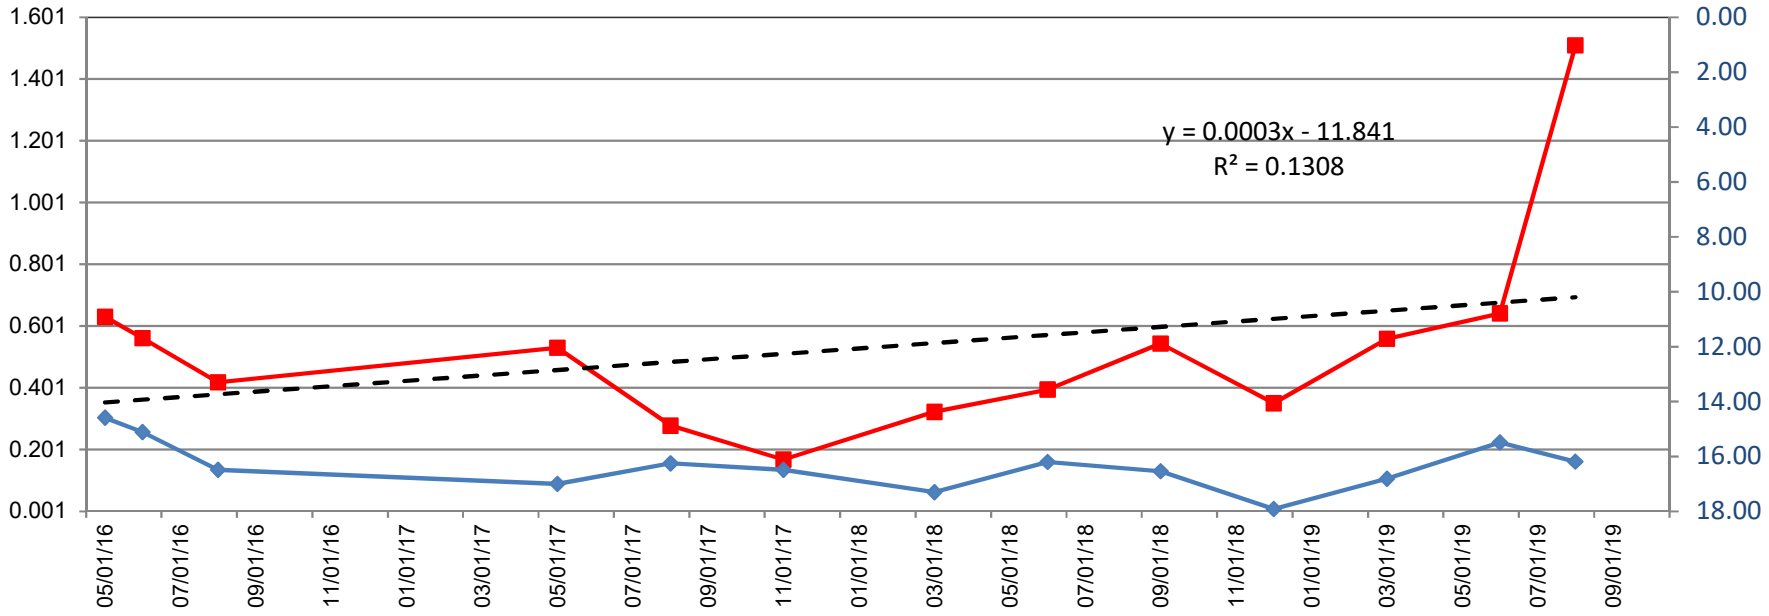
**Former Pik Kwik - OPS Event ID 1989
Benzene Trend - MW-17**

■ MW-17 (mg/L) ◆ Groundwater Depth (ft)
- - - Linear (MW-17 (mg/L))

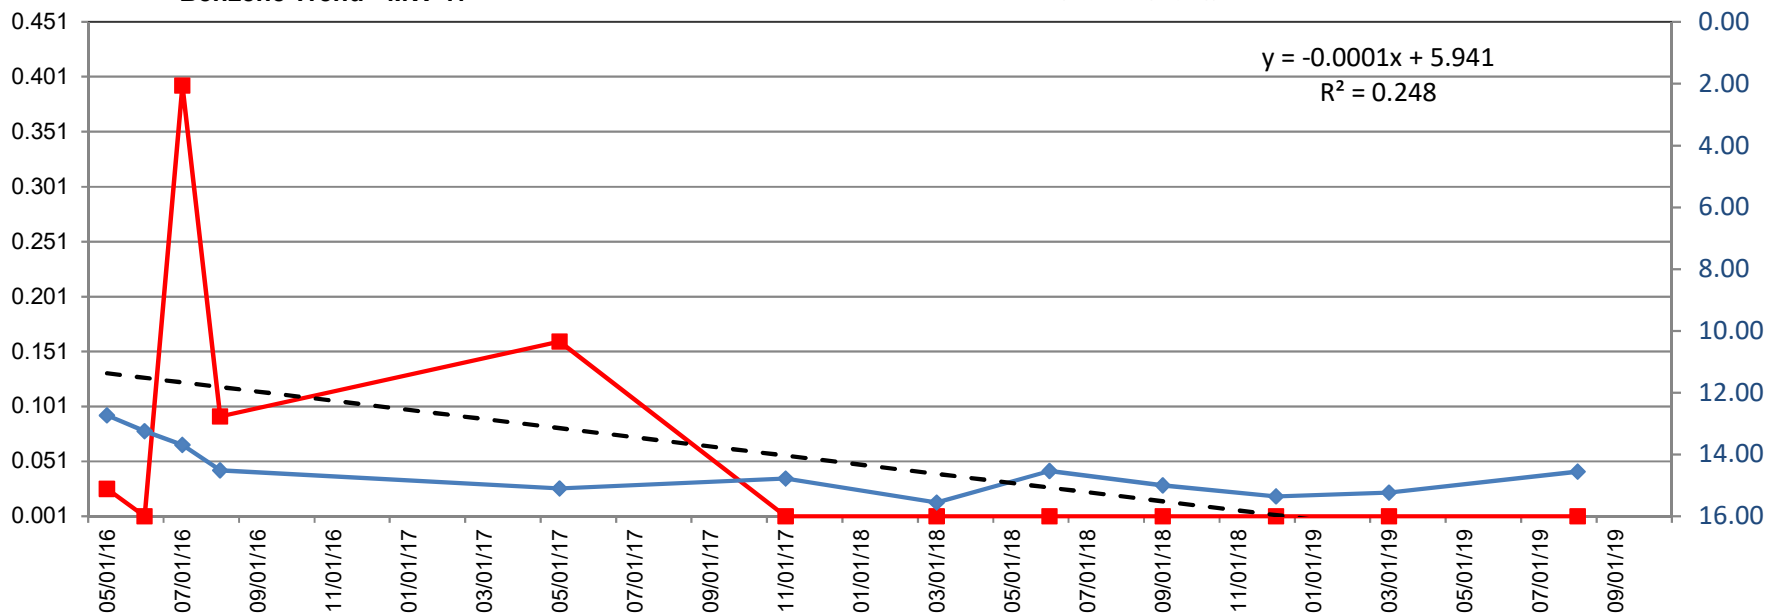
**Former Pik Kwik - OPS Event ID 1989
Benzene Trend - MW-19**

■ MW-19 (mg/L) ◆ Groundwater Depth (ft)
- - - Linear (MW-19 (mg/L)) $y = 0.0002x - 7.7817$
 $R^2 = 0.0044$

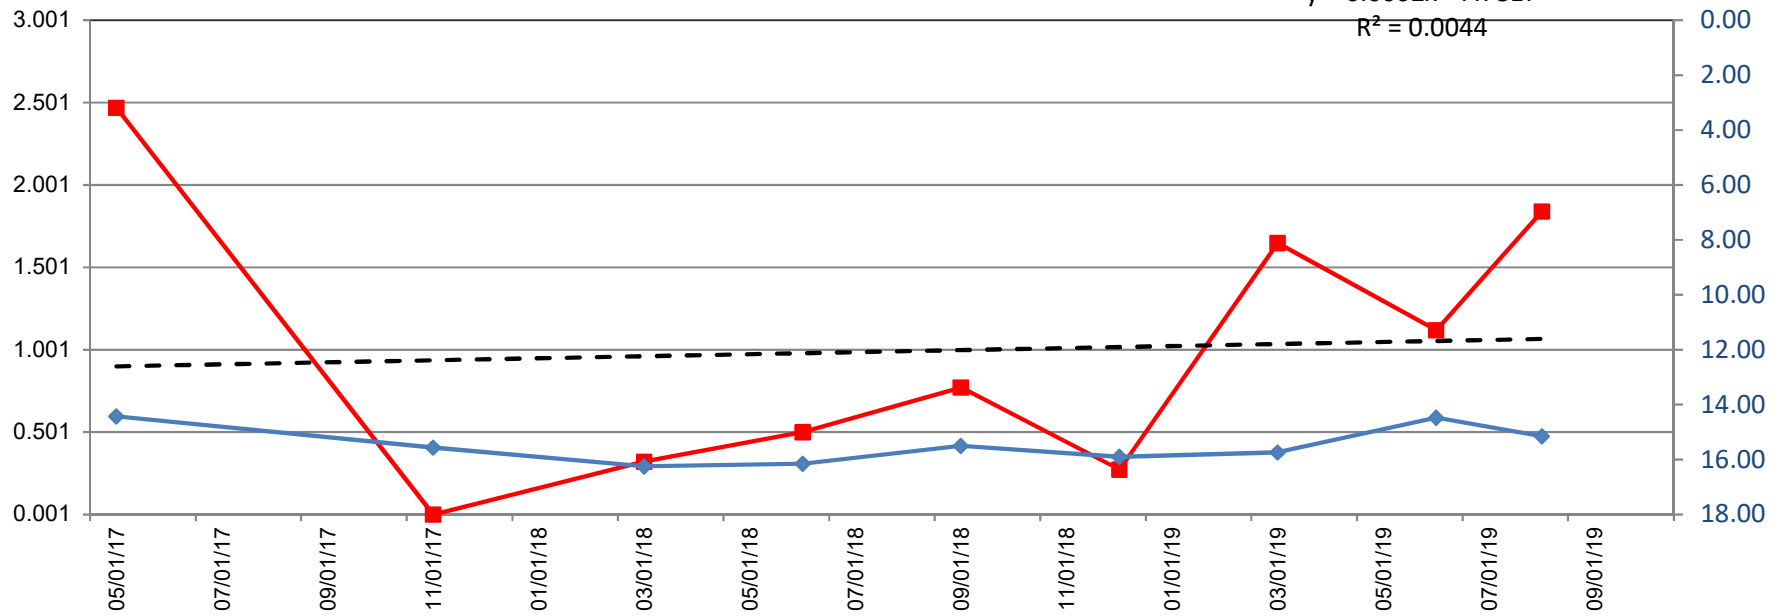
**Former Pik Kwik - OPS Event ID 1989
Benzene Trend - SVE-04**

■ SVE-04 (mg/L) ◆ Groundwater Depth (ft)
- - - Linear (SVE-04 (mg/L))
