Shoenberg Farm

Historic Structures Assessment Project #2007-M2-011 March 14, 2008

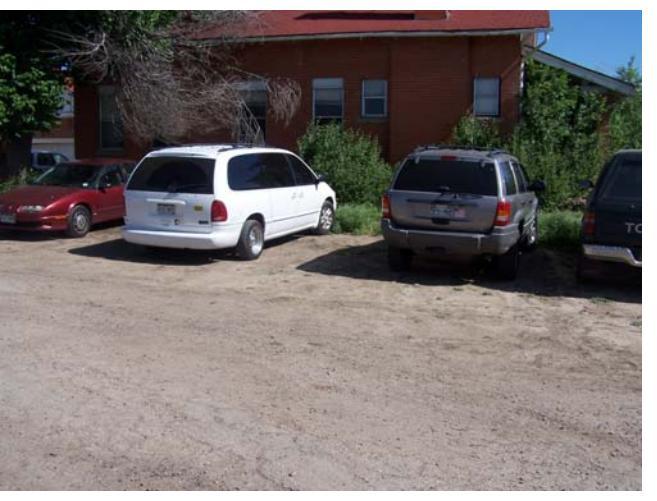
Parking area south of the 1911 Brick Bungalow

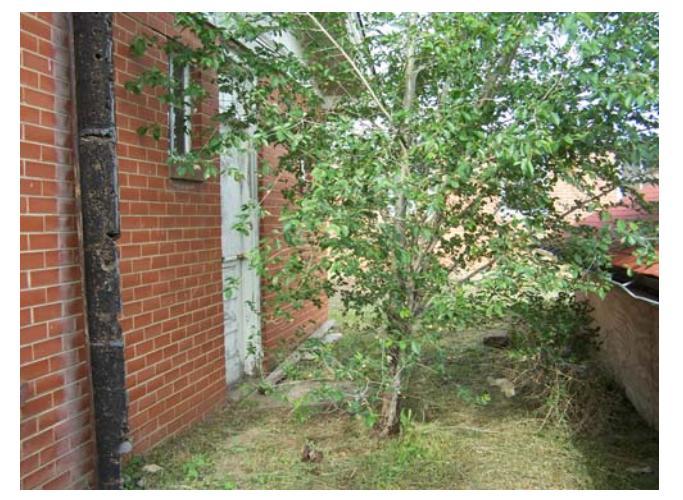
Volunteer tree between 1911 Brick Milk and Ice House and 1911 Brick Pump House

RECOMMENDATED TREATMENT:	Trim the overgrown grasses and shrubbery surrounding all the existing structures at the site. Remove the volunteer groves of trees adjacent to the structures so as to provide clear access paths and diminish damage to the foundations.
	Repair the concrete sidewalks and driveway as necessary for possible future tenant use. Slope the sidewalks away from the

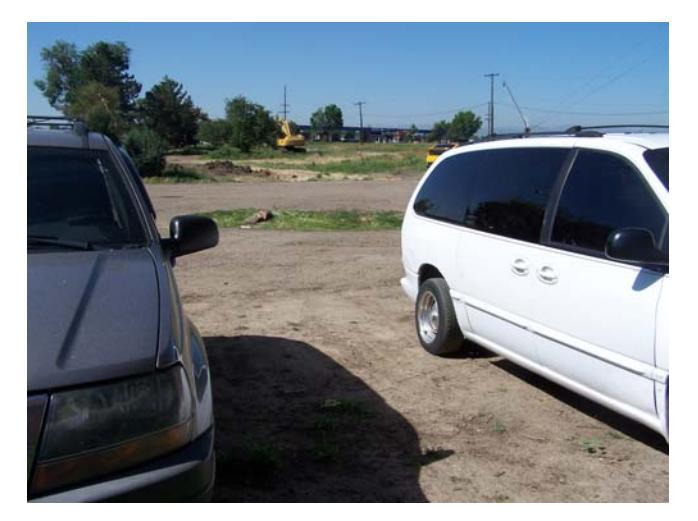
View of graded dirt parking area

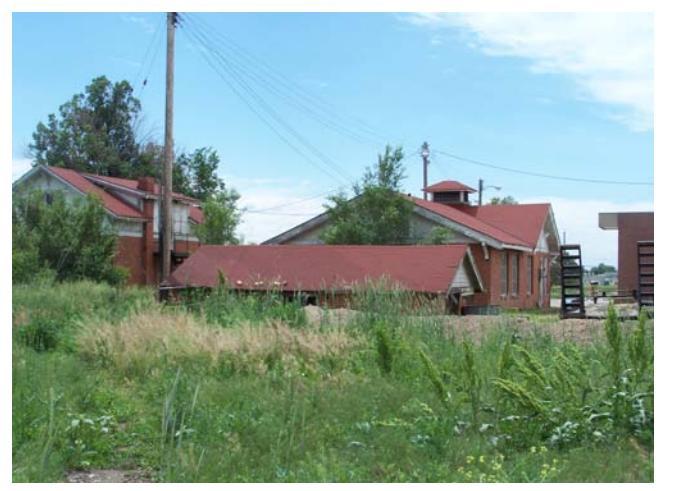
Site north of Pump House and Brick Milk and Ice House showing overgrown grasses and volunteer trees

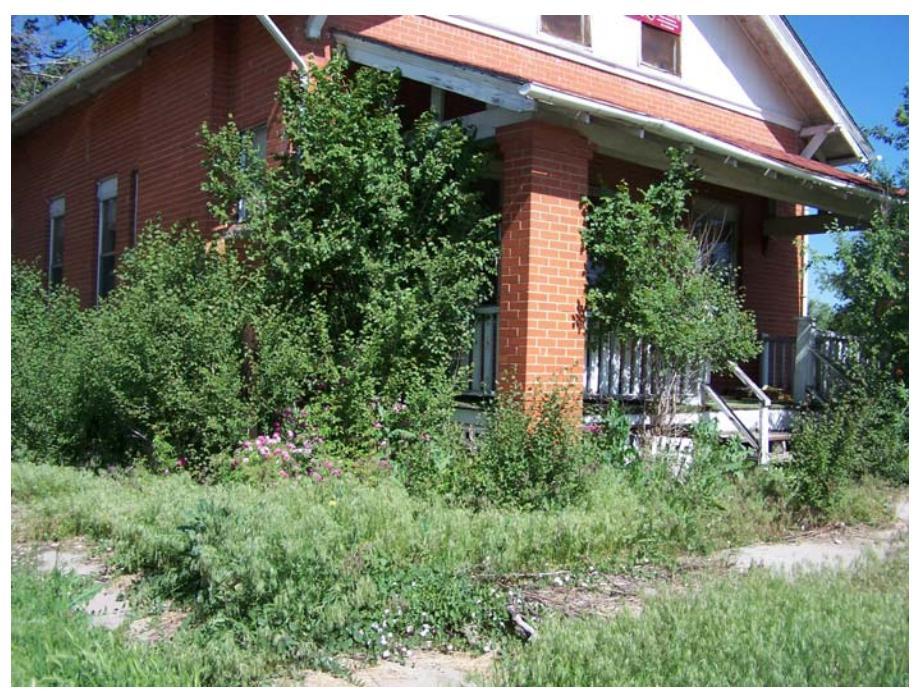
Overgrown volunteer grasses and trees at east entrance of 1911 Brick Bungalow

EVALUATION: In general, the site at the 1911 Brick Bungalow is in poor condition. The grasses and shrubbery have been allowed to overgrow, specifically at the northern edge of the structure. The large tree has a significant number of

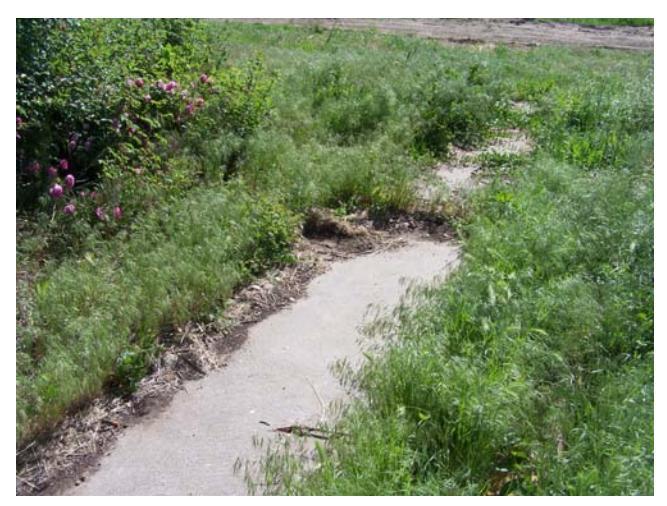
Three-foot-wide concrete sidewalk and overgrown grasses at south elevation of 1911 Brick Bungalow.

Replace the concrete sidewalk. Slope the sidewalks away from the structures to allow for proper water drainage.

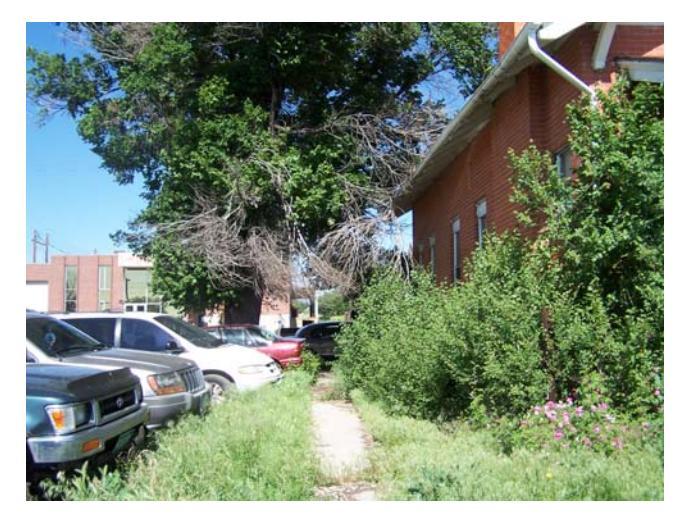
dead branches and limbs, inhibiting proper roof drainage at the south elevation of the structure. The concrete sidewalk is spalling and cracked in multiple locations. The west concrete porch has significant cracking and spalling. Vegetation has been allowed to grow in the existing cracks, further expanding the deterioration of the sidewalk.

Old growth tree with dead branches and concrete sidewalk at south elevation of 1911 Brick Bungalow

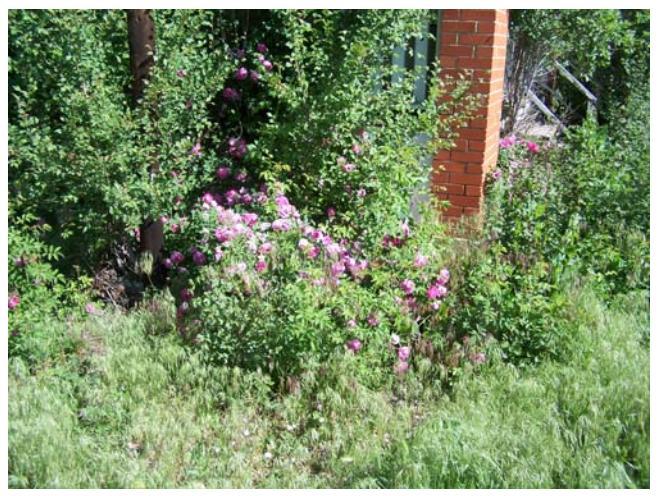
Climbing roses at southeast porch corner of 1911 Brick Bungalow

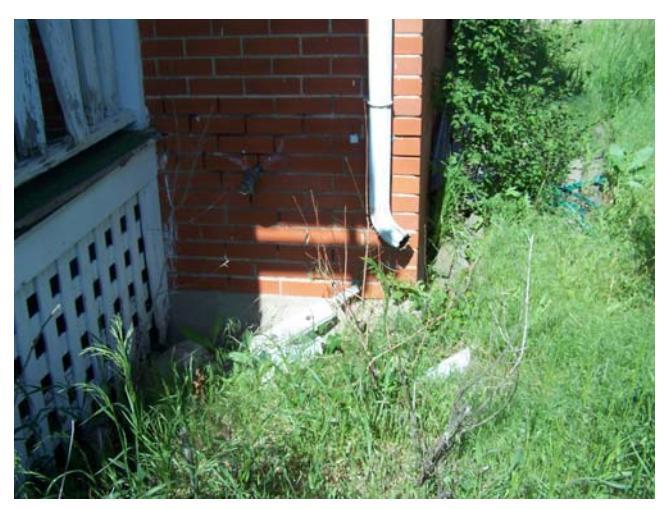
There is inadequate slope away from the structure to allow proper water drainage, specifically at the northeast corner downspout.

Negative slope at downspouts on northeast corner of 1911 Brick Bungalow

Re-slope the dirt graded area at the northeast corner of the porch and Bungalow, just below the existing downspout to allow water to drain away from the porch and foundation

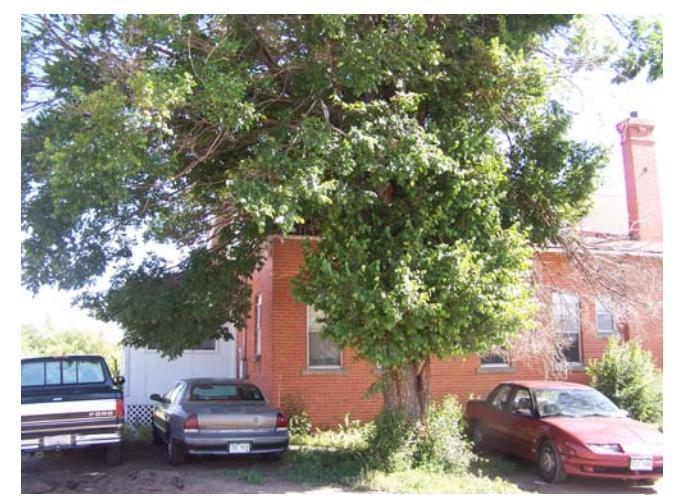
Large tree at southwest corner of 1911 Brick Bungalow.

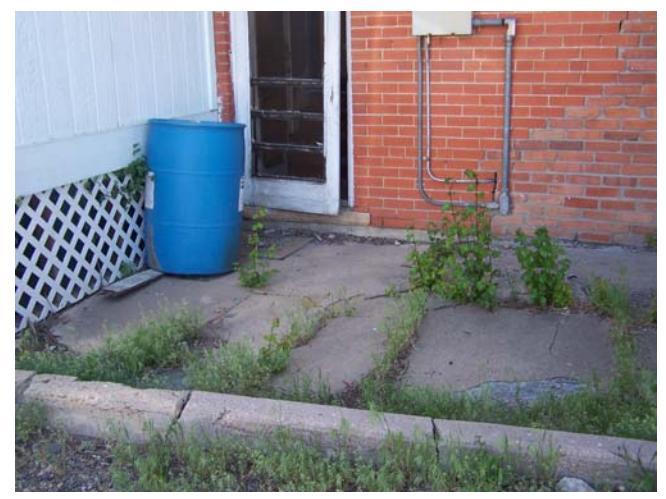
Termination of concrete sidewalk at west elevation of 1911 Brick Bungalow

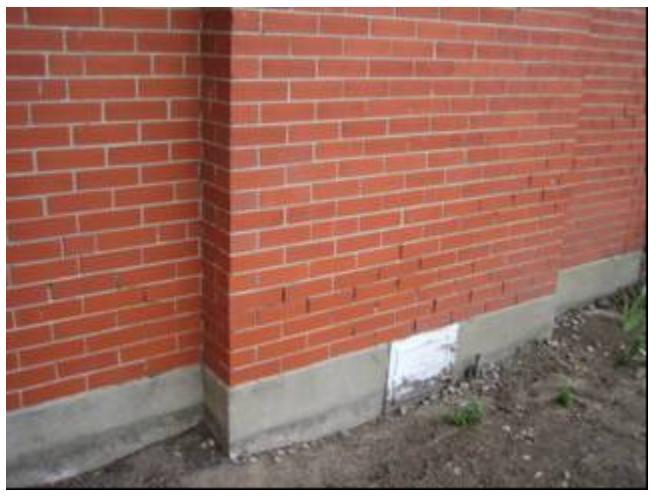
Concrete parging along south elevation of Bungalow.

A perimeter drain should be installed to prevent hydrostatic pressure build-up on the basement walls. The walls should be waterproofed with an appropriate membrane waterproofing system over the exterior face to prevent water infiltration and degradation of the walls. Some mortar and brick replacement may be necessary if deterioration of the exterior wythe is discovered during excavation.

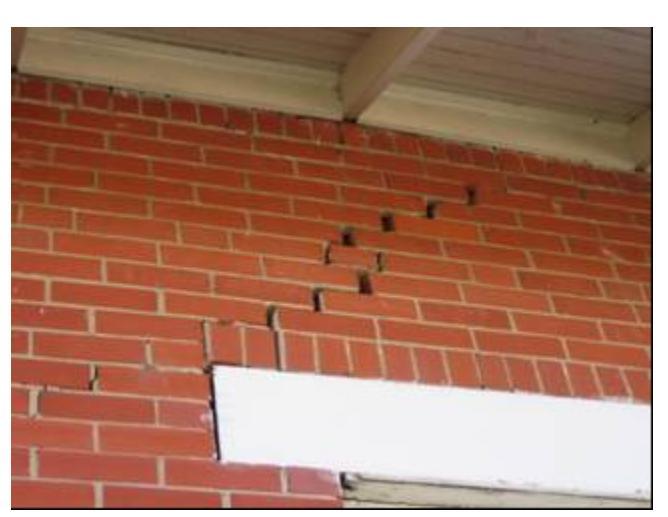
Stair step cracking is visible in the brick walls above grade. These cracks are likely a result of foundation movement.

Stair step cracking along north elevation of Bungalow.

RECOMMENDED TREATMENT: The foundation should be underpinned to prevent further movement.

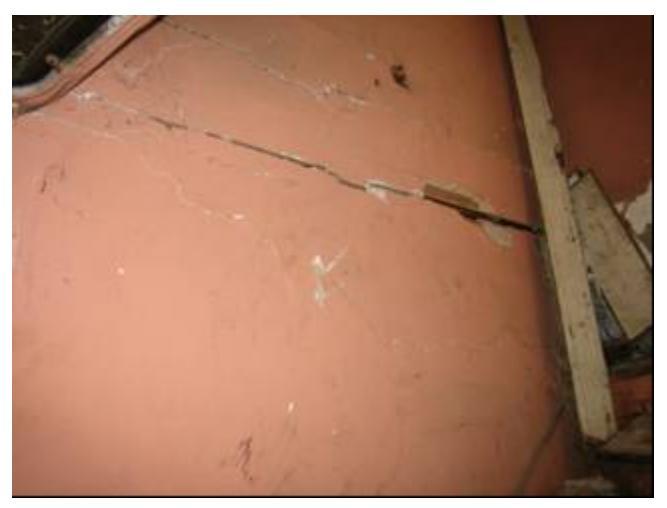
Crack in wall on south side of basement stairs

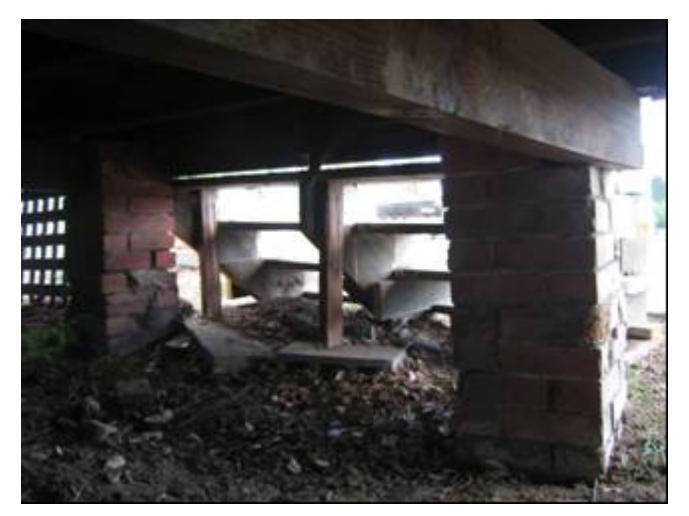
The four brick pilasters supporting the porch are in poor condition. The pilasters have twisted and are out of plumb due to movement of the underlying foundation elements. The pilasters' mortar and brick deterioration can be characterized as severe.

Twisted and deteriorated porch pilasters

The four brick porch pilasters should be removed and rebuilt on new concrete caissons or on stabilized (underpinned) existing footings.

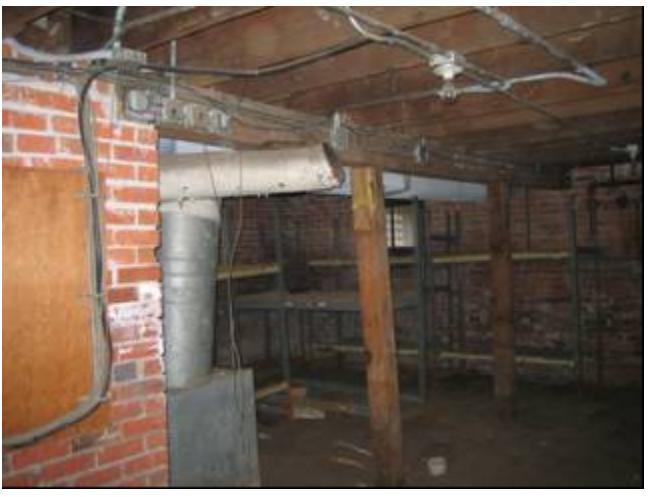
EVALUATION:	The first floor framing is in fair condition. Distress is evident in the first floor framing. In some locations the first floor deflects noticeably under a person's weight and is out of level.
	On the western portion of the building an approximately 1/2" high north-south running step is visible in the first floor finish, possibly indicating a compromised support condition for the floor joists below. As mentioned in the 'Foundation' section, the interior wood walls on the western third of the building have displaced along with the basement slab. The movement of the support walls is translating to the first floor joists.
	The east-west running brick bearing wall located in the middle section of the building appears to be in good condition.
	The 6x8 supporting the first floor joists on the eastern third of the building is visibly distressed. One of the 6x6 posts has lost engagement with both the beam above and the foundation below and is thus ineffective. The bottom of the post has rotted where in contact with the slab. As a result the 6x8 beam has deflected and developed horizontal cracks near the original location of the post.

Post-and-beam construction on east side of Bungalow. Note: near post is not flush with bottom of wood beam

The floor joists and the wood bearing wall on the west half of the building will need to be exposed so that their condition can be assessed and their capacities calculated. Given the current condition and performance of the first floor, some reinforcing, repair, or replacement of these elements should be expected.

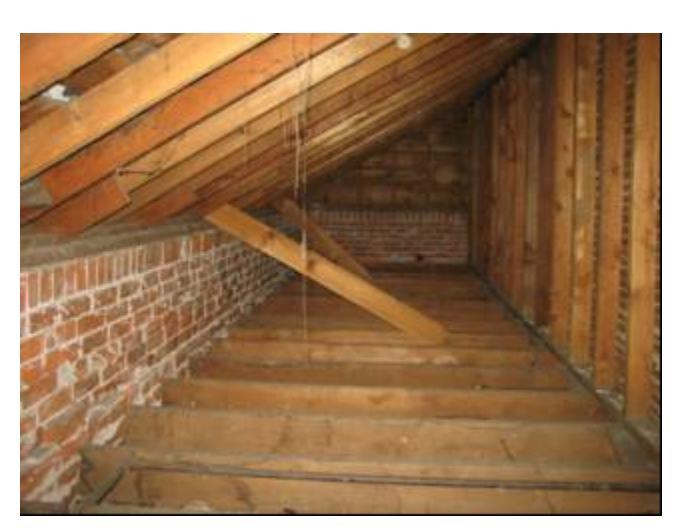
Bungalow north attic. Note: exterior brick bearing wall, sloped roof rafters, second floor joists, and cripple wall.

The roof framing will need to be investigated further to determine its condition and capacity. Based on preliminary calculations some selective reinforcing should be expected.

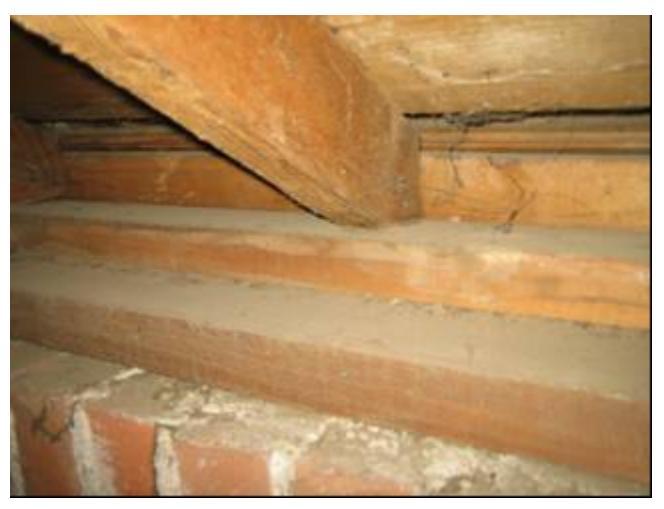
Roof rafter connection to wood plate atop exterior wall

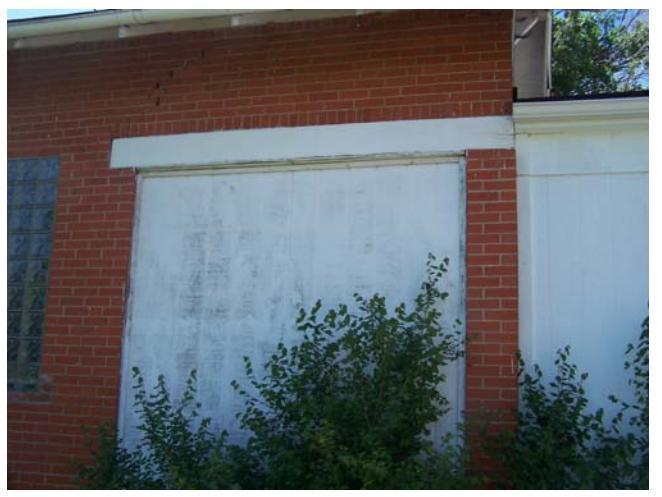
1911 Brick Bungalow. North elevation showing wood infill

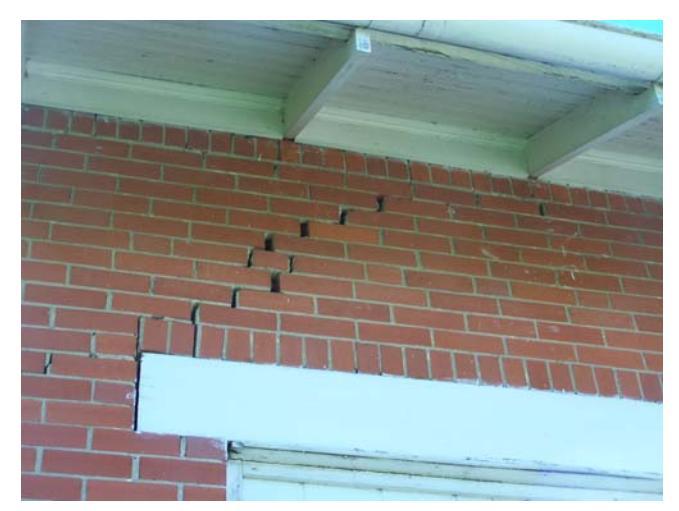
1911 Brick Bungalow. Note large stair-stepping crack above wood infill at north elevation.

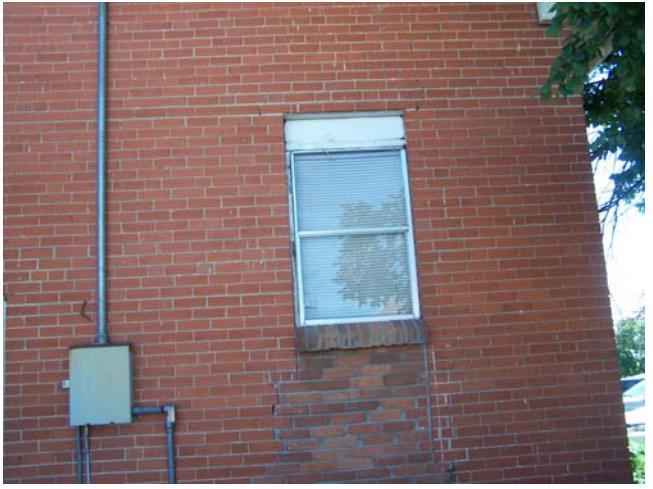
1911 Brick Bungalow. Brick infill at original door location on west elevation. Note brick sill element.

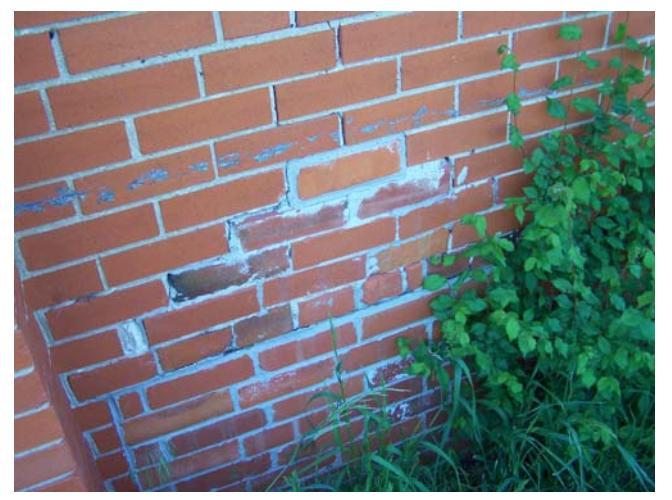
1911 Brick Bungalow. Mortar patch with non-historic cementitious mortar

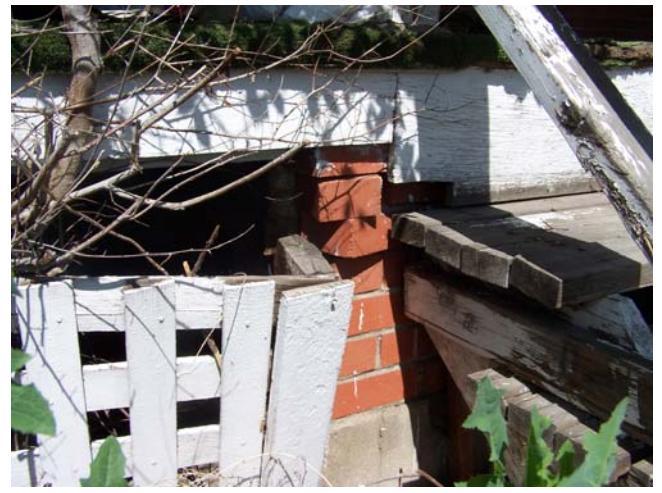
1911 Brick Bungalow. Brick piers supporting porch floor deck

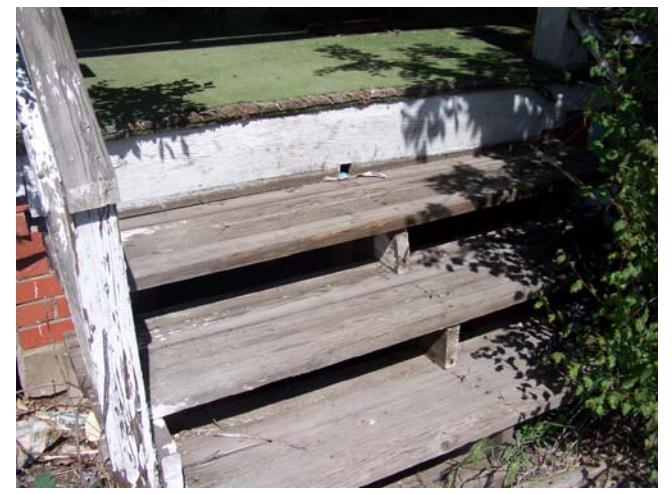
1911 Brick Bungalow. Wood stairs and tongue and groove flooring at east porch appendage

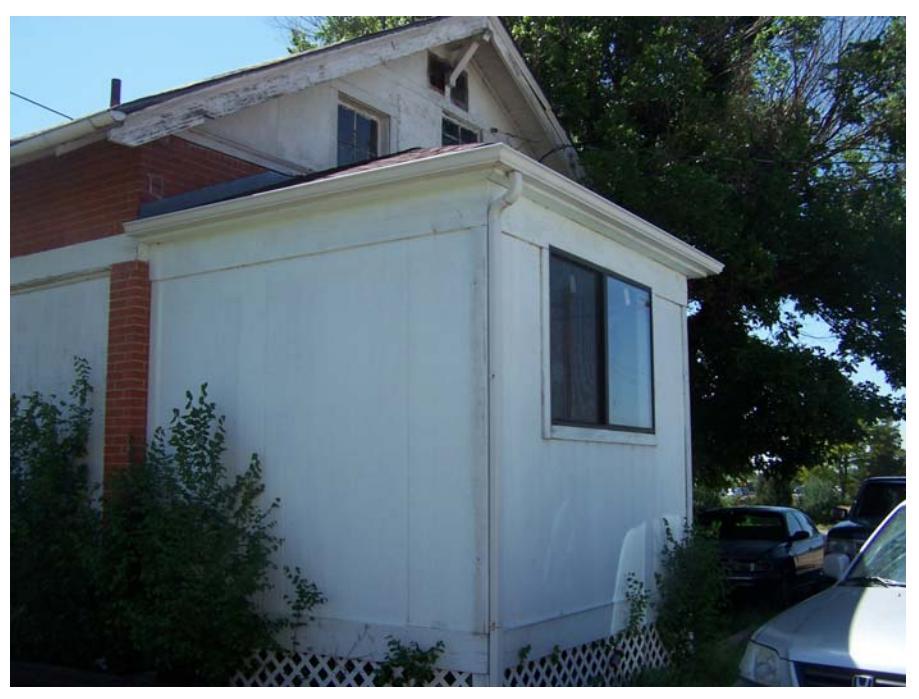
1911 Brick Bungalow. West porch addition.

The west porch addition is in good condition. All materials are of recent vintage.

It is recommended that the non-original replication of the west porch be removed and reconstructed with a porch more in keeping with the historic fabric of the structure. Historic photographs are available of the west elevation and could be utilized to historically re-create the porch.

Although the new porch is in good condition, the removal of the modern porch and the reconstruction of a porch constructed of in-kind materials and spatial configuration will be more in keeping with the historic fabric and will reestablish the historic character and integrity of the Bungalow structure as a whole.

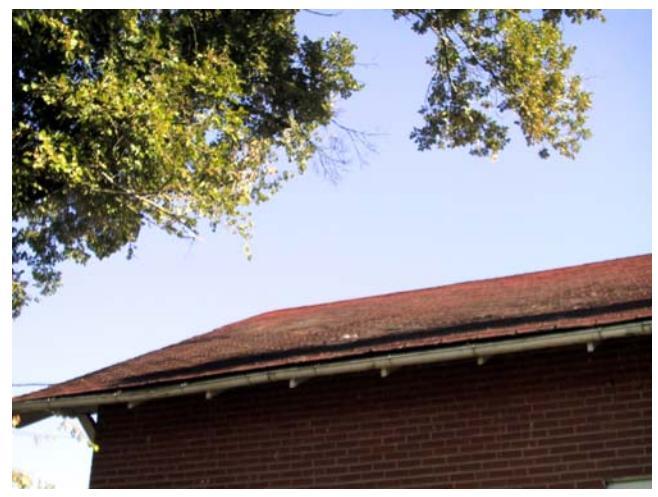
Deteriorating asphalt shingles with UV degradation at southern exposure on 1911 Brick Bungalow

All existing roofing materials should be removed to solid sheathing. Replace any rotted sheathing. Install new No. 1 cedar shingles directly over spaced, wood sheathing, and match exposure of original wood shingles. Remove existing gutters and downspouts at north and south elevations, install new and paint. Scrape, sand and repaint rafter tails and bargeboards. Replace missing 4x4 support bracket at northwest corner to match original brackets that remain.

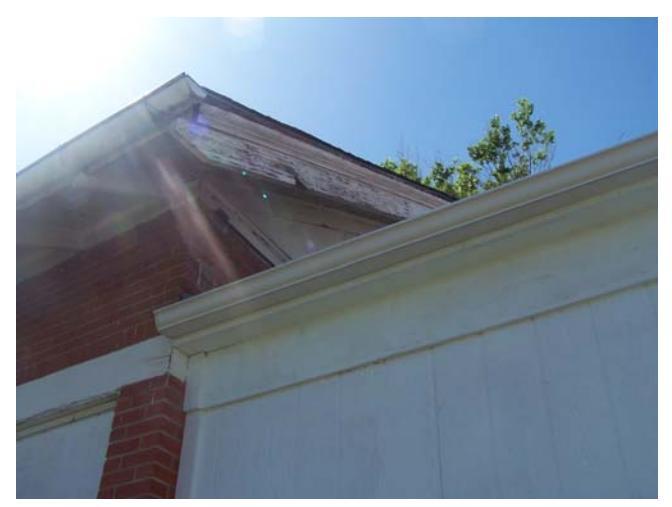
Northwest corner of roof with missing 4x4 support bracket

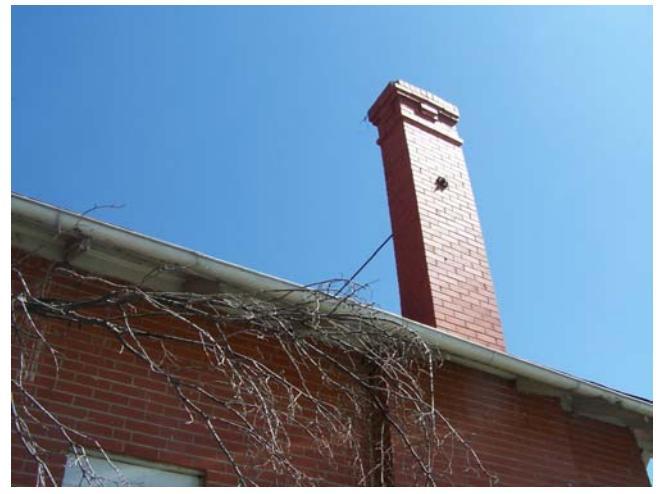
1911 Brick Bungalow. South masonry chimney.

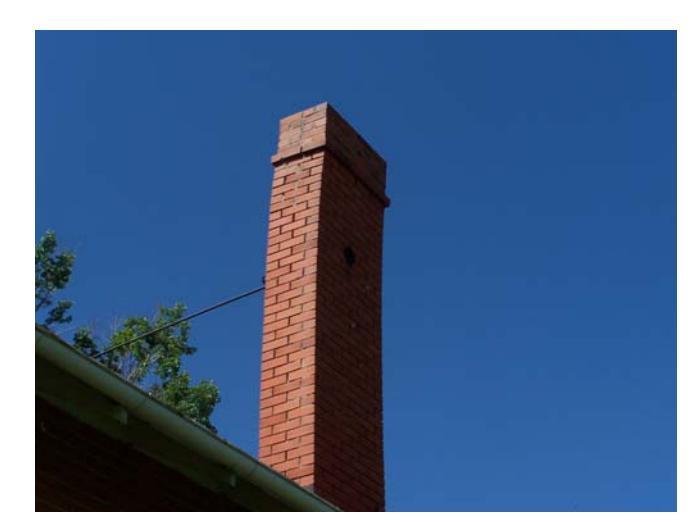
North masonry chimney at 1911 Brick Bungalow.

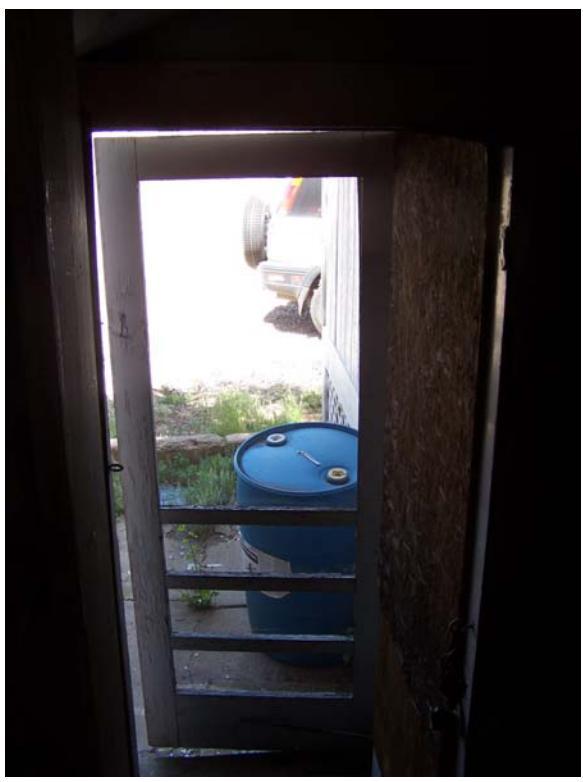
Four-paneled screen door at rear of 1911 Brick Bungalow

RECOMMENDED TREATMENT:	Replicate and replace the screen door at the rear entrance. Replace the missing screen and door hardware. Remove the plywood and restore the wood paneled door at rear entrance.
	Remove the non-historic faux wood paneling on the first floor interior doors. Remove layers of paint and stain to match the original as evident on the back sides of the doors.
	Further investigation is needed to determine the cause for the moisture and water staining at the basement doors. The basement doors should be removed, sanded, and stained to match the original. Install hardware, to match original, at the basement level doors so as to make useable.

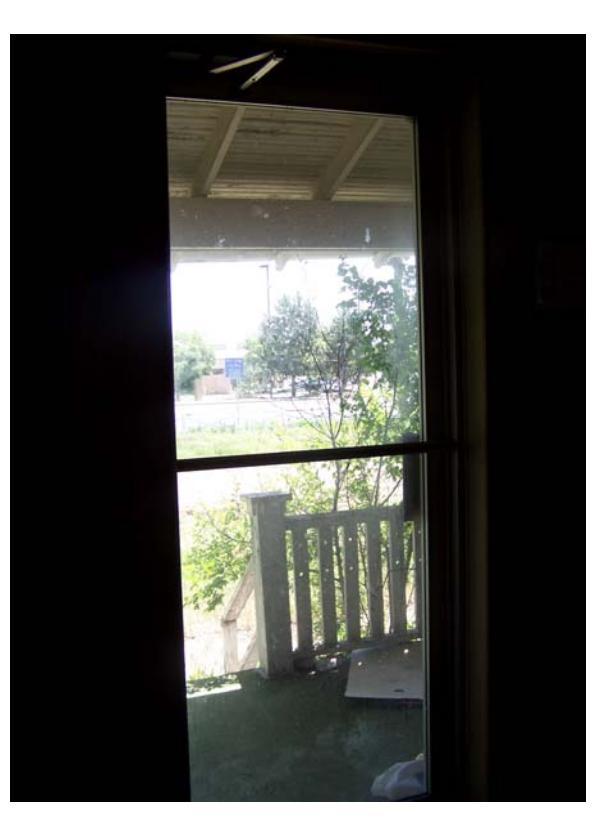
1911 Brick Bungalow. Modern aluminum storefront door at main entrance of bungalow.

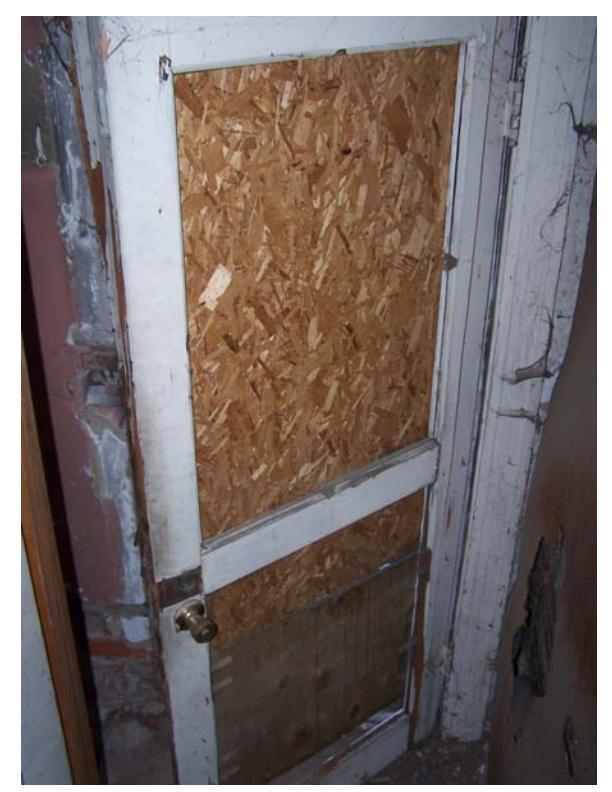
Original door at rear of 1911 Brick Bungalow

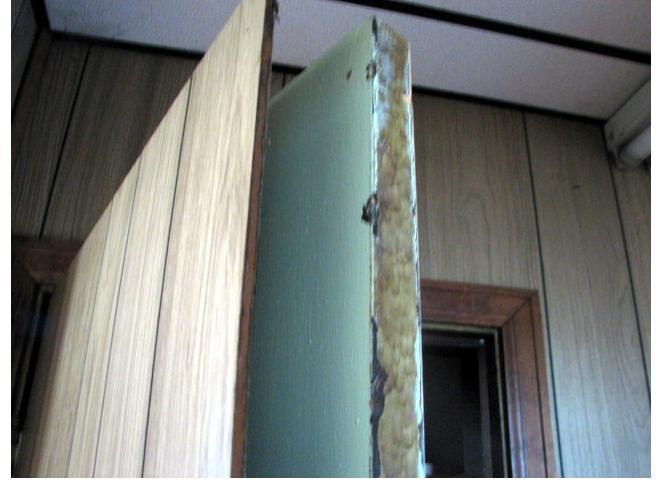
Historic interior doors are five-paneled stile and rail wood doors. The historic doors have been covered, specifically on the first floor, with non-historic imitation wood grain paneling on the exposed side of the door. The non-exposed, 'interior' planes of the doors remain in their original finish condition. Original paint is visible where the faux paneling has delaminated from the door. Hardware is original, with modern hinges.

First floor interior doors with faux wood grain paneling over the historic solid core door.

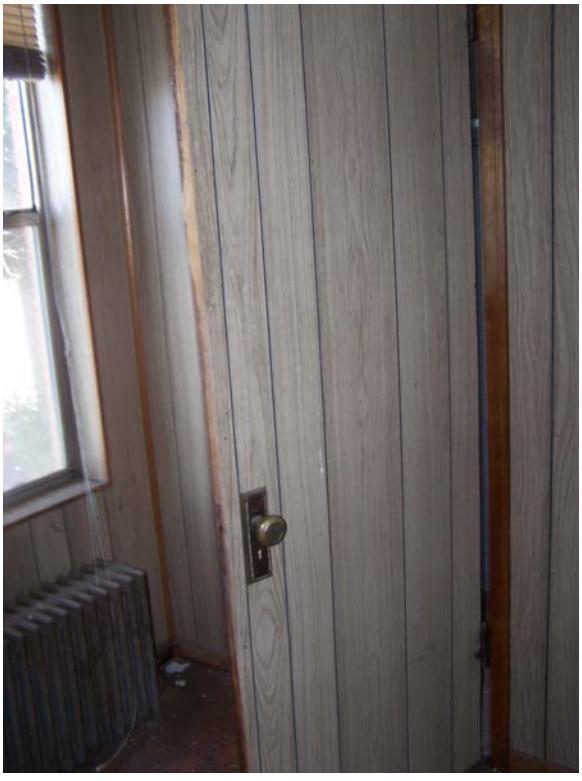
First floor interior door with faux wood grain paneling

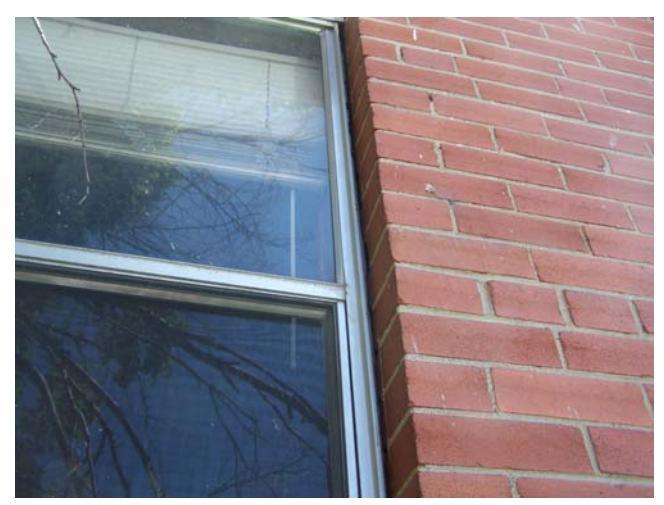
The south elevation has four large and two small windows, all with original cast stone sills. None have the original sash or glass intact. Replacement frames are aluminum with new wood sills and heads installed to accommodate the smaller window size. The windows are double-hung with screens on the four larger windows.

Aluminum windows at south elevation of 1911 Brick Bungalow

RECOMMENDED TREATMENT:	All the windows on the west, east and south elevations should be replaced with frames and glass that match the original in function and size. All remaining wood trim should be scraped and repainted.

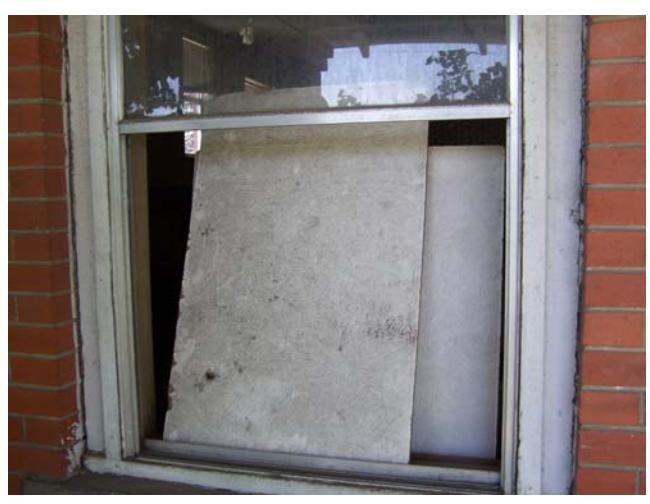
The southern most window, on the front elevation is missing the lower pane of glass and is currently covered by wood particle board.

Glass is missing from one front window at the east porch. Screens, where present, are in good condition and intact. New wood infill above the windows on the south and east elevations has minor paint flaking.
	The original wood framed windows at the gable ends are in poor condition. Screens are torn and rusted, frames are warped and deteriorating. Trim pieces are loose and the window glazing is dry, cracked and gapped.
	The glass block infill on the north elevation is in good condition, although not original. Non-historic cementitious mortar has been used to infill areas of toothed-in brick adjacent to the windows where cast stone sills were originally located. Cementitious mortar is detaching at the brick and glass block juncture in several locations, allowing water infiltration between the glass block and the masonry.
	The aluminum windows at the west porch addition are in good condition and are of recent vintage.

Missing glass at east window location of 1911 Brick Bungalow

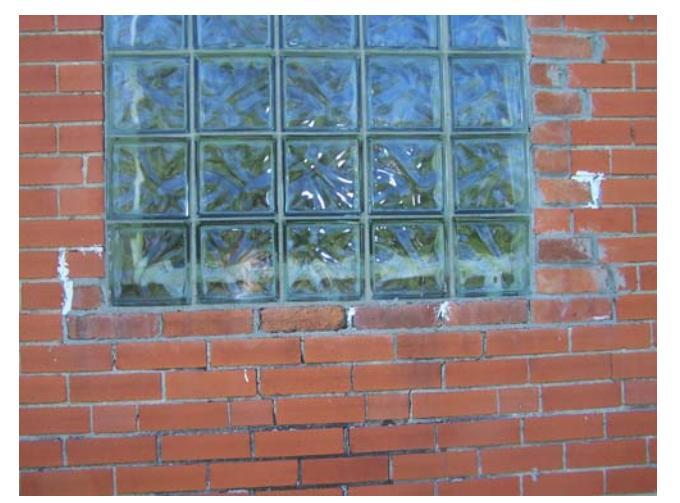
Four windows are located on the north elevation. All have been altered with the removal of the original wood frame and glass. All of the windows have been infilled with non-historic glass block. An air-conditioning unit has been installed at the upper level of one of the windows. Only one window retains the original cast stone sill. There is evidence the other three sills were

Missing cast stone sill and glass block infill of 1911 Brick Bungalow

The non-historic glass block infill at the windows on the north elevation should be removed and replaced with double-hung wood frame windows and glazing to match the original in function and size. The cast stone sills that are salvageable should be restored and reinstalled. Any damaged sills should be replicated to match the original and installed.

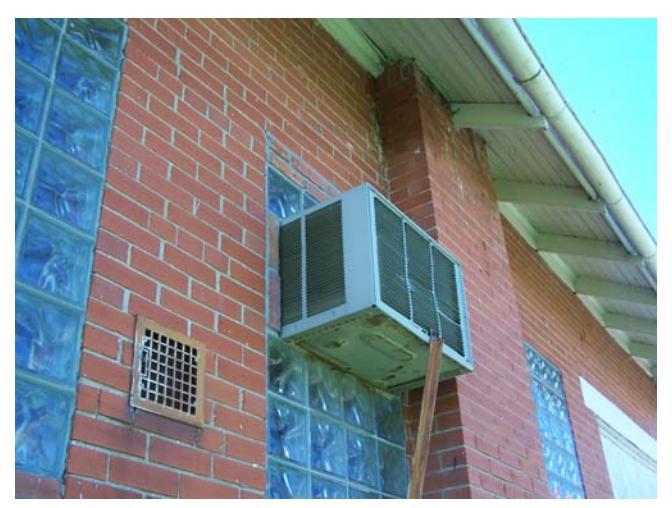
Air conditioning unit at north elevation window of 1911 Brick Bungalow

Remove the air conditioning unit located on the north elevation of the building.

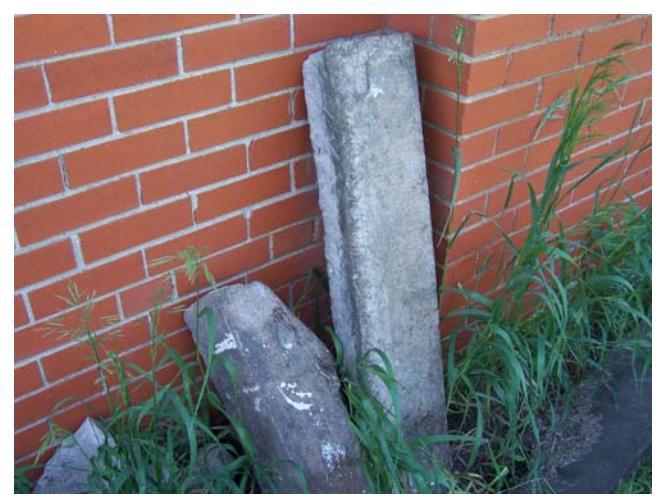
Removed cast stone sills at north elevation

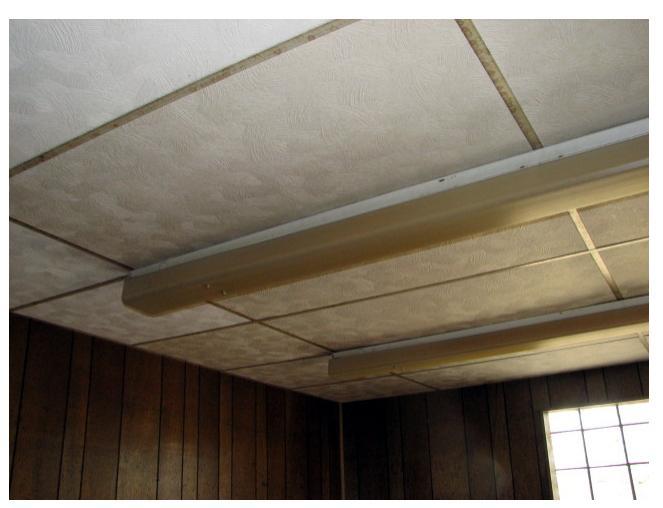
Fluorescent lighting in first floor interior ceiling

RECOMMENDED TREATMENT: Remove non-historic carpet, lighting fixtures and faux wood paneling on the first floor level. Assess finishes at that time to determine what original materials remain.

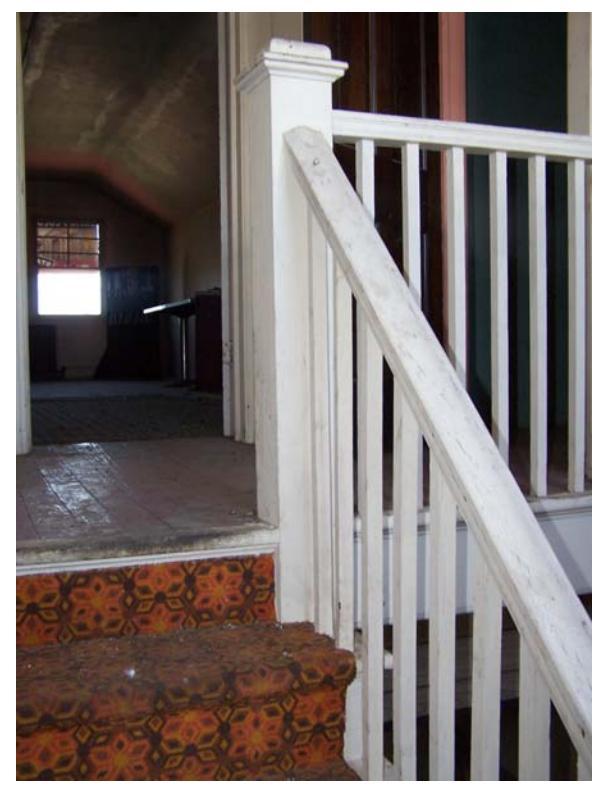
Original wood railing at second floor staircase

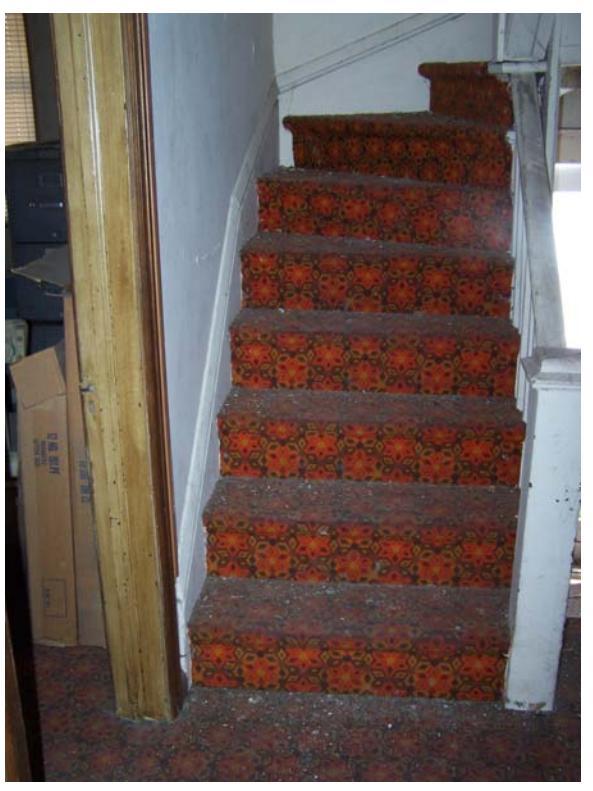
Carpeted staircase to second floor level

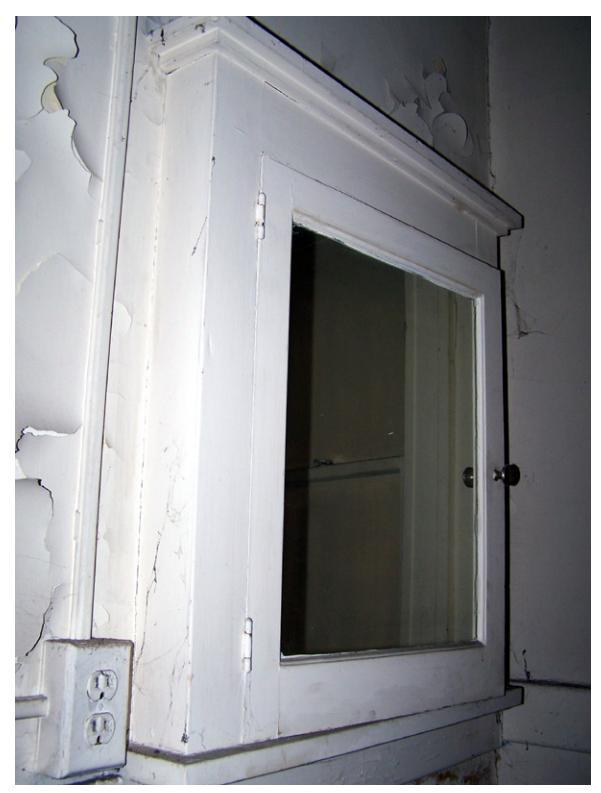
The original base and mirror cabinets in Room 108 are in fair condition with areas of flaking and peeling paint. The interior wall paint is in poor condition. Moisture and humidity has delaminated the paint, causing large areas of peeling and flaking paint. The City of Westminster has conducted a hazardous materials test on the paint in the Brick Bungalow. Tests indicated high levels of lead content, specifically on the second floor and in Room 108 where the paint is damaged and peeling.

Original mirror cabinet in Room 108 of 1911 Brick Bungalow.

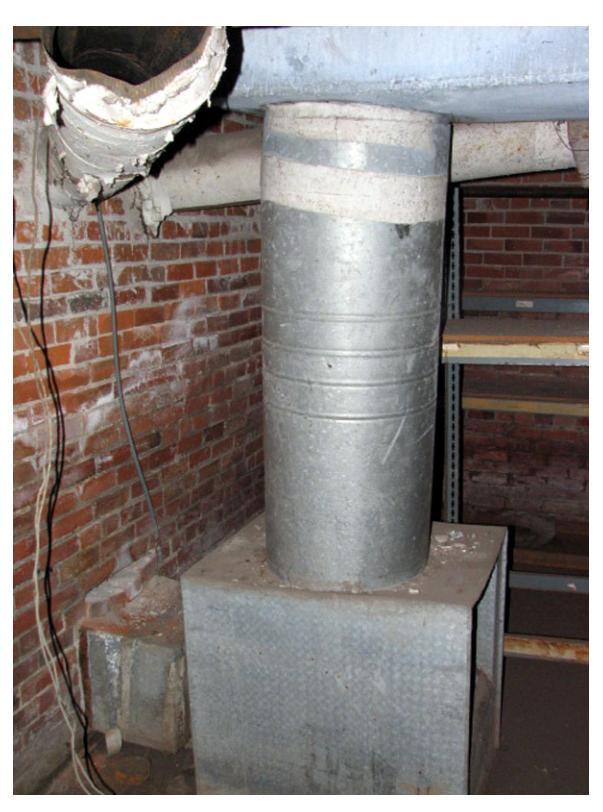
Fan box and ductwork in basement of 1911 Brick Bungalow

All of the piping to the steam radiator system is badly rusted as are the condensate components. The ductwork of the former furnace distribution system is in poor condition and the furnace is far beyond its

All mechanical systems, piping, ductwork, and component parts should be removed and a new codecompliant system should be installed. Radiators could be abandoned in situ for historic context. Install new central air conditioning unit.

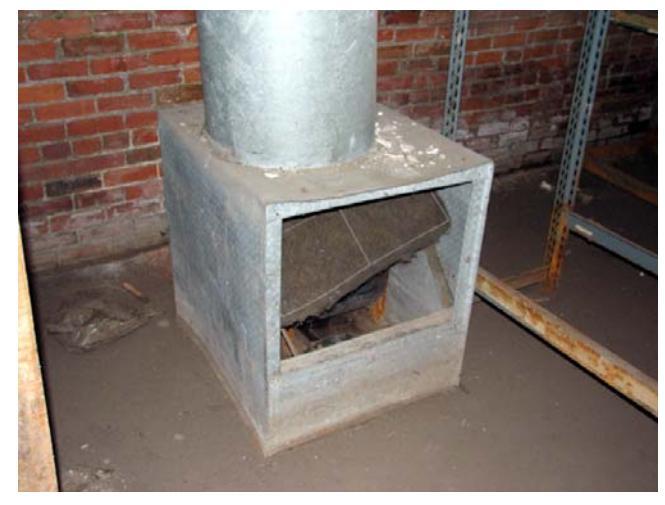
Fan Box located in basement of Bungalow

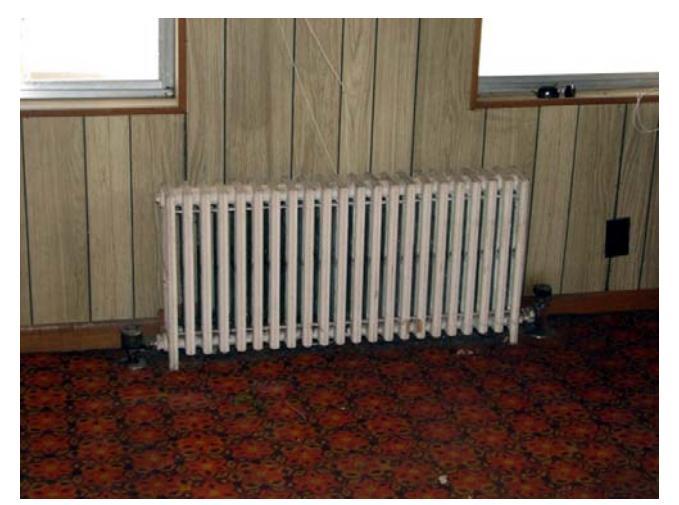
serviceable life. Likewise, the window air conditioner is in poor condition and appears to have been vandalized. Of all the components, the steam radiators may be the only salvageable elements. However, to test this, they would need to be removed, cleaned and pressure tested.

Original steam radiator located in Room 105 of Brick Bungalow.

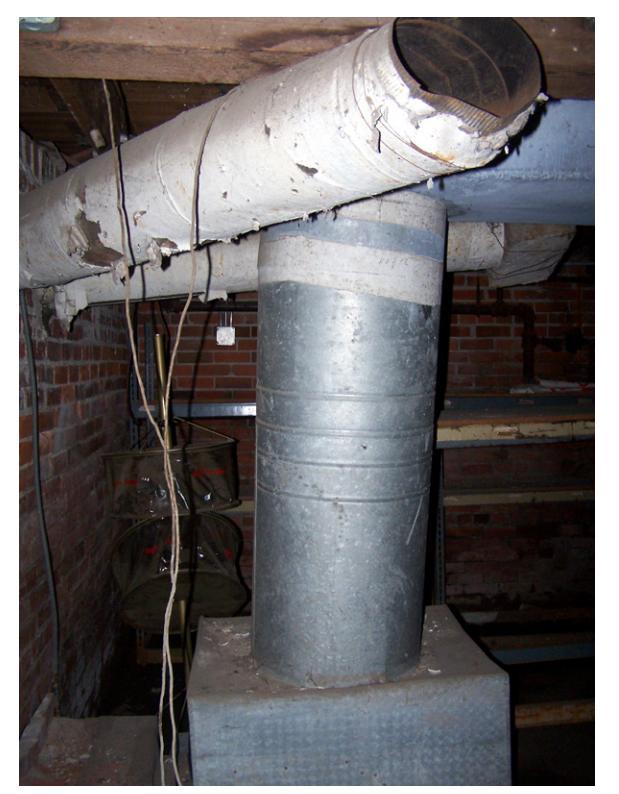
Ductwork associated with gravity furnace.

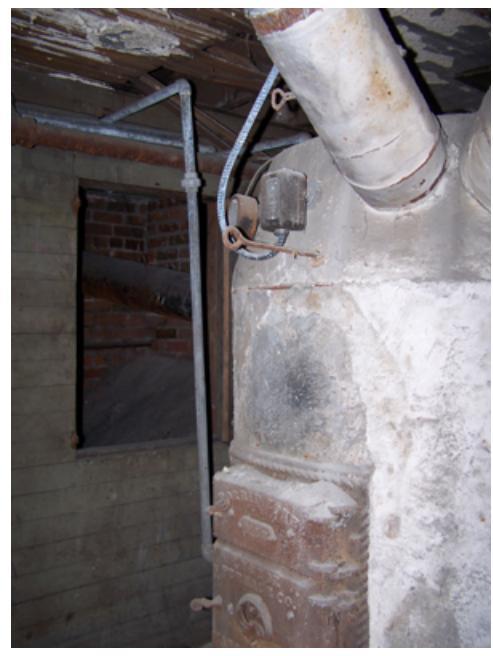
Gravity fed furnace

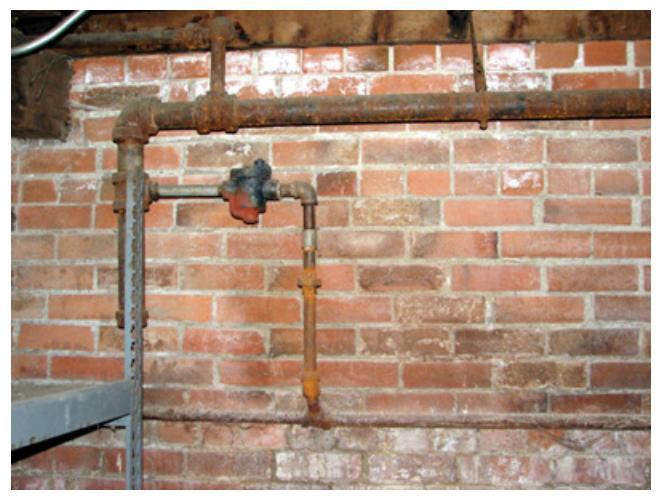
Steam line trap and line drip

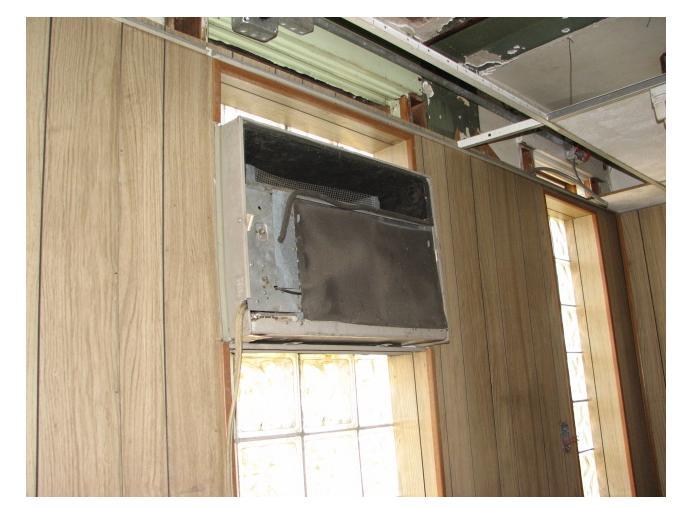
In Room 105, there is a thru-window, air conditioning unit.

Window mounted air conditioner
