Shoenberg Farm

Historic Structures Assessment Project #2007-M2-011 March 14, 2008

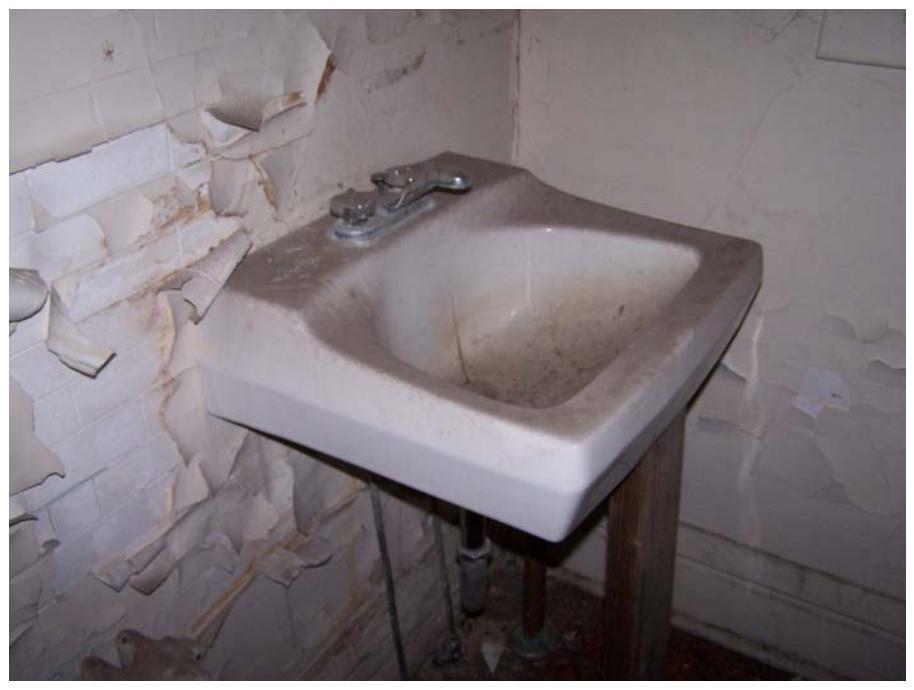
Wall lavatory in Room 108 at 1911 Brick Bungalow

CATEGORY:	3.8c Water Service, Plumbing, and Sewer
DESCRIPTION:	There are three extant plumbing fixtures – two lavatories and a water closet in the building. One lavatory and the water closet are located in Room 108 on the first floor. They appear to date to the 1950s. A single lavatory is on the north wall of the second floor in Room 202 appears older and maybe original ((See floor plans of Brick Bungalow, page 68-69).
EVALUATION:	All three fixtures are in poor condition with missing components, dry seals, mineral build-up on the handles and corroded piping. Waste piping is also corroded.
RECOMMENDED TREATMENT:	All water supply and waste piping in the Bungalow should be removed and replaced with code-compliant piping. The water closet will need to be replaced with a new, low-water-use fixture but it may be possible to retrofit both of the historic lavatories with new piping and fittings.

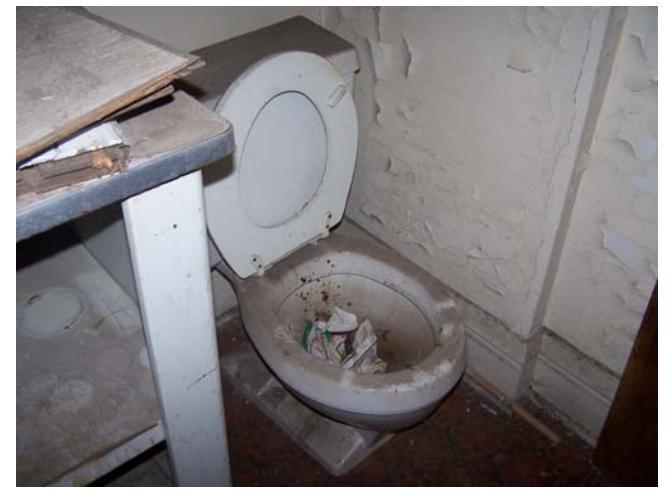
Water closet in Room 108 at 1911 Brick Bungalow

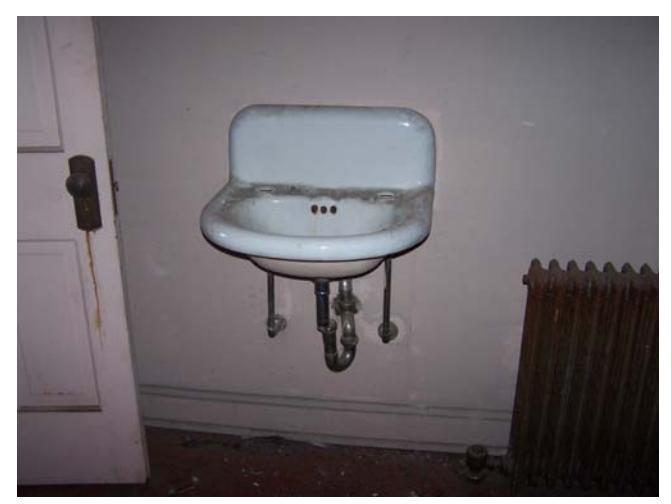
Historic lavatory at 2nd floor of 1911 Brick Bungalow

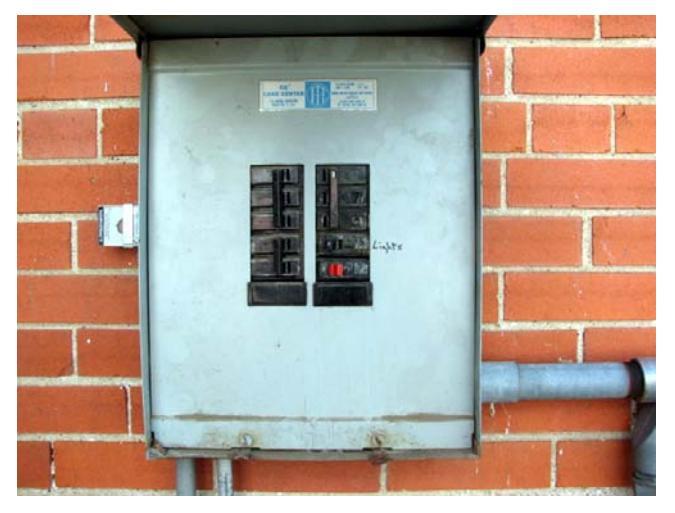
CATEGORY:	3.9 Electrical Systems
DESCRIPTION:	The electrical service throughout the Bungalow is composed of un-grounded wiring distributed through fuse panels, with the exception of the main panel which has conventional breakers. Lighting is predominately lens-wrapped linear fluorescent.
EVALUATION:	With the exception of the main panel, none of the electrical system complies with code. The fluorescent lighting detracts from the historic nature of the building.
RECOMMENDED TREATMENT:	Remove all wiring and devices, back to the main panel and rewire the building. Install glass-shrouded, ceiling- mounted fixtures (with fluorescent lamps, if the lamps can be concealed) to be more in character with the building.
	Once an adaptive re-use is determined for the Bungalow, an underground power feed could be installed to the building. This would require subsequent design phases and is not included in this scope of work.

Main electrical service

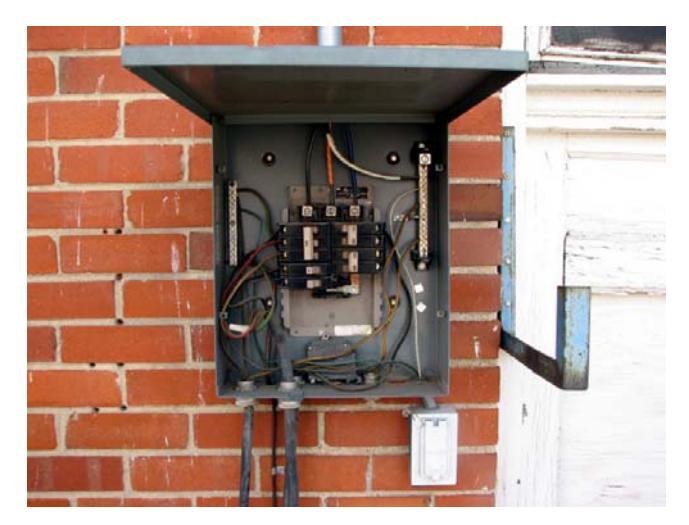
Branch distribution panel

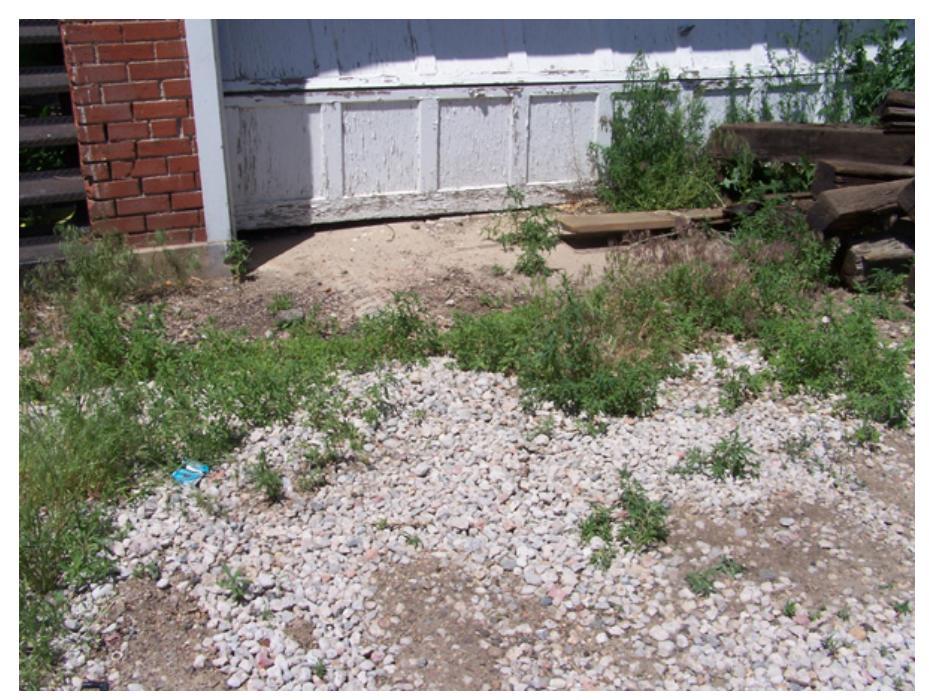
Gravel driveway and concrete pad at south elevation of Two-Story Garage

CATEGORY:	3.1 Site
DESCRIPTION:	The site at the Two-Story Garage is flat with a moderate rise to the north and west. Shrubbery and grasses surround three sides of the structure, all unkempt. Several volunteer trees are beginning to grow close to the foundation and masonry elements of the structure.
	A gravel parking area is located within four feet of the structure at the south elevation; joined with a four-foot wide concrete threshold at the garage door entrance. This area is currently used by the site's tenant for parking.
EVALUATION:	In general, the site surrounding the garage is in fair to poor condition. The vegetation, shrubbery and trees have been allowed to overgrow, specifically at the north elevation of the site.
	The concrete pad at the garage entrance is spalling, cracked and deteriorating. Inadequate slope is allowing water to pool at the garage door.

Remove the deteriorated concrete pad at the garage door location and replace with a new pad. Proper slope should be provided for water drainage away from the structure.

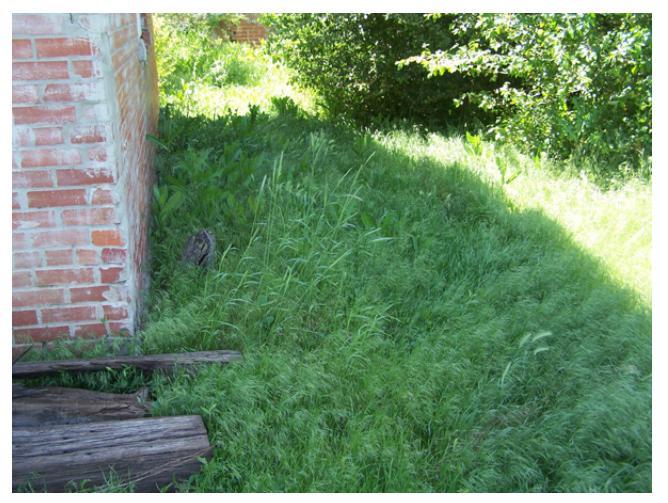
Overgrown grasses and trees at north elevation of Two-Story Garage

Remove the grove of trees located on the north side of the structure. All volunteer grass areas should be cut and maintained so as not to allow overgrowth.

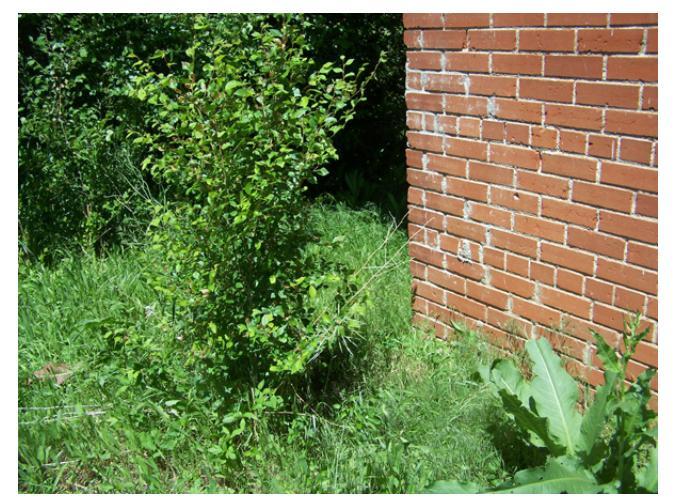
Overgrowth of grasses and trees on the northwest corner of Two-Story Garage

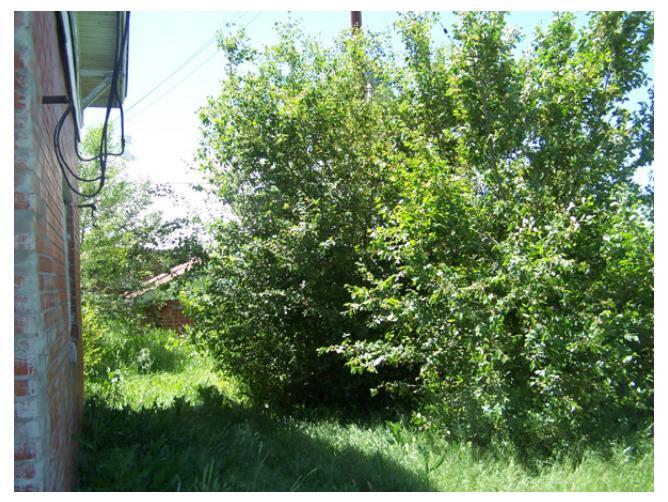
Grove of trees on the north side elevation of Two-Story Garage
SHOENBERG FARM

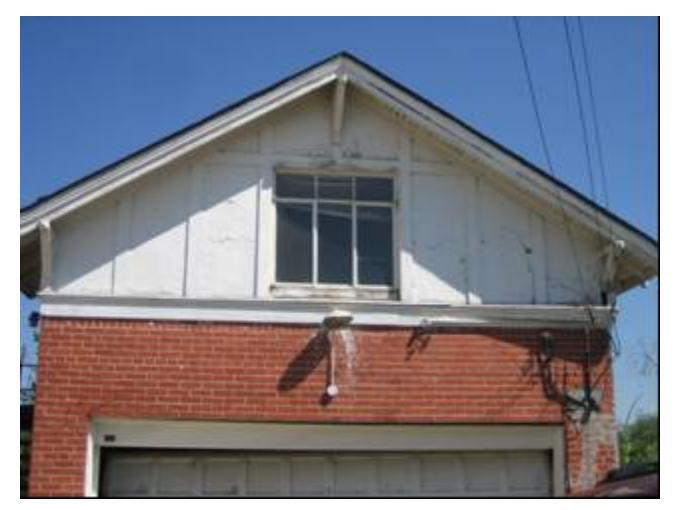
The garage door head is supported by a steel lintel. The condition on the interior side of the head is not visible. The garage door head is visibly deflected downward and thus the brick and steel lintel assembly is undersized.
	The apartment floor framing is not visible, but there are no obvious signs of distress.
	The roof appears to be in serviceable condition and no significant deterioration or deflections were observed.
RECOMMENDED TREATMENT:	In order to repair the perimeter brick walls the foundation system must first be stabilized (or the building moved to a new foundation system). After which the portions of the walls and chimney with severe cracking will need to be taken down and rebuilt. Less severely damaged wall sections can be restored with selective brick rebuilding and re-pointing of the mortar joints.
	The second floor diaphragm connection to the brick perimeter walls will need to be investigated. Any compromised sections of the diaphragm connection will need to be reestablished in order to restore the building's capacity to resist lateral loads.

Deflected garage door head along south elevation

The garage door head will need to be shored level and the steel lintel reinforced.
	The apartment floor and roof framing should be surveyed to determine member sizes, configuration, and condition; and then analyzed for their load-carrying capacity. It may be necessary to reinforce some framing

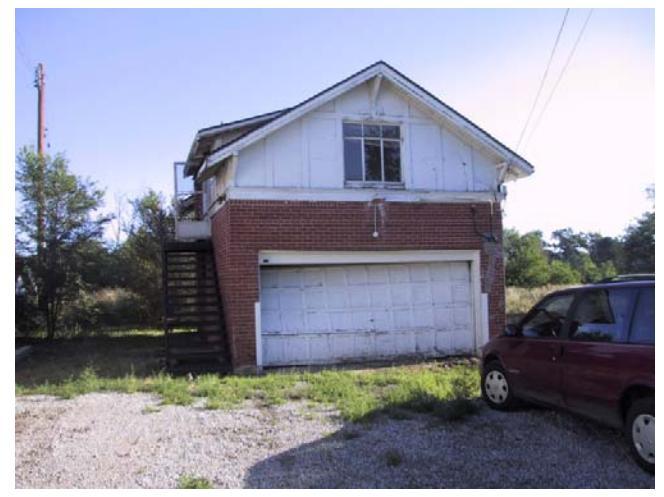
The garage is in poor condition. At the south elevation the structure is settling, possibly due to shifting soils.

South Elevation of 1911 Two-Story Garage

RECOMMENDED TREATMENT:	The structure is unstable and continues to show signs of additional settlement and deterioration. Temporary stabilization should be performed to arrest additional cracking and damage to the masonry structure until a permanent solution can be found. Removal of the cementitious mortar at the areas of previous patching should be considered, although it may be difficult, and the bricks may need to be replaced.
	Remove the damaged and loose areas of stucco infill at the gable ends and replace with new stucco, paint to match original. It is recommended a paint analysis be completed to determine the original finish of the decorative "stickwork" at the gable ends. Once determined, the non-historic paint should be removed at the "stickwork" trim areas on the gabled ends. Refinish to match per historic photographs.
	Currently, plans for the garage include moving the building slightly to avoid new traffic site patterns on the site. Design implications of the move are beyond the scope of this assessment.

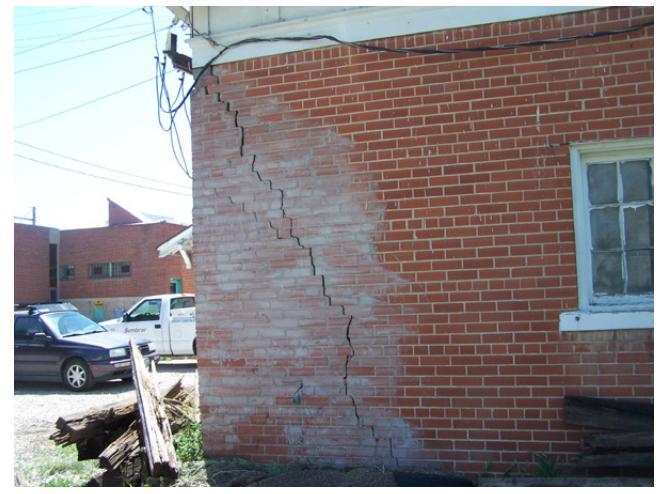
EVALUATION: The brick walls are in poor condition. Stair-step cracking propagating from the window heads or from the foundation stem wall cracks is visible. The crack at the south end of the east wall is particularly severe and measures over 1" wide. This crack is unusually severe in that it passes directly through bricks in some locations rather than following the mortar joints. In conjunction

Critical crack at the southeast corner perimeter wall of the Two-Story Garage

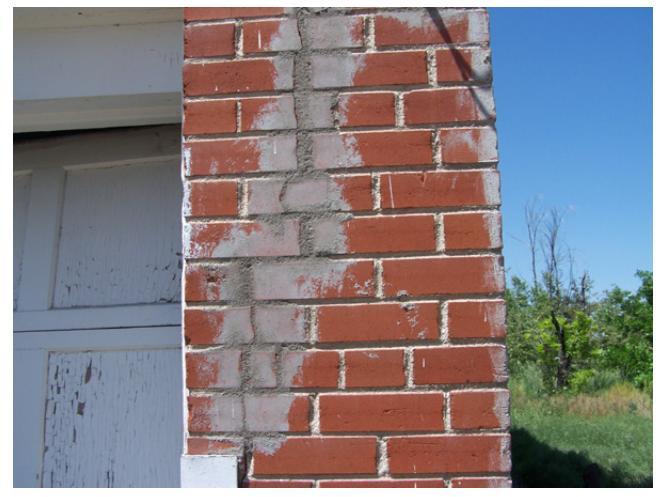
Masonry flanking garage on the southeast corner of Two-Story Garage. Patching of critical crack with non-historic mortar application

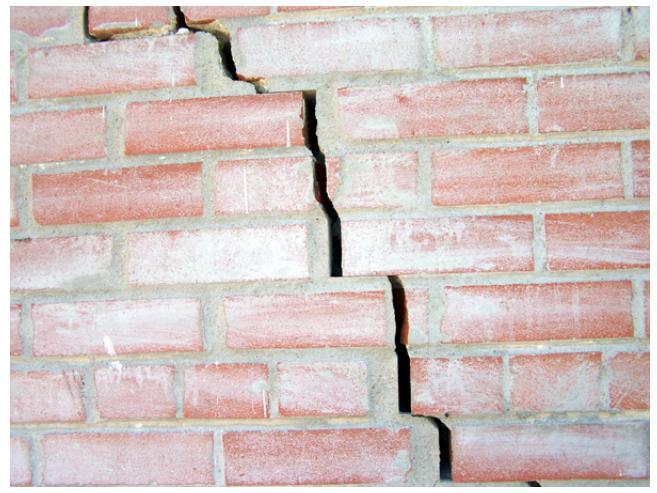
Large stair-step crack at the southeast corner of Two-Story Garage.

After the move, the walls would then require further repair. Portions of the perimeter walls with severe cracking will need to be taken down and rebuilt. Less severely damaged wall sections can be restored with selective brick rebuilding and re-pointing of the mortar joints.

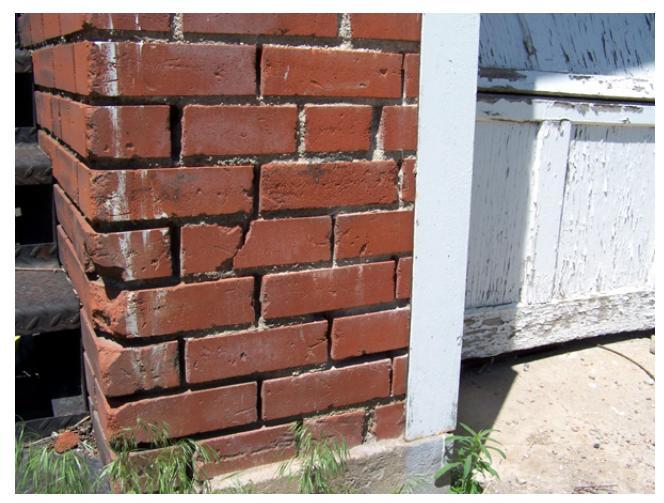
SHOENBERG FARM	
1911 Two-Story Garage	The garage door has shifted and dislodged from the masonry structure and no longer functions.
	Eroded mortar joints are located on most elevations most significantly at the south and east elevations. Previous attempts at brick repair with cementitious mortar and slurry are evident throughout the structure.
	The cast stone window sill at the north elevation is in pieces and lies on the ground. The mortar joints are failing at the remaining sill location. The metal stair access to the upper level is in fair condition.
	The gable ends infilled with stucco are in poor condition with peeling paint and stucco. The non-historic paint on the decorative trim pieces is peeling and flaking.
	The gable ends are infilled by original painted stucco but the decorative "stickwork" elements are painted making them indistinguishable from the stucco, consequently hiding the "stickwork".

Eroded mortar joints on the brick at the southwest corner or the Two-Story Garage

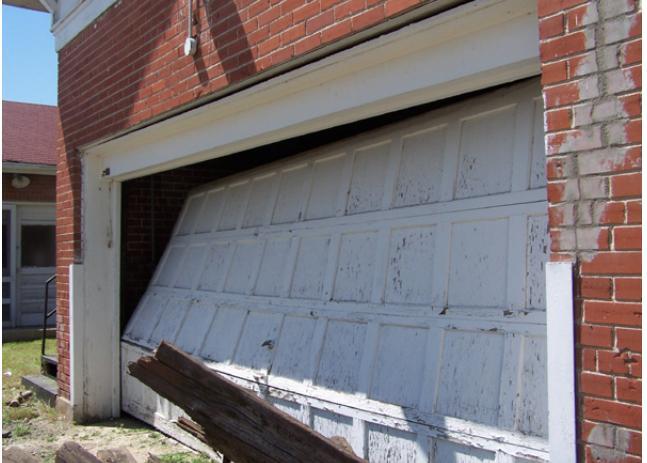
Dislodged garage door on the south perimeter wall

The garage door and frame should be removed. Prior to wall and foundation stabilization, a new door and track, matching the original, should be installed.

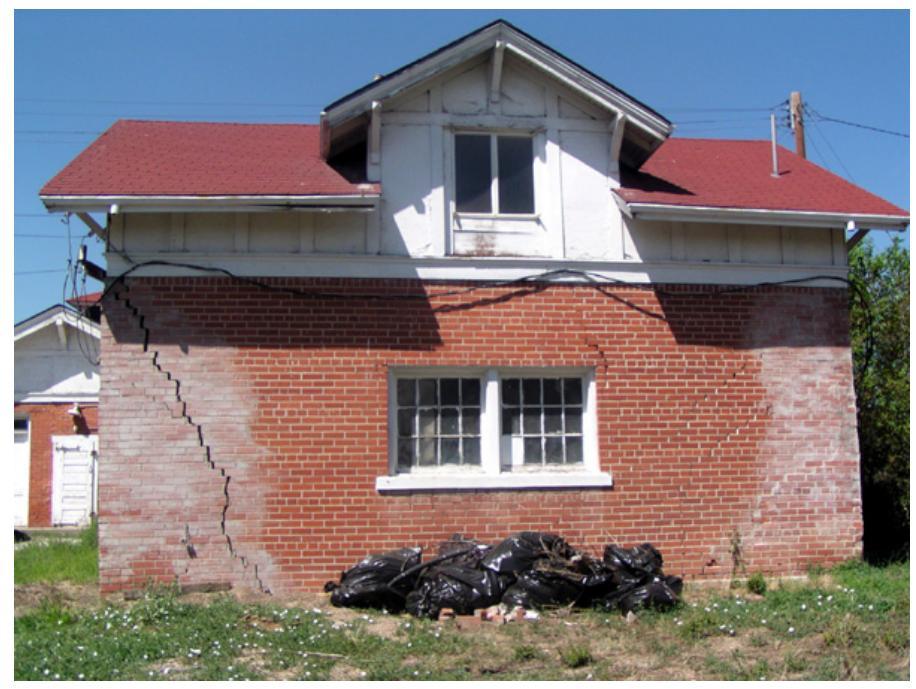
Gabled roof with gabled dormer on the east elevation of Two-Story Garage

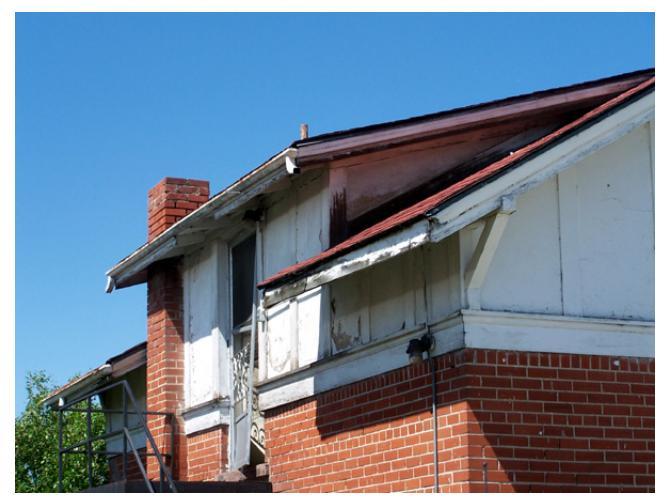
Shed dormer, chimney and apartment entrance at the west elevation

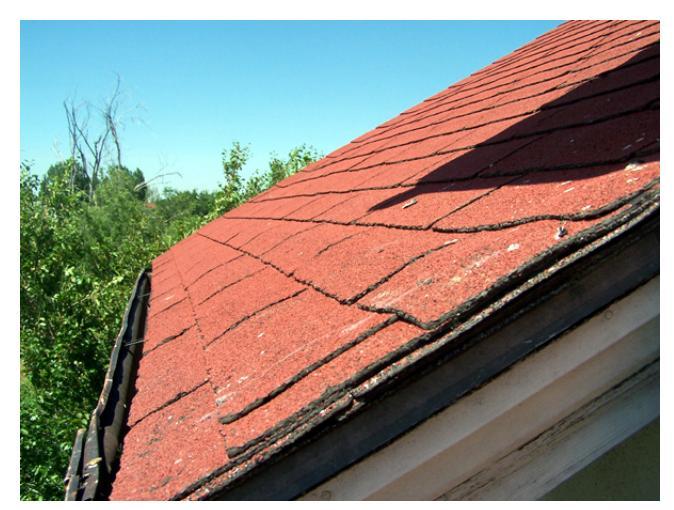
Asphalt shingles on the Two-Story Garage

Remove existing shingles and original wood shingles down to wood decking. Install new No. 1 cedar shingles to match exposure of original. The existing gutters and downspouts should be removed at the east and west elevations and new installed and painted to match original. The rafter tails, support brackets and bargeboards should be scraped, sanded and re-painted.

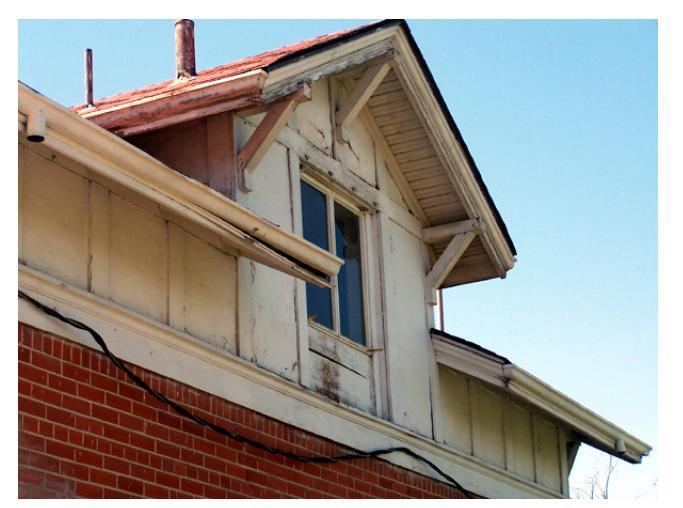
The paint is peeling at the support brackets as well as the rafter tails and bargeboards.
	The downspouts are in poor condition; disconnected or missing from the gutter system, which is loose and failing with rusted sections and visible holes.

Gabled dormer and painted decorative trim pieces at the east elevation of Two-Story Garage

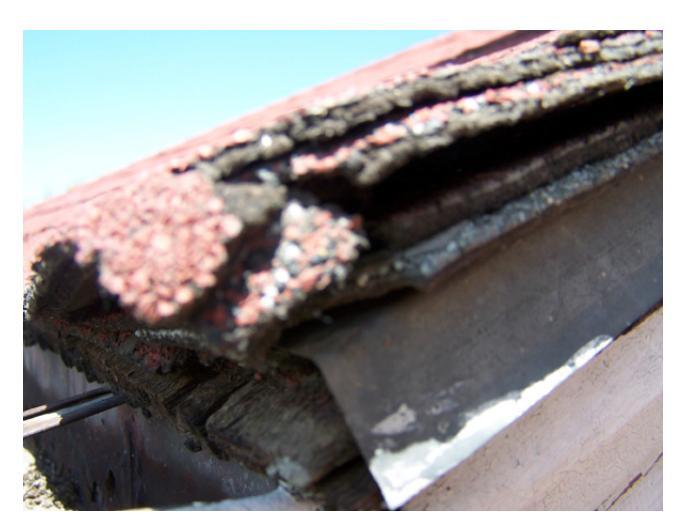
Original wood shingle roof under asphalt shingle roofing system

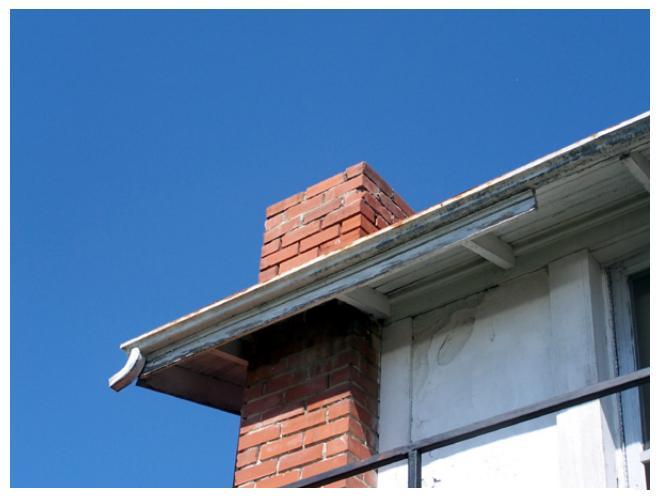
Disconnected downspout location

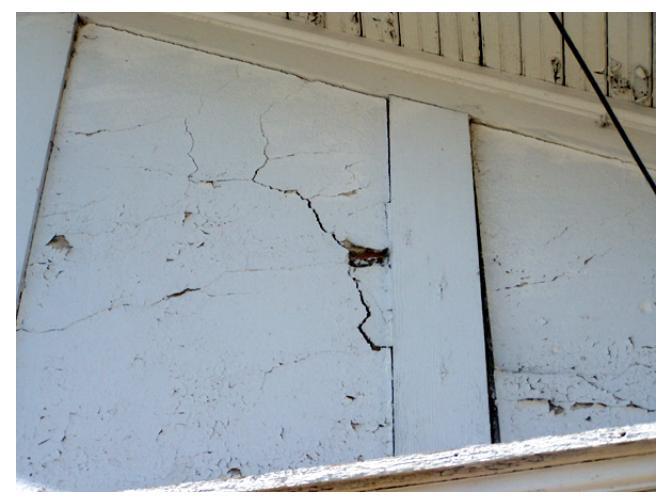
Damage to stucco infill areas

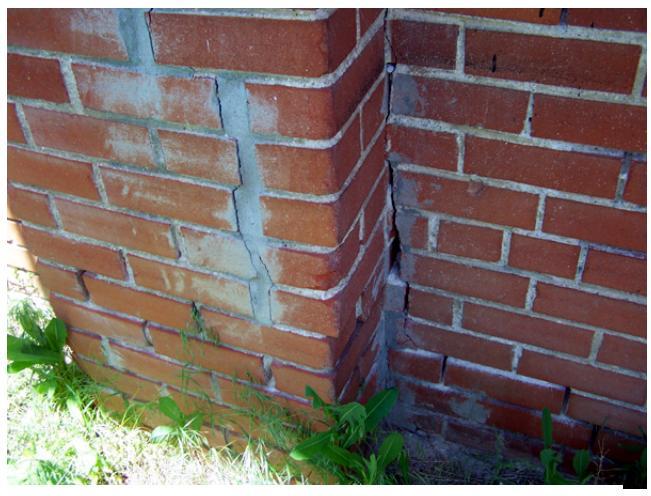
Areas of detachment at the lower level of chimney

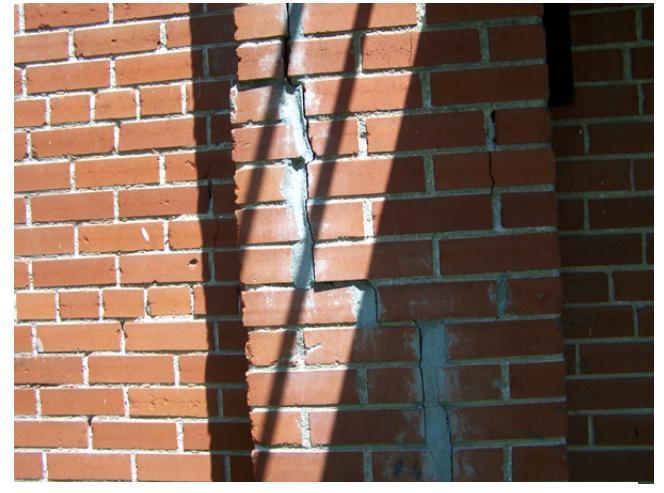
Stair-step crack and mortar patch at chimney

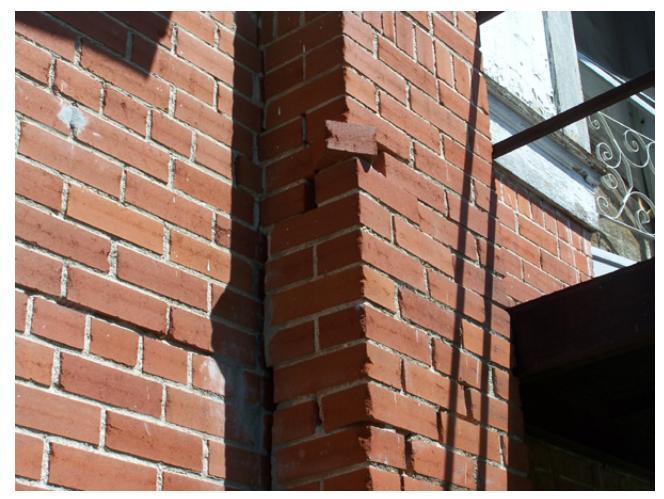
Dislodged bricks and eroded mortar joints at the chimney of the Two-Story Garage.

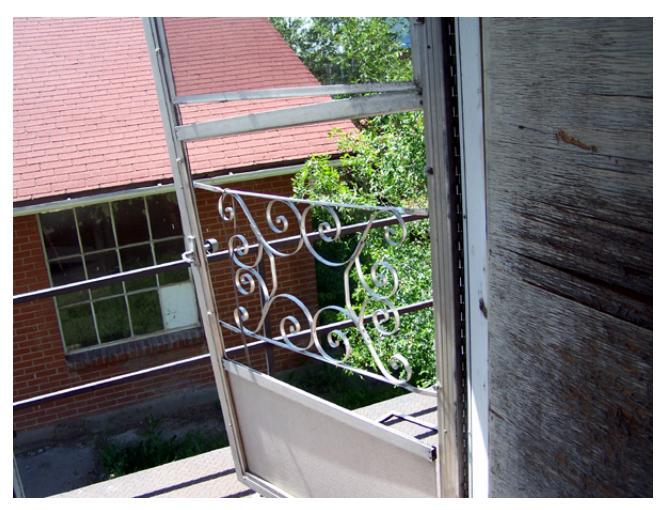
Modern screen door at apartment level. Glass and screening are missing

The apartment door and screen should be removed and replaced with new wood doors that are appropriate to the building's age.

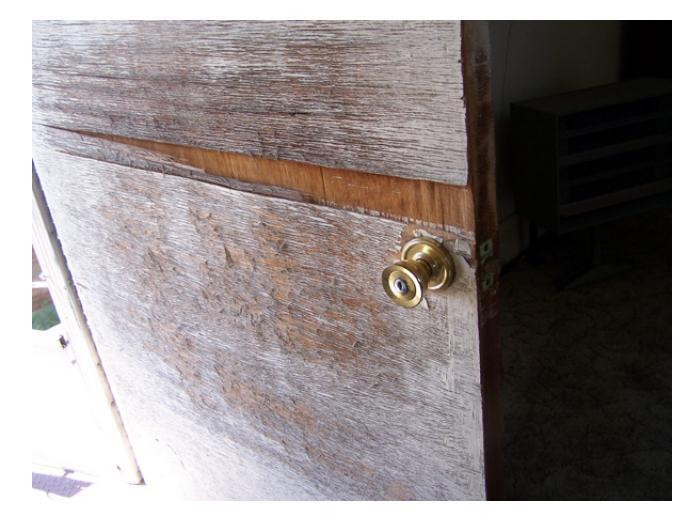
Modern solid core wood door at apartment level. Weathering and UV damage

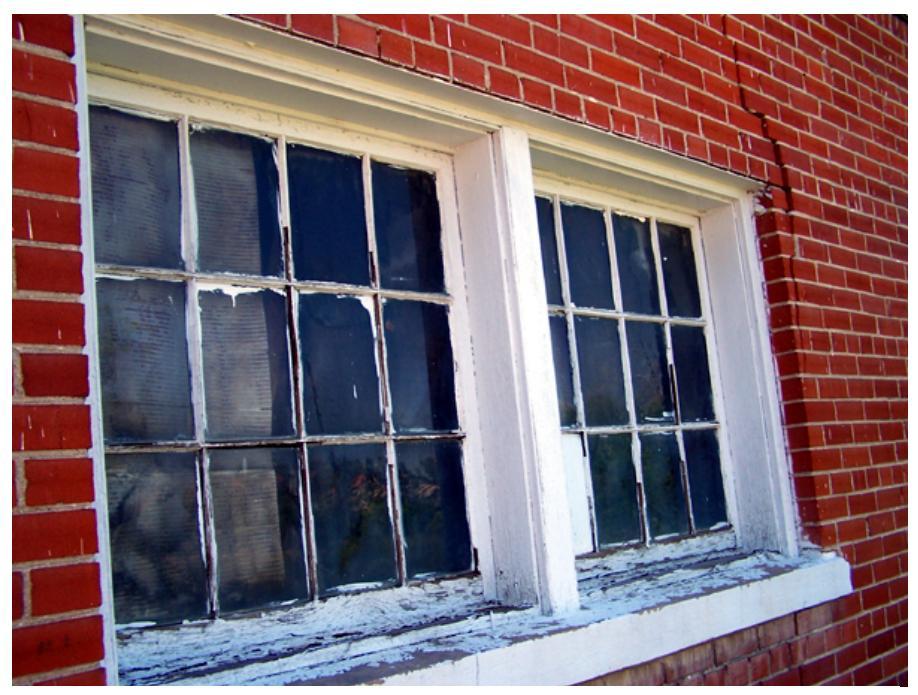
12-light fixed window on the east elevation of the Two-Story Garage

SHOENBERG FARM	
1911 Two-Story Garage	
	The wood frame surrounding the 12-light window is in fair condition with cracking paint. A minor crack exists on the south end of the cast stone sill.
	The window at the north elevation is missing, as well as the cast stone sill, exposing the brick wall below.
RECOMMENDED TREATMENT:	The aluminum casement windows should be removed and replaced with historically compatible wood frame windows. Replace the broken panes of glass.
	The wood board at the north window should be removed. It is assumed this window is a replica of the 12-light window on the east. The window, frame and cast stone sill should be replaced with an in-kind replication to retain the character of the structure.
	The wood frame, trim and muntins of the original 12-light window should be scraped, sanded and repainted. The glass should be cleaned. Paint on the cast stone sill should be removed and the stone cleaned.

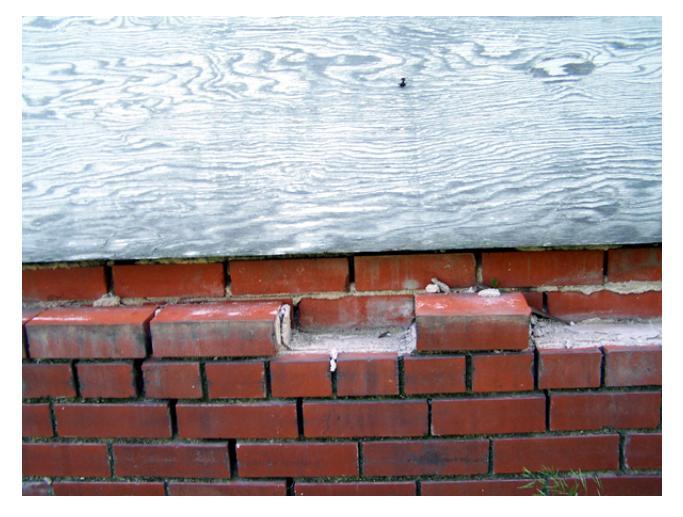
Location of original cast stone sill at north window location

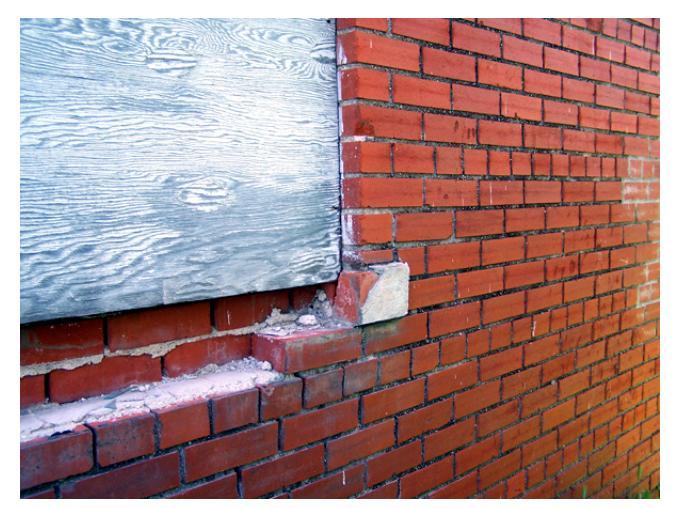
Boarded window at north wall

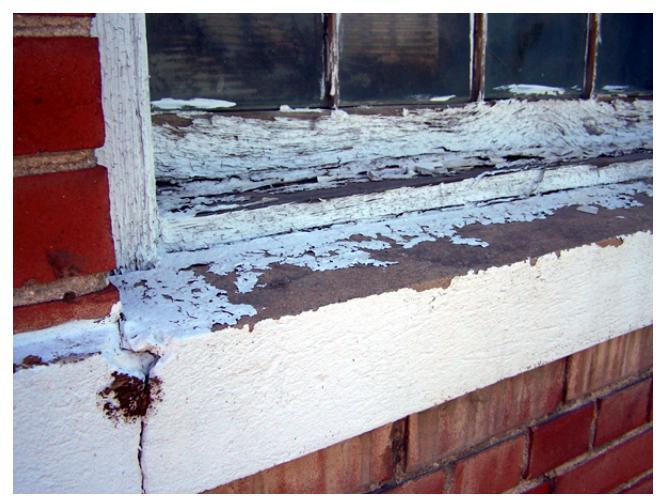
Painted cast stone sill at 12-light window location with painted wood frame and muntins

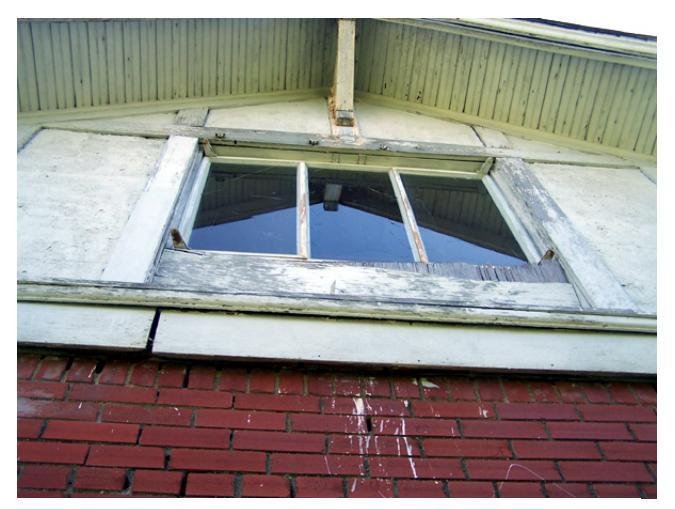
Damaged wood section under window at apartment level

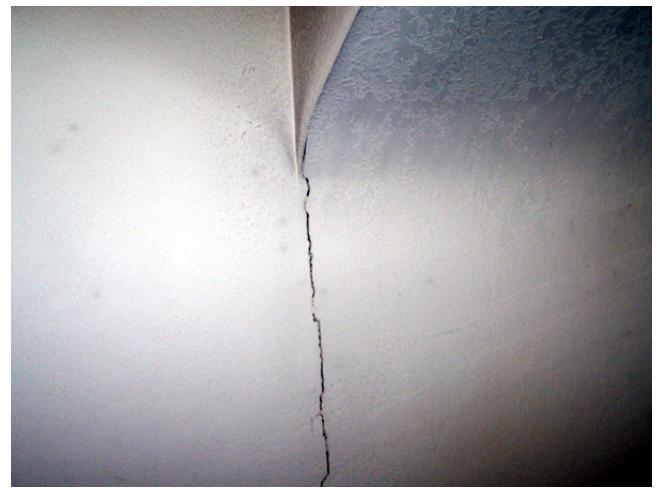
EVALUATION: The apartment interior is in fair condition. The finishes have been altered and are not original. The plaster walls are in fair condition with damage attributed to previous tenants. There is a visible crack at the southeast corner of the interior space at the soffit between the bathroom, bedroom and main space. The wood trim is detaching from the plaster walls at the closet in the bedroom

Crack in plaster wall at the southeast corner of main room

The interior finishes do not need immediate treatment. Once it is determined if this space will be used as a residence or possible office space, the finishes can be updated.

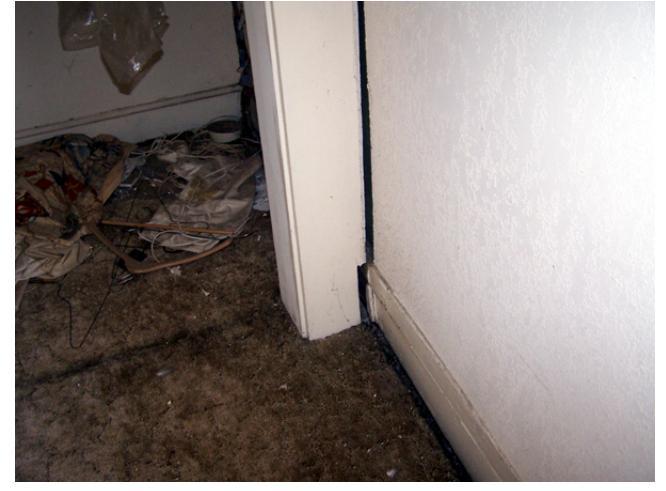
Wood trim detaching from plaster walls in bedroom

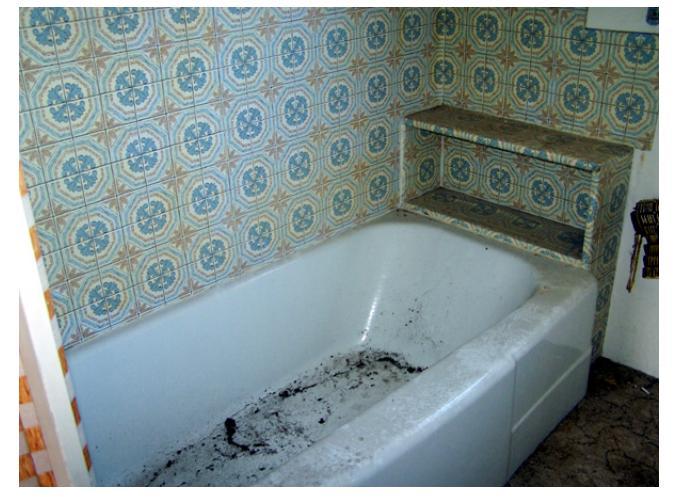
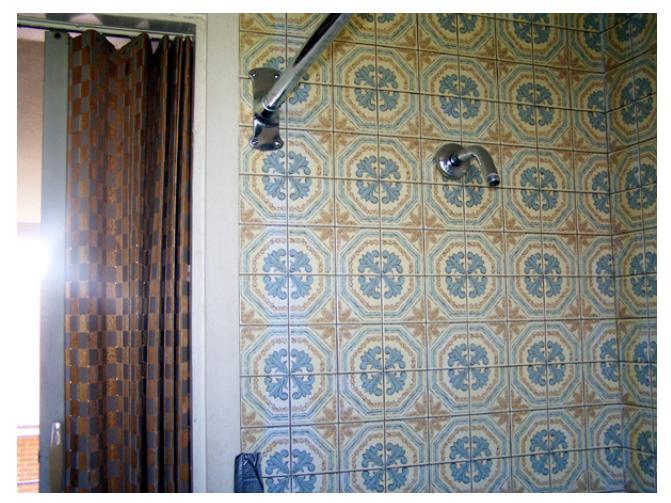
The wallpaper in the bathroom is in fair condition with minor peeling and water staining.

Wallpaper on bathroom walls and built-in cabinetry.

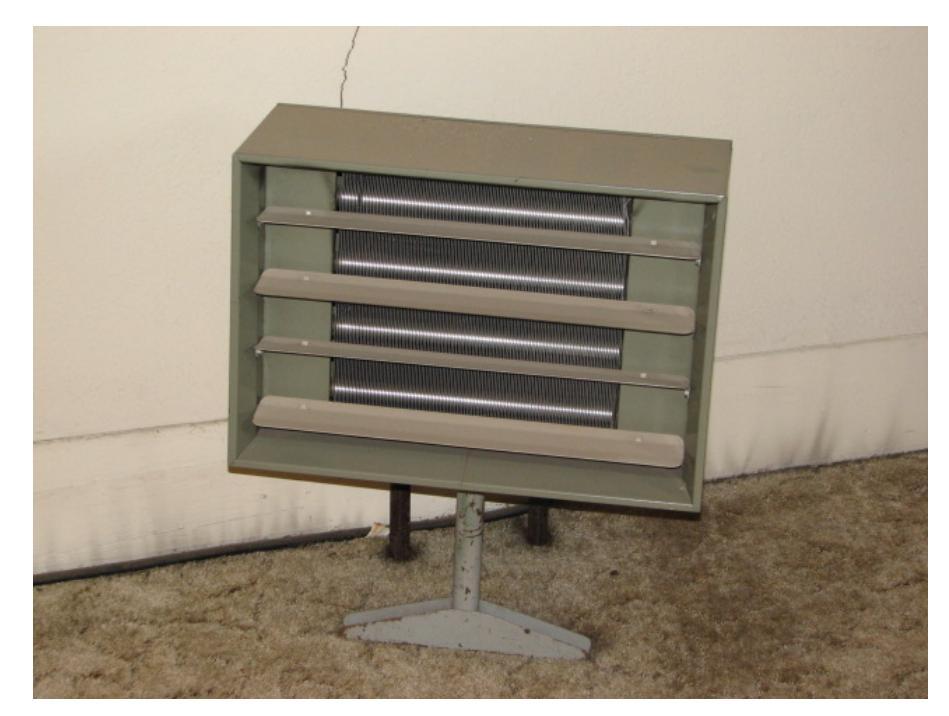
Unit heater in Two-Story Garage apartment

CATEGORY:	3.8 Mechanical and Plumbing Systems
DESCRIPTION:	The apartment and garage were heated by unit heaters, located in the main room and garage space respectively. Plumbing fixtures include a tub, lavatory, water closet and kitchen sink. All fixtures appear to date from around the 1960s.
EVALUATION:	The unit heater is past its serviceable life. Plumbing fittings are in poor condition, piping is corroded and of mixed types. The fixtures are not energy code-compliant.
RECOMMENDED TREATMENT:	Once an adaptive re-use for the structure is determined, a code analysis will be required to determine the type and number of fixtures and HVAC units required.

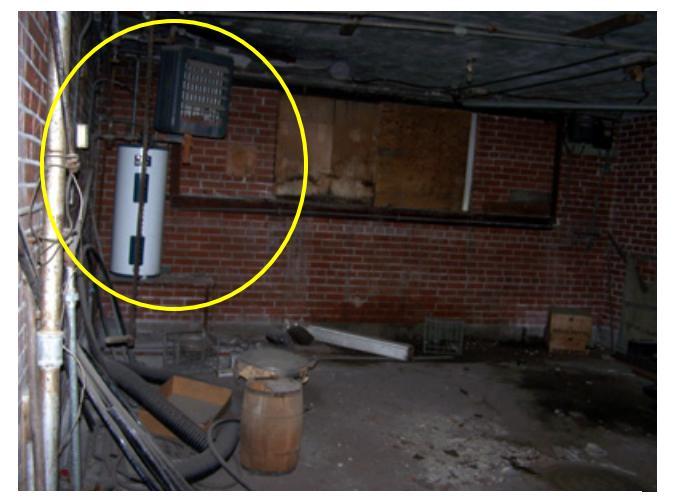
Unit heater and hot water heater located in the Garage below apartment

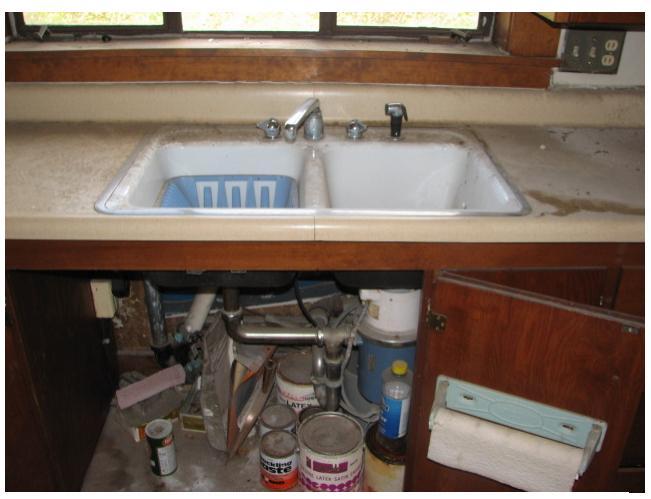
Sink in kitchen of Two-Story Garage apartment level.

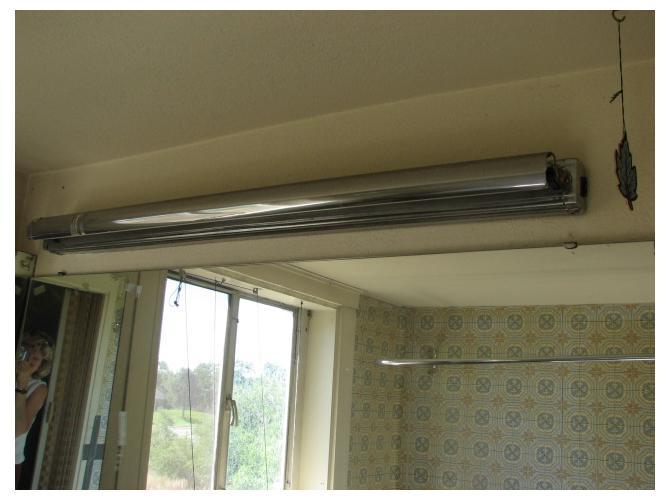
CATEGORY:	3.9 Electrical Systems
DESCRIPTION:	Electrical distribution panels have been removed from the building. Extant wiring is run partially in conduit, partially exposed. Lighting the apartment is a combination of early-vintage, exposed fluorescent lamp and simple, ceiling-mounted incandescent fixtures.
EVALUATION:	In general, the electrical system is not grounded and not code-compliant. The lighting fixtures are in fair condition.
RECOMMENDED TREATMENT:	Complete replacement of the electrical system is recommended and will be reliant on the requirements of the building's future use. Fluorescent and incandescent fixtures, with the exception of the linear fixture, could be rehabilitated, to illustrate the spaces simple, utilitarian history.
	Once an adaptive re-use is determined for the Garage, an underground power feed could be installed to the building. This would require subsequent design phases and is not included in this scope of work.

Fluorescent lighting - early vintage

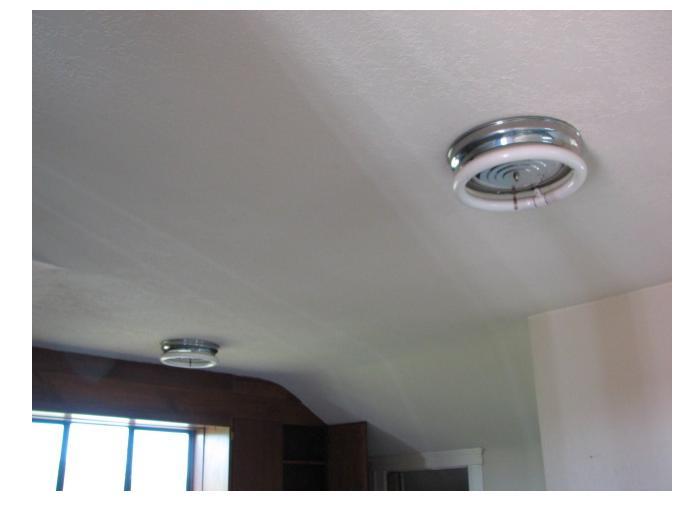
Fluorescent lighting

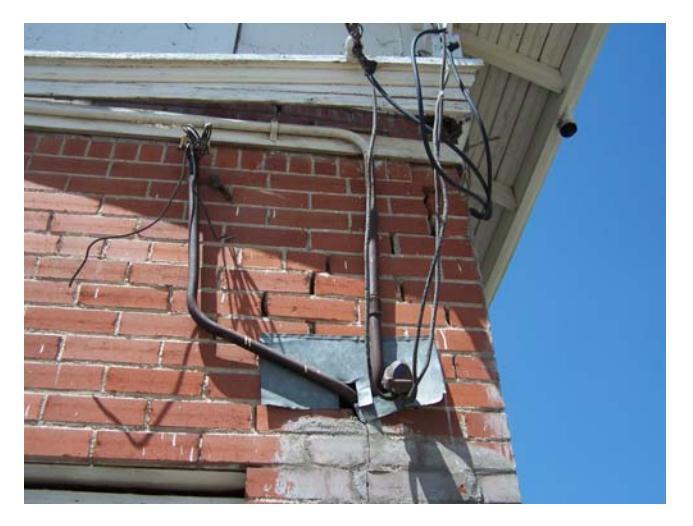
Electrical service masthead

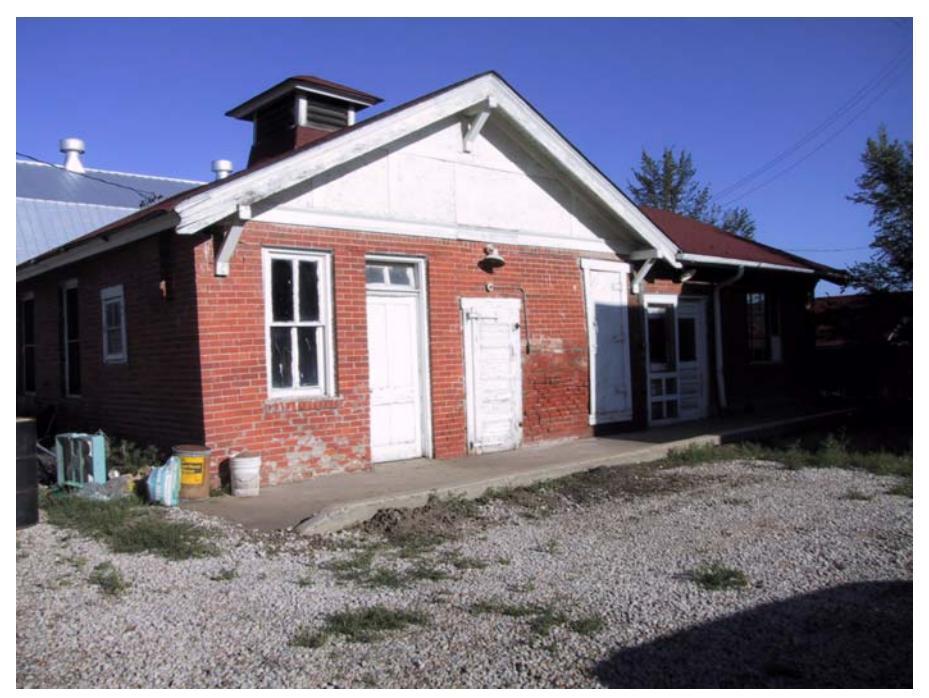
Gravel driveway at east elevation of 1911 Brick Milk and Ice House

EVALUATION: The site adjacent to the Milk and Ice House is in poor condition. The small amount of vegetation surrounding the structure has been allowed to overgrow, especially

on the north side. Volunteer trees and vegetation are crowding the foundation and perimeter sidewalks.

RECOMMENDED TREATMENT: Trim the overgrown grasses surrounding the structure. Remove the grove of trees located on the north side of the structure to protect the foundation. All grass areas should be cut and maintained so as not to allow overgrowth.

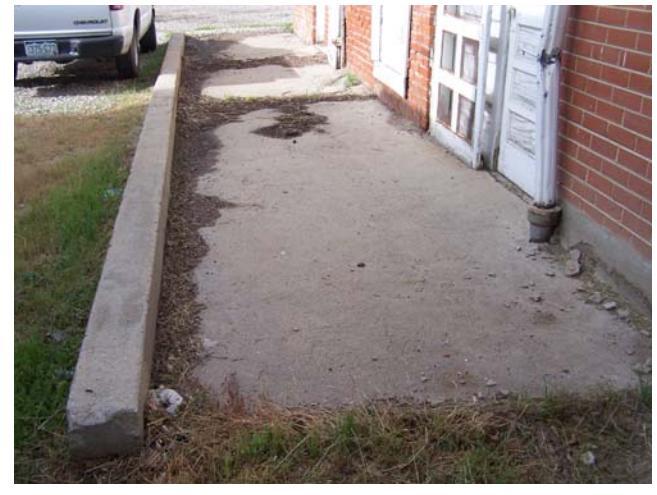
The concrete sidewalk is spalling and has a significant number of cracks and missing areas along the curb, most likely due to the current tenant's vehicle traffic. At the northeast corner of the structure, the three-foot wide sidewalk has a severe crack due to the settlement of the sidewalk at the corner location. Vegetation is continuing to grow in between existing cracks, further damaging the sidewalk. Due to recent tenant activity, the grasses to the west have been damaged with patches of dirt remaining.

Six foot wide concrete sidewalk at 1911 Brick Milk and Ice House. Note damaged curb and spalling concrete locations

Replace the six-foot and three-foot wide concrete sidewalk at the east and north elevations. Retain the existing curb. Slope the sidewalks to drain away from the structure. Restore grass area on the west side of structure.

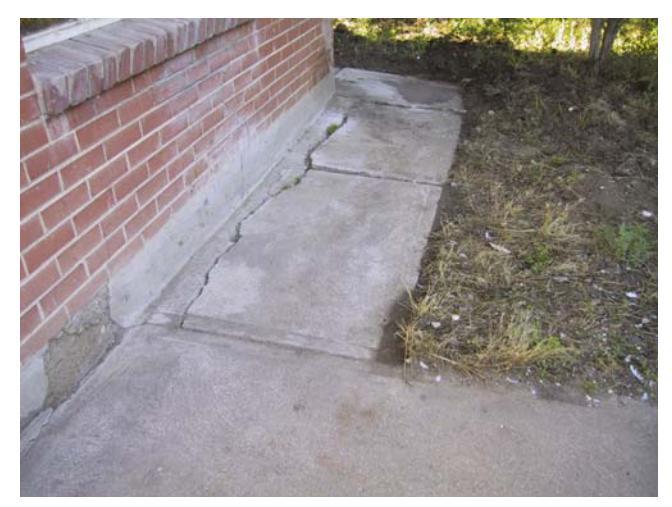
Cracked sidewalk at eastern edge of 1911 Brick Milk and Ice House

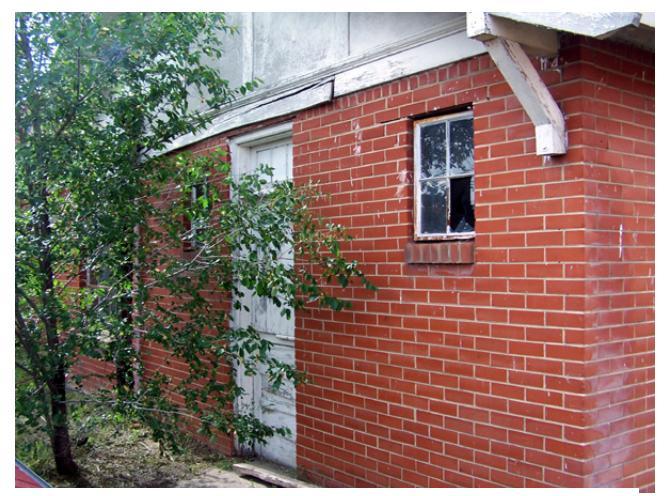
Tree at north elevation of Milk and Ice House

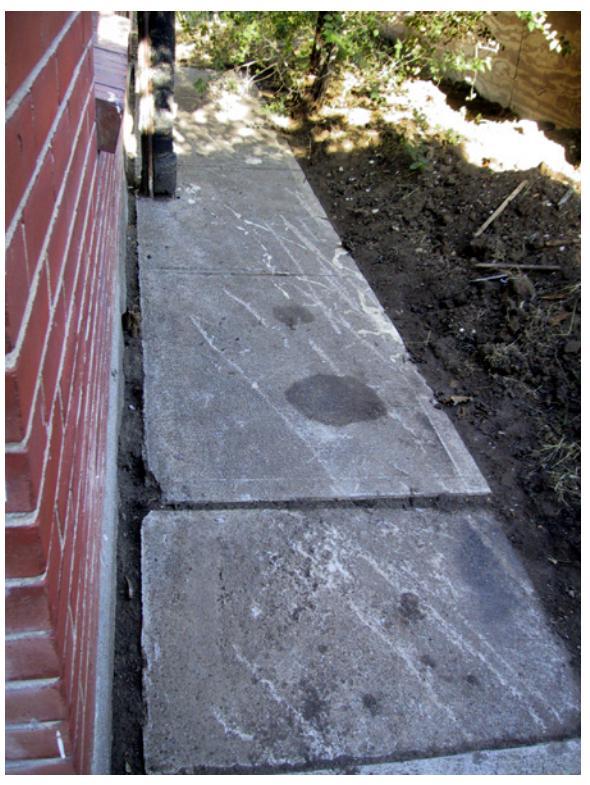
Sidewalk at the north elevation
