Shoenberg Farm

Historic Structures Assessment Project #2007-M2-011 March 14, 2008

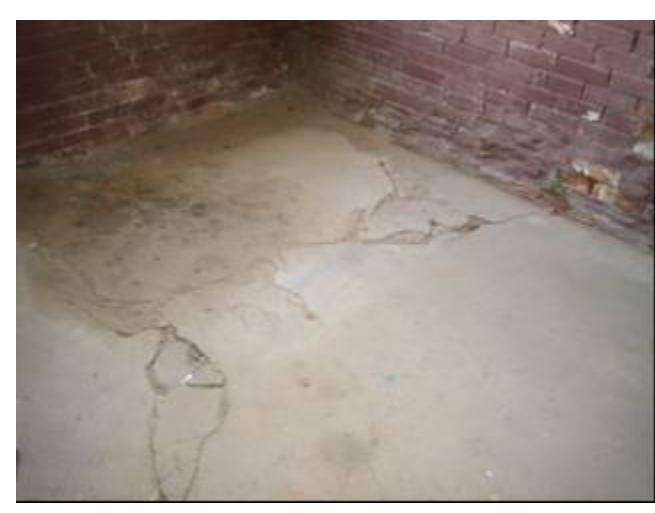
Overall, the slab-on-grade is in poor condition. Significant floor slab cracks up to 1/4" wide are apparent throughout the structure. A slab crack in the northeast room of the building appears to be propagating from the base of a stair step crack in the east wall.
Evidence of water infiltrating the interior floor space is apparent in the southwest room of the building. Soil is deposited in a pathway between the west door and the floor drain. The water infiltration is not directly distressing the floor slab but it is indicative of an exterior drainage problem. Also, soil and debris carried by the rainwater can interfere with proper functioning of the interior floor drain.

Slab cracking and brick deterioration in southeast corner

The foundation should be underpinned to prevent further differential settlement. With appropriate underpinning it should be possible to lift the foundation back to near its original elevation. This will help close the cracks in the walls although some damage will remain and additional damage may occur during the lifting process.

After the perimeter foundation system is stabilized, slab cracks should be filled with a suitable cementitious grout.

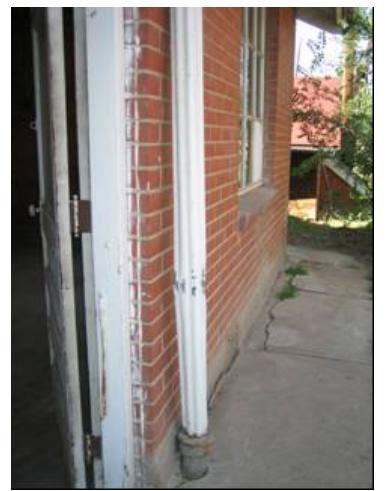
Parge coat and sidewalk cracking and displacement along east elevation

Soil excavation on the west side of the building is recommended to bring the exterior grade down to the level of the interior slab. The perimeter grade around the entire building should be re-graded to provide a slope away from the building.

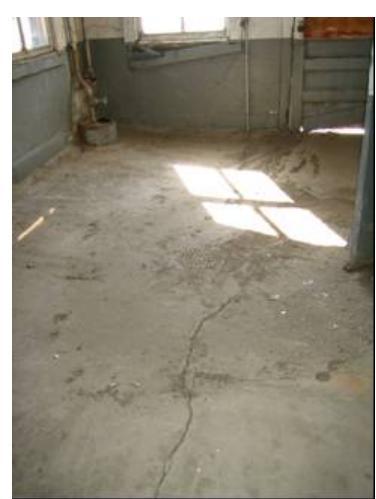
Slab cracking and water infiltration in southwest corner

A perimeter drain should be installed around the perimeter of the building to prevent water infiltration under the foundation.

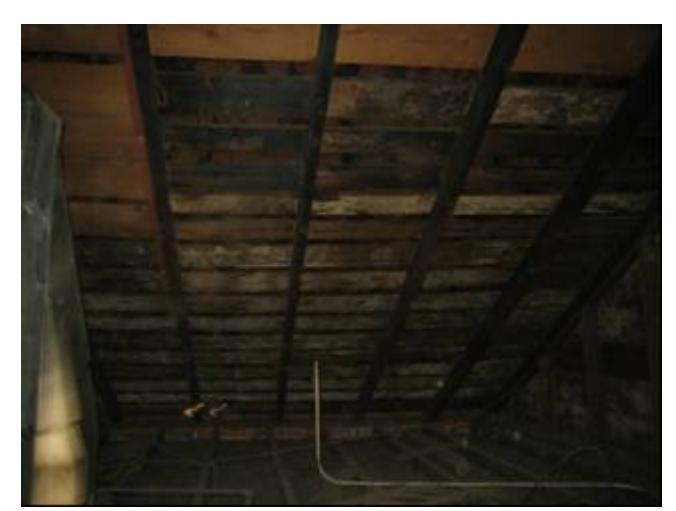
Typical roof framing, south facing aspect on west side

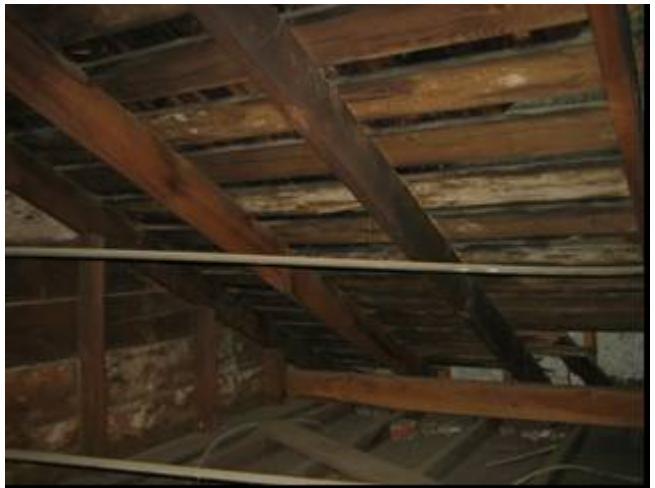
North facing aspect of roof framing on west side, 4x6 support beam

On the north side of the building, the second floor diaphragm connection to the top of the brick walls will need to be evaluated and if failed, reestablished in order to restore the building's capacity to resist lateral loads. Destructive investigation will be required to acquire the necessary information for analysis of the existing connection.
	On the south side of the building, the roof rafters, ceiling joists and top plates should be anchored to the top of the wall using new epoxy anchors once all wall repairs are complete.
	Typical roof rafters should be reinforced with 2x6 sisters so that the roof is capable of supporting the design snow load. In doing so in the few locations where severely fire damaged rafters have not yet been replaced or reinforced, the new sisters will adequately address both the snow load and fire damage problems. The 4x6 support beam will also require reinforcing. The fire damaged ridge board should be replaced.

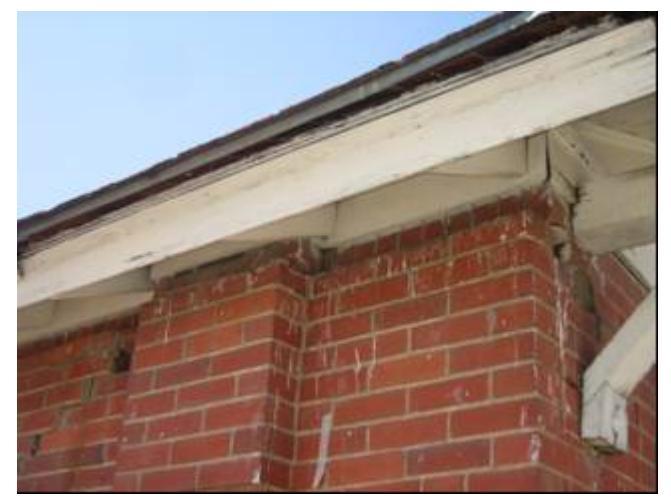
The brick and mortar deterioration is confined to the south side of the building, with the most severe case occurring in the southeast corner room. It is assumed that the particularly severe state of deterioration is the result of the building's historic use as an ice house and the associated high levels of moisture. As both the current use and proposed adaptive reuse of the building do not include adverse ambient conditions, the damage is no longer ongoing.
	The roof framing system is in fair condition. The roof rafters have insufficient calculated capacity to carry the Code-required snow loading. The ceiling joists are adequate to support the ceiling self-weight. The 4x6 support beam has insufficient calculated capacity to carry the Code-required loading. Although the roof appears to be performing adequately, it has insufficient calculated capacity and requires strengthening to meet current Code requirements.

Displaced south wall at southeast corner

Shoenberg Farm	Aluews & Alueison Alumeus, Fo
1911 Brick Milk and Ice House	to have been repaired or replaced. Some of the damaged 1x6 decking has been replaced.
RECOMMENDED TREATMENT:	In order to repair the perimeter brick walls the foundation system must first be stabilized. After which, the walls can be restored by rebuilding the compromised sections and re-pointing the joints. The severely displaced south wall however will likely require a more elaborate restoration. A new foundation element under the wall as well as entirely rebuilding the wall should be expected. In terms of structural stability, repairs to the south wall are paramount.
	Brick replacement and joint re-pointing should be performed in locations of severe damage. The most severe deterioration is localized to the lower wall courses in the southeast portion of the building.
	Wall cracks throughout the building should be re-pointed after the foundation is stabilized.

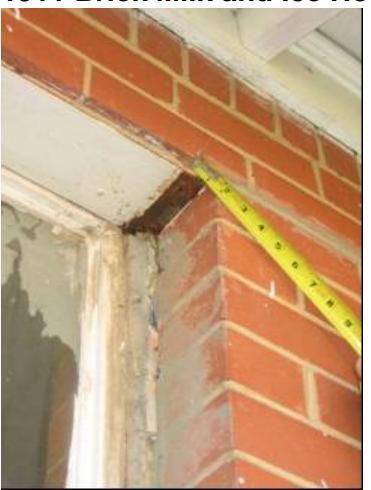
Displaced wall along east elevation

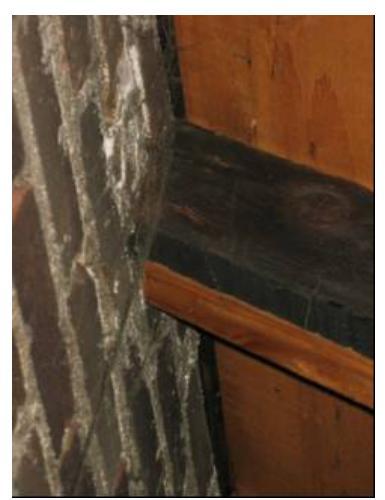
Some of the fire damaged roof rafters have been sistered. The fire-damaged ridge board does not appear

Fire damaged roof member and new sister

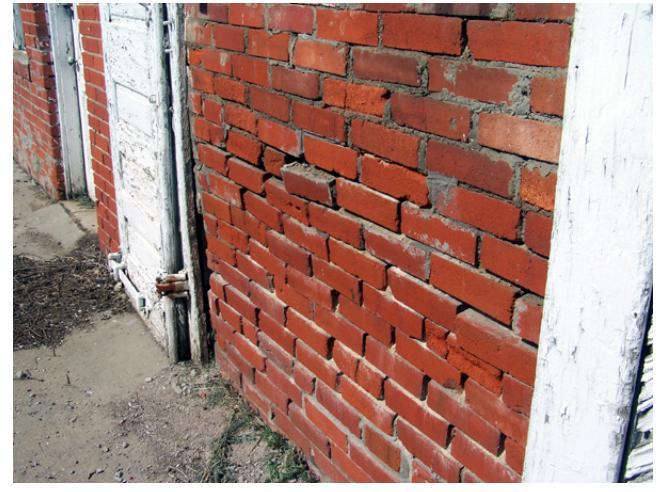
Deformed area on the east elevation

RECOMMENDED TREATMENT:	Once the foundation has been stabilized, remove the cementitious mortar joints and re-point the mortar at the deteriorated and cracked areas with a historically compatible mortar. Anticipate replacing approximately 500 square feet of damaged brick. Replacement brick should match the compressive strength of the historic brick.

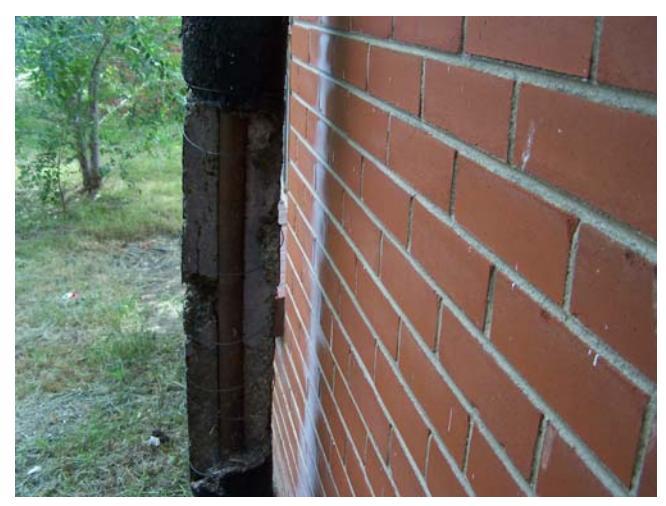
Insulated pipe on the north elevation of Milk and Ice House

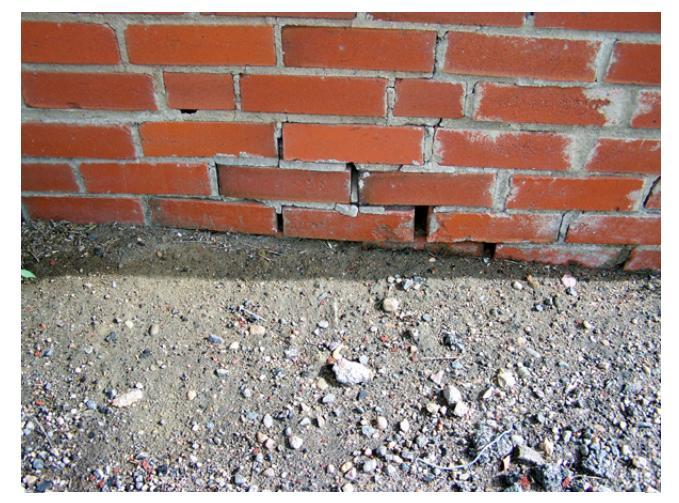
Missing mortar at ground level due to water infiltration

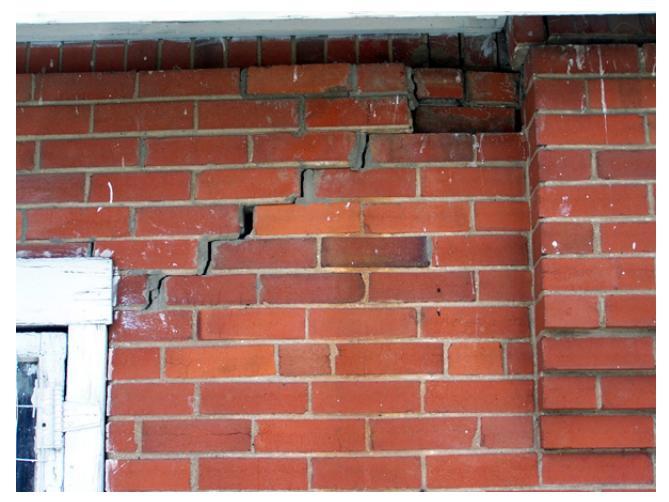
Shoenberg Farm	
1911 Brick Milk and Ice House	that decorative braces or ornamented "stickwork" were at one time visible at the gabled roof ends. This detail imitated structural elements and gives the impression of exposed wood framing elements.
	An insulated pipe is located at the north exterior wall. The original use of the pipe is unknown.
EVALUATION:	The exterior walls of the Milk and Ice House are in fair to poor condition. There is evidence of deterioration in several locations from severe to moderate. The most serious area is located on the south and east elevations where the masonry is buckling towards the south causing a large displacement crack at the wall and roof intersection.
	A moderate size, approximately three-feet high by four- feet wide area, on the east elevation is deformed and bowing out. The mortar joints are failing and deteriorating and several bricks are loose, detaching from the wall.

Loose bricks and stair-step crack at wall and roof intersection on the southeast corner of structure.

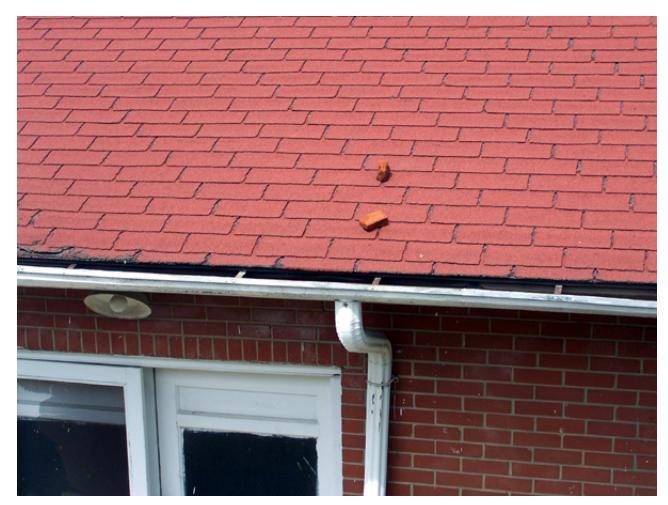
CATEGORY:	3.5 Envelope - Roofing & Waterproofing
DESCRIPTION:	The roof is a simple gabled plan of two intersecting gables. It is rectangular in shape with modern asphalt shingles with 2x6 rafters at 24 inches on center. The gabled ends have moderate overhangs with a painted, plain verge board. The eave extensions are supported by 4x4 wood brackets at the ridgeline and outside walls.
	Water drainage is by continuous half-round metal gutters and downspouts on the east and west elevations.
	A louvered cupola-ridge ventilator with a hip roof is located at the center of the original structure. The vertical surfaces of the cupola are shingled to the bottom of the louvers.
EVALUATION:	The roof is in fair to poor condition. Several shingles are showing signs of UV degradation, specifically on the west elevation.
	Paint is peeling at the support brackets, rafter tails and verge boards. One 4x4 support bracket is missing at the southwest side of the roofline of the original 1911 structure. Gutters are loose and missing in some locations.

Roof, gutter and downspout on east elevation

All existing roofing materials should be removed to solid sheathing. Replace any deteriorated sheathing with an in-kind material and install new No. 1 cedar wood shingles to match exposure of original shingles. Remove existing gutters and downspouts at east and west elevations. Install new gutters, downspouts and concrete splash blocks; paint to match original. Scrape sand and repaint rafter tails and bargeboards. Replace damaged bargeboards with like kind. Replace missing 4x4 support bracket to match original brackets that remain. Paint to match original.

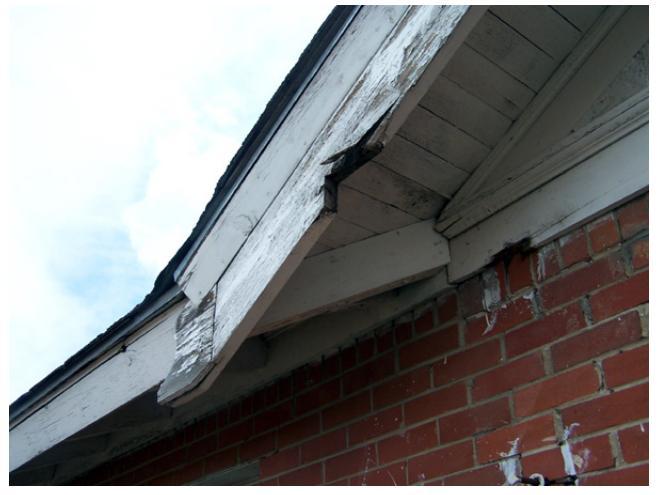
Missing 4x4 bracket

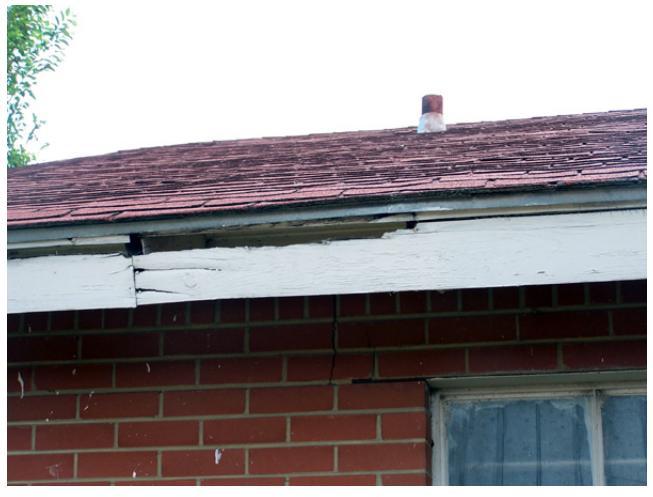
Damage at eave trim

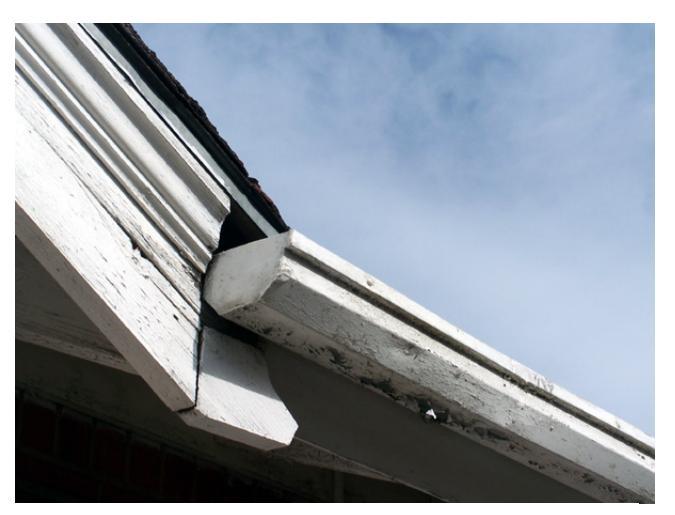
Half round metal gutter

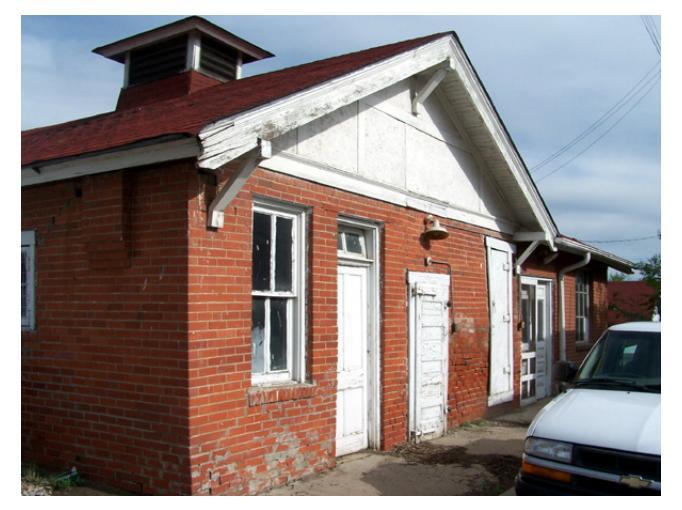
Doors on the east elevation of Milk and Ice House

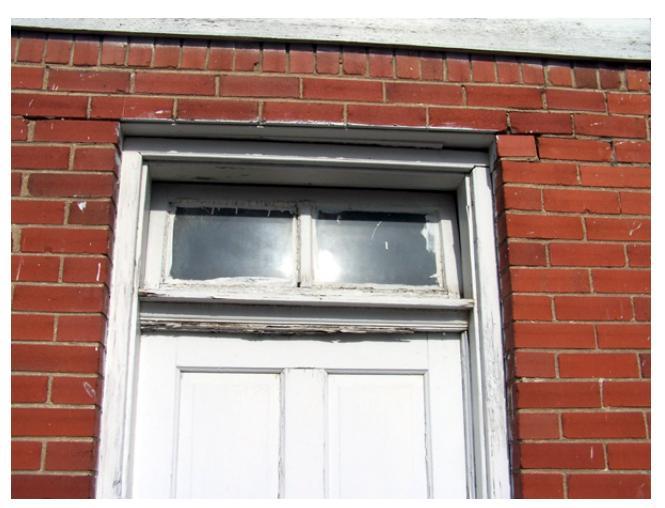
Two-light transom over door to Room 100

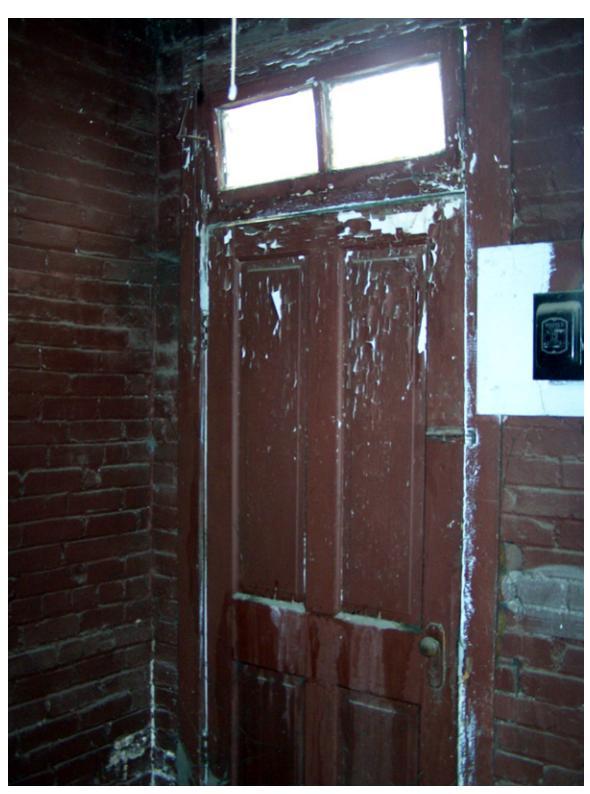
Interior view of the exterior door of Room 100

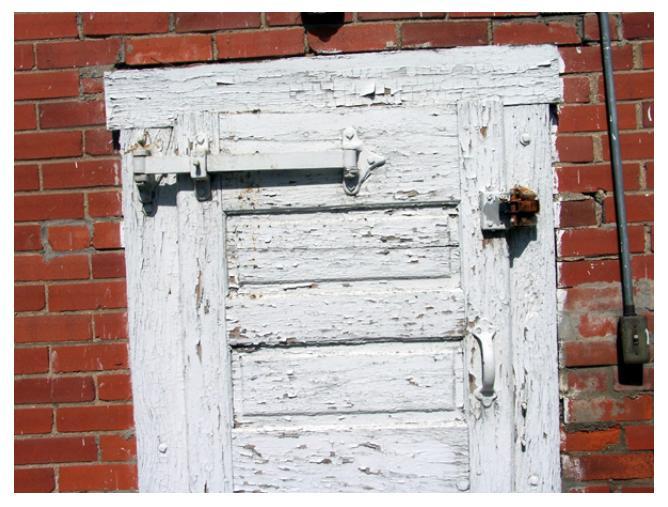
The five-paneled exterior refrigeration door to Room 101 is in poor condition and is inoperable. Since access to the interior space at this location was impossible, it cannot be determined the condition of the door at the interior of the space. On the exterior, the paint is peeling and flaking. The door to Room 101A is also in poor condition as it cannot be opened. The diagonal wood beadboard and wide trim surround has peeling and flaking paint.

Original hardware and five-paneled wood door to Room 101

removed, reconditioned and reinstalled. All screening should be replaced. The two doors to the refrigeration room should be made operable.

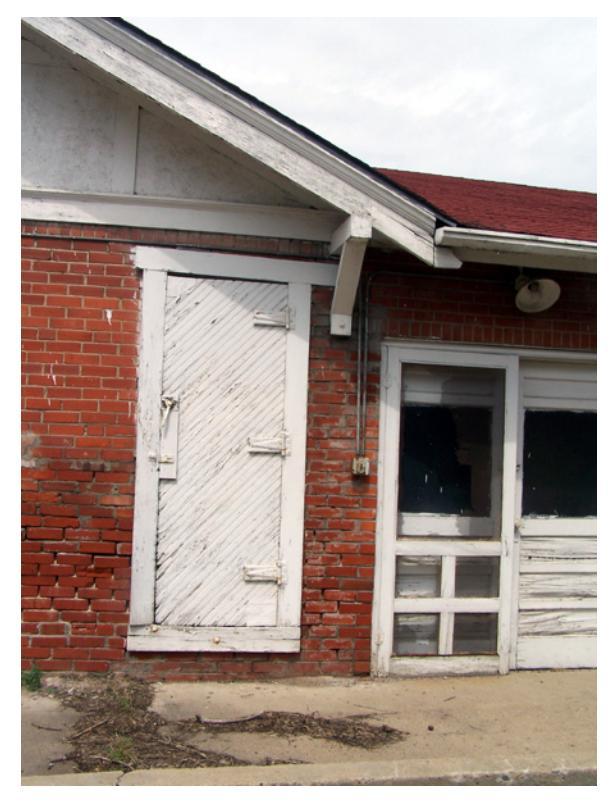
Diagonal beadboard refrigeration door on the east elevation of Milk and Ice House

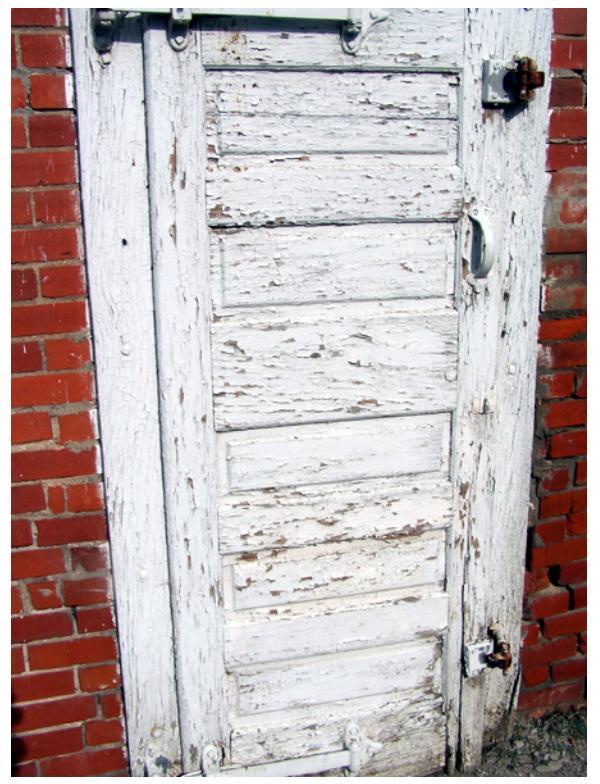
Five-paneled wood door at Room 101

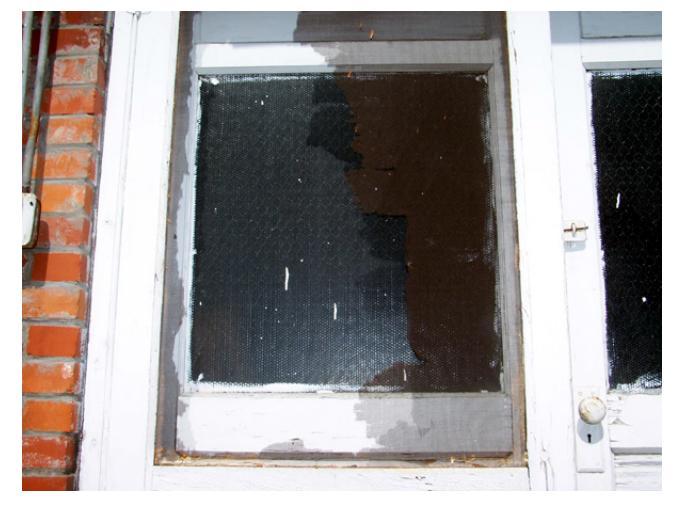
Wire glass glazing a the double exterior doors to Room 102

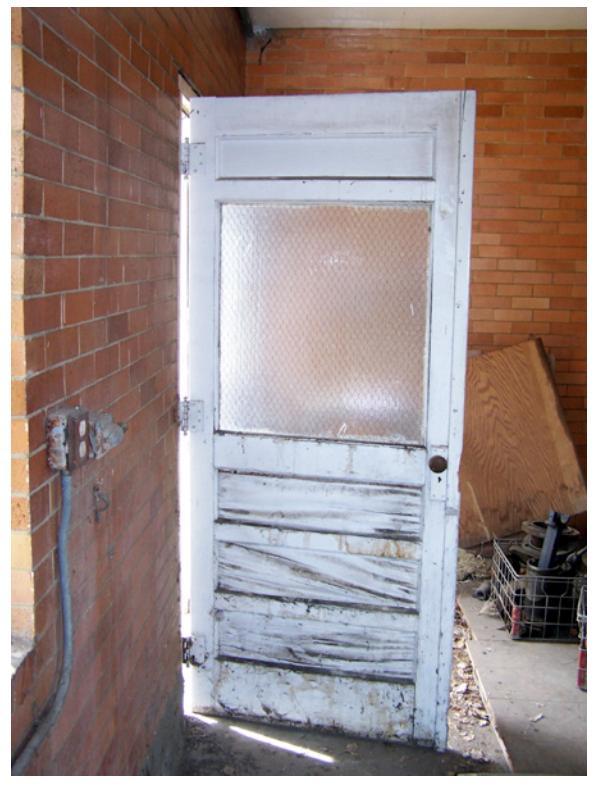
Interior view of exterior doors at Room 102

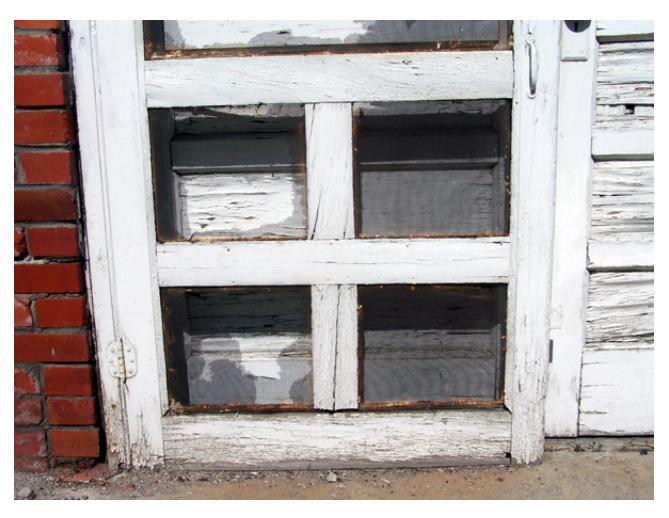
The double doors to Room 102 are in poor condition. Screens are missing and torn at the screen door and the horizontal wood panels on the two doors are warped and weathered. The paint is peeling and flaking.

Torn and missing screens at wood screen door

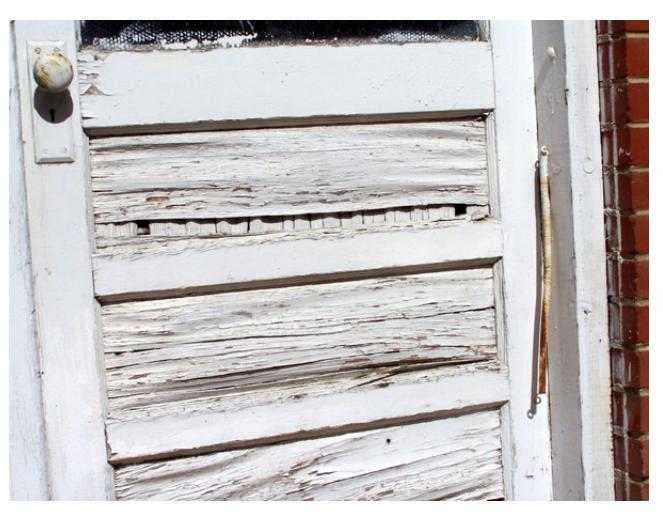
Warped and weathered horizontal panels at exterior doors to Room 102 $\,$

> All the areas of peeling paint should be sanded and painted to match the original color. Wood members such as panels, rails, stiles, trim, and frames that cannot be stabilized with epoxy should be replaced in kind. Glazing at the wood paneled doors should be replaced and the wood paneled boards replaced and painted to match the original. Original hardware should be

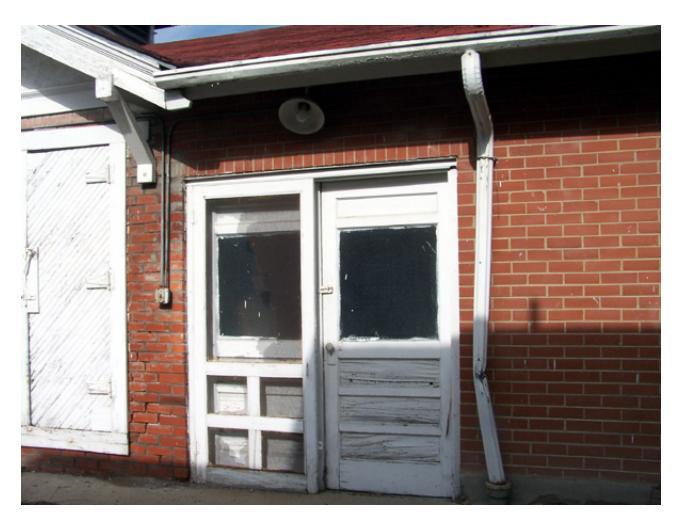
Wood double doors and screen doors to Room 102

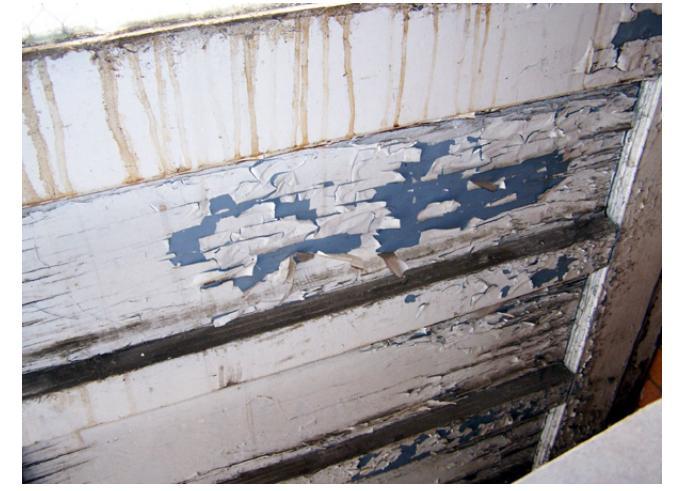
Peeling paint at wood doors of Milk and Ice House

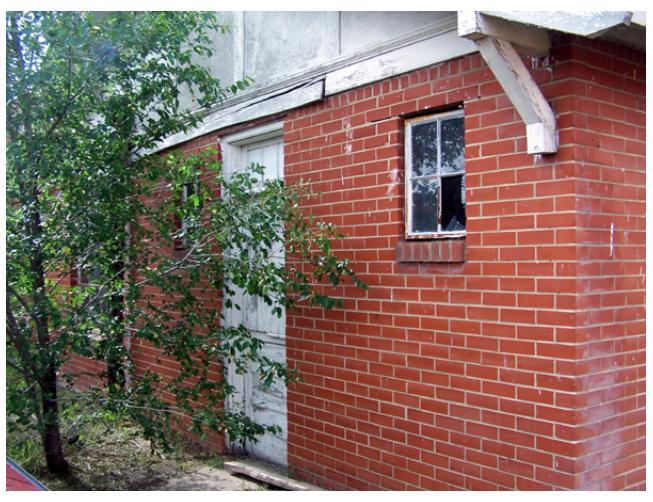
The north and west three paneled wood doors are in poor condition. The half-light window originally above the middle rail is missing in both doors and currently covered with painted plywood. The transom lights are not functional and the north transom is painted. The north door is not operable. The paint is peeling and flaking at both locations.

Door at north elevation

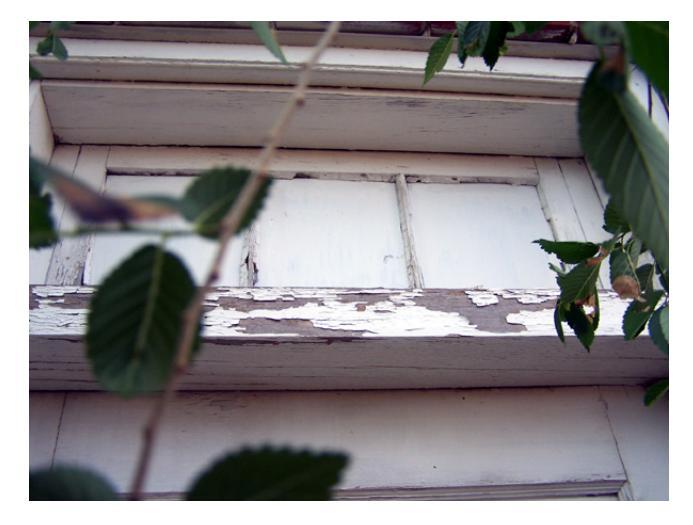
Painted three-light transom above door on the north wall

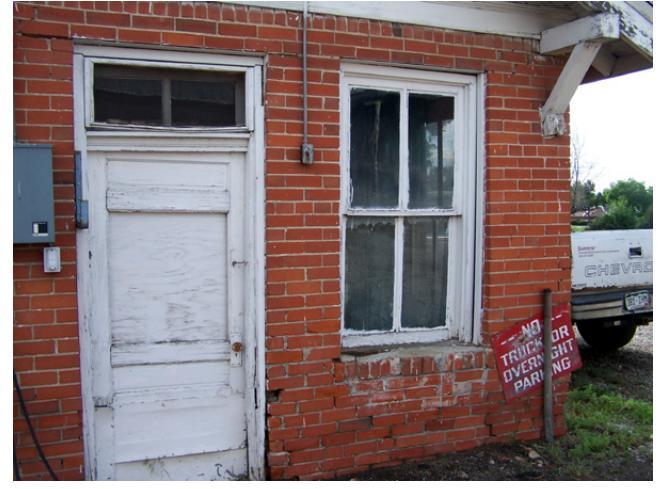
Wood paneled door and two-light transom at west wall

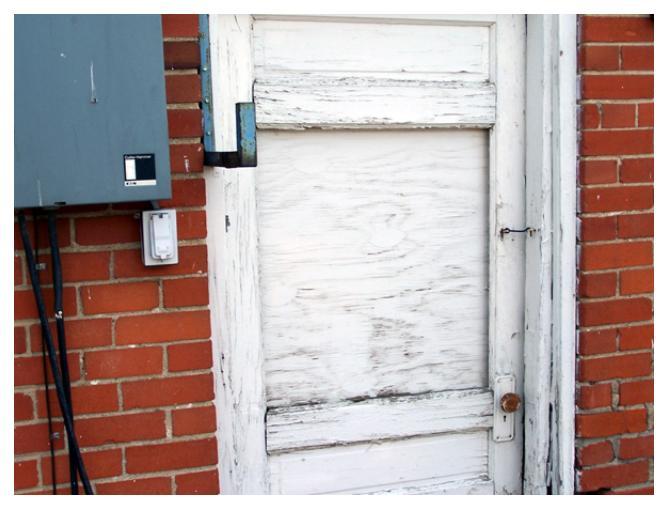
Wood board covering missing window glazing on the west door

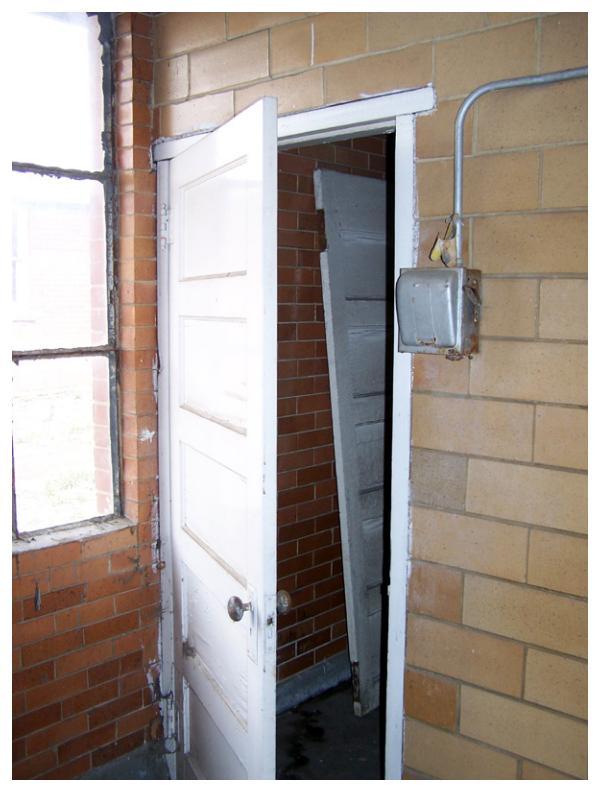
The interior doors are in good to fair condition with a few minor exceptions. All are operable and retain their original hardware. One of the double doors between Rooms 102 and 104 is not installed. It is currently being stored in Room 103 and is in good condition. The two interior doors in poor condition are the doors from Rooms 104 to 105 and 105 to 100. Both have significant areas of flaking and peeling paint and some minor damage. The horizontal plank door in Room 100 is in poor condition. Several of the horizontal wood planks are missing and broken.

Interior door to Room 103. The missing double door from Room 102 is visible in the storage area

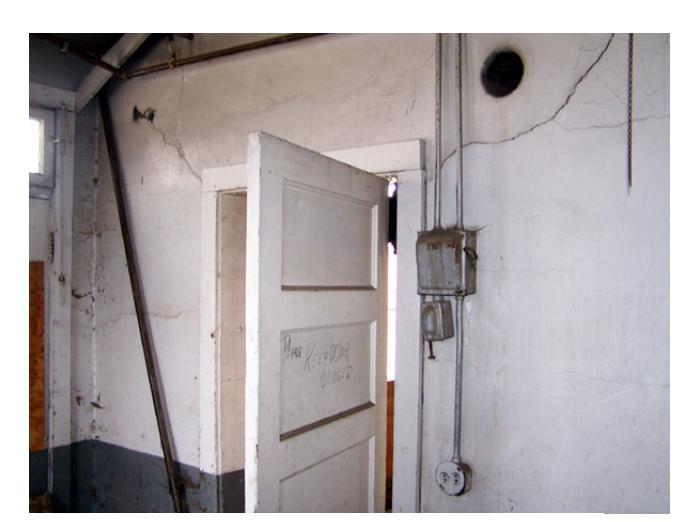
Interior door at Room 105

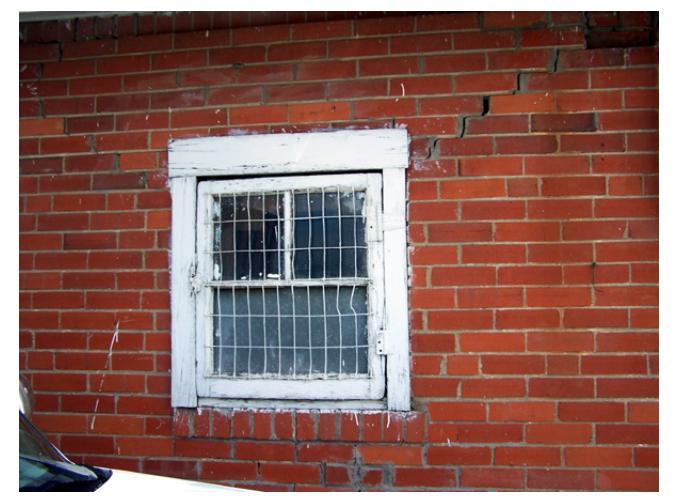
Two-over-two window with substitute glass replacement at lower sash

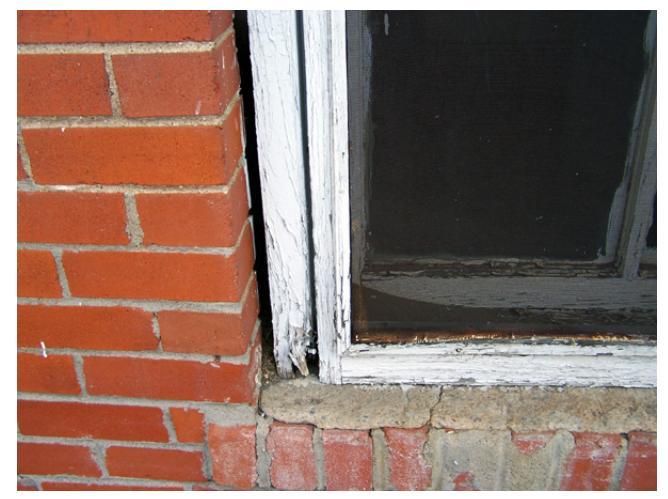
Separated wood window frame at the frame and masonry junction.

The sloped brick masonry sills are in fair condition. Some locations have damaged areas of brick and are showing signs of deterioration. The parge coats on the sills of the 1911 construction are in poor condition, either missing sections or areas of deterioration are evident.
RECOMMENDED TREATMENT:	Remove all broken glazing and replace with new glass at all necessary locations. Epoxy stabilize or replace the deteriorated wood members. Replace glazing compound throughout. Sand and repaint the wood frames of the double-hung windows and the small fixed windows.
	Replace broken or missing brick elements at the sloped window sills. Remove damaged parge coat at the 1911 structure and reapply to those original areas.
	Replace all screens at the two-over-two double hung windows. Replace the rusted hinges at the casement window to make operable. Replace the broken and missing glazing.
	Clean the rusted sash and frame members of the 12- light fixed windows. Replace the cracked and missing glass elements and deteriorated glazing compound throughout. Caulk at the masonry junction and paint the metal frames and sash to match original.

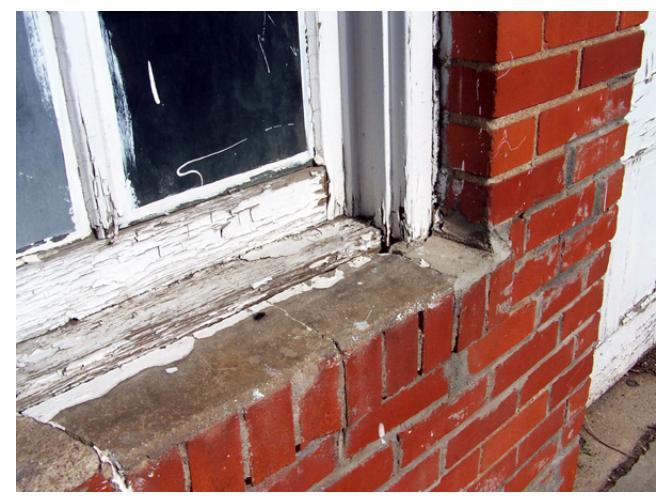
Concrete parge coat at sloped masonry window sill

Remove damaged parge coat on exterior masonry window sills. Test the composition of the parging. Restore to match original.

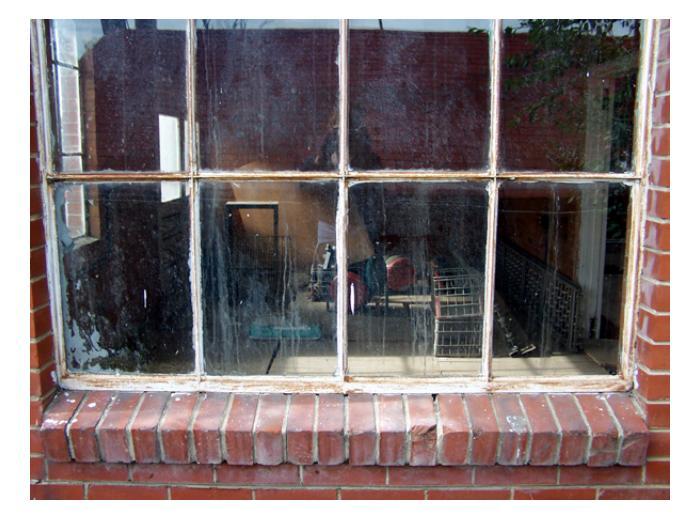
Sloped brick masonry window sills below 12-light window system

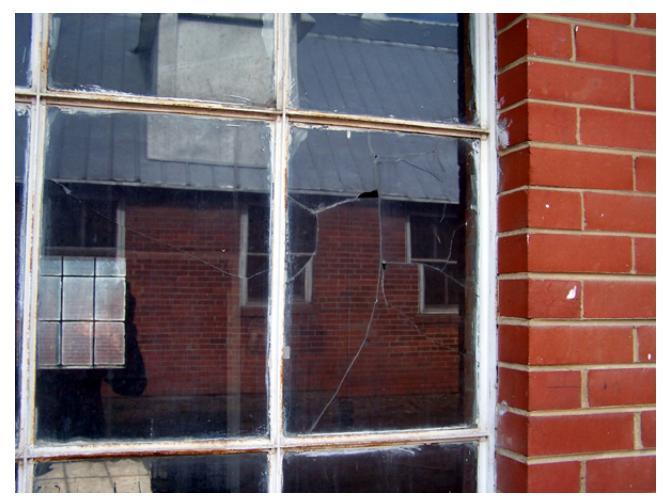
SHOENBERG FARM	
1911 Brick Milk and Ice House	The north, south and east elevation walls have 12-lights fixed metal window assemblies at the 1940s era addition to the structure. The sills are sloped brick. A small two-over-two fixed window is on the north elevation, just to the west of the north entrance door.
EVALUATION:	The windows are in fair to poor condition. The wood double-hung windows are still operable. The paint on the frames is peeling and weathered. Several of the windows are missing panes of glass or have broken panes. The casement window on the north façade is not operable. The lower pane is broken and the hinges have rusted. Sash members are in fair condition, with signs of weathering and paint cracking. The 12-lights fixed windows are in fair condition. Several panes of glass are still intact, but cracked and broken in place. The metal sash members are in fair condition. Some are showing signs of rust where the paint has deteriorated.

Painted window muntins and broken glazing at 12-light window system

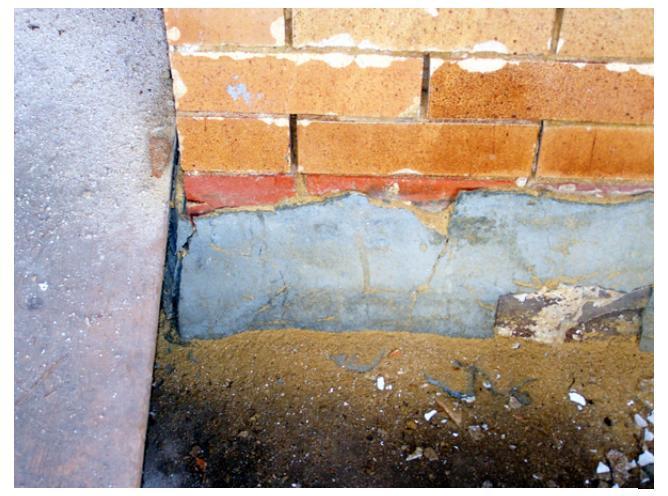
Damaged area of concrete baseboard parging on the east wall of Room 104

Remove the damaged areas of coved 'baseboard' parging and replace with new to match original.

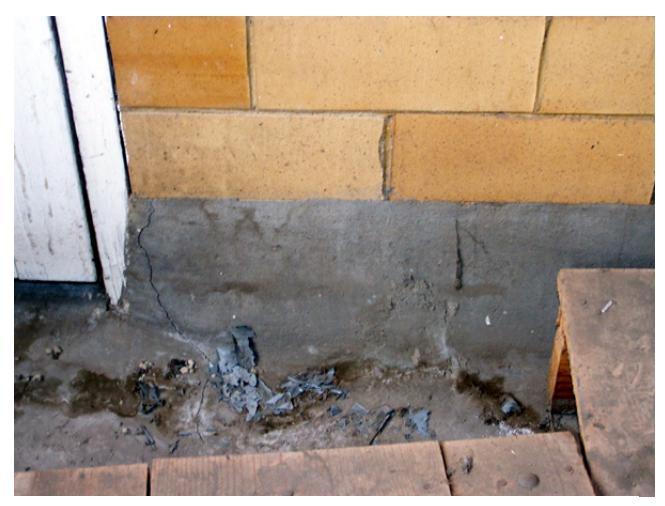
Damaged area of concrete baseboard parging on the north wall of Room 104

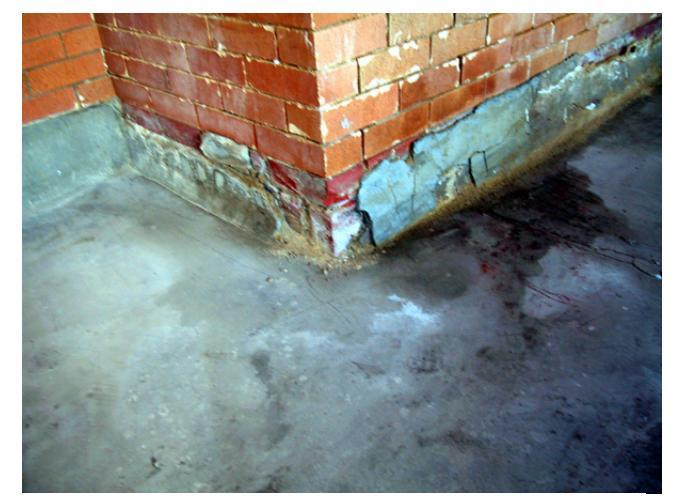
Damaged area of concrete baseboard parging on bump out wall of Room 104

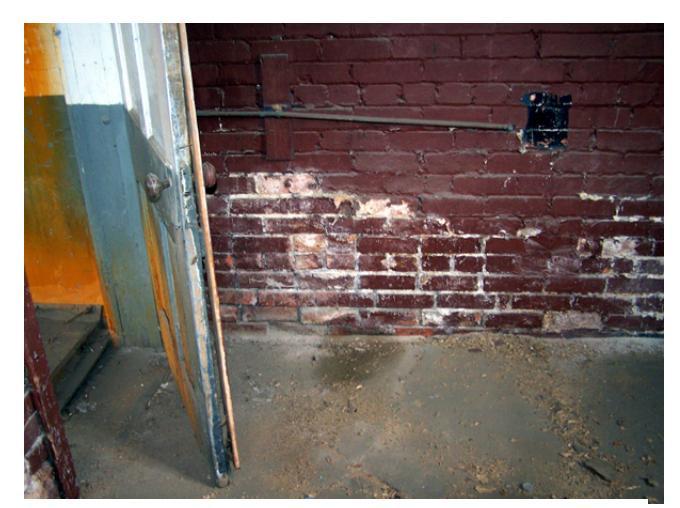
Painted plaster walls are in fair condition with minor damage most likely due to its original use. Painted brick in Room 100 is in poor condition. Several layers of paint are painted over the brick, and are peeling and cracking in multiple locations.
	The ceiling finishes are in good to poor condition. Locations of the lath and plaster ceilings show no signs of damage or deterioration, while other areas show significantly more deterioration. Areas of peeling paint and exposed areas are evident.
	Rising damp is apparent at the base of several exterior walls, up to 30 inches in some areas. The condition has caused some of the bricks to spall and efflorescence. Given the groundwater conditions of the site, it may be difficult to completely mitigate this condition without completely rebuilding the foundation in concrete and installing a perimeter drain and sump pump. Due to the expense of this measure, we recommend monitoring the situation after perimeter drainage is improved.

Painted brick and efflorescence in Room 100

The stair-step cracks should be re-pointed once the foundation has been stabilized. Damaged bricks should be replaced and re-pointed and the efflorescence should be removed with a stiff, natural bristle brush.

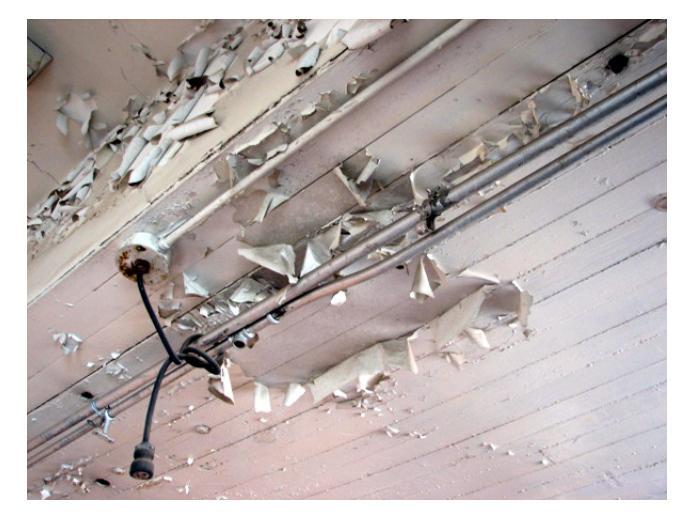
Peeling paint at beadboard soffit

The concrete 'baseboard' parge coat in Rooms 102 and 104 should be removed and restored where damage has occurred, specifically on the southeast corner of Room 104. All of the ceiling areas should be scraped of the peeling paint and re-painted. The plaster walls should be patched and painted to match original.

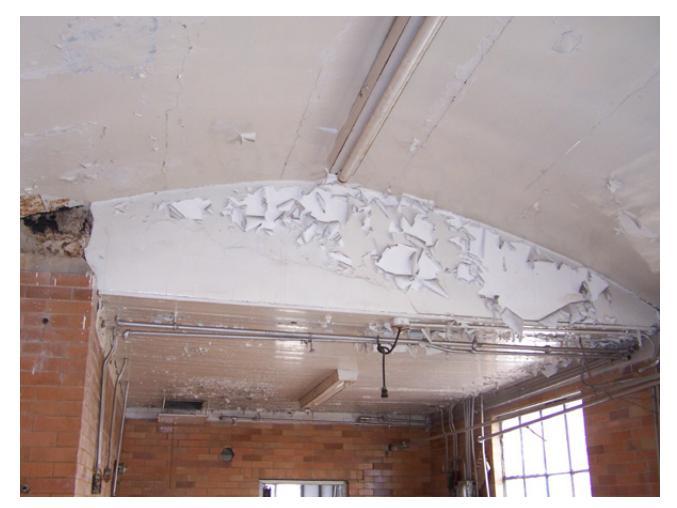
Peeling paint at vaulted lath and plaster ceiling

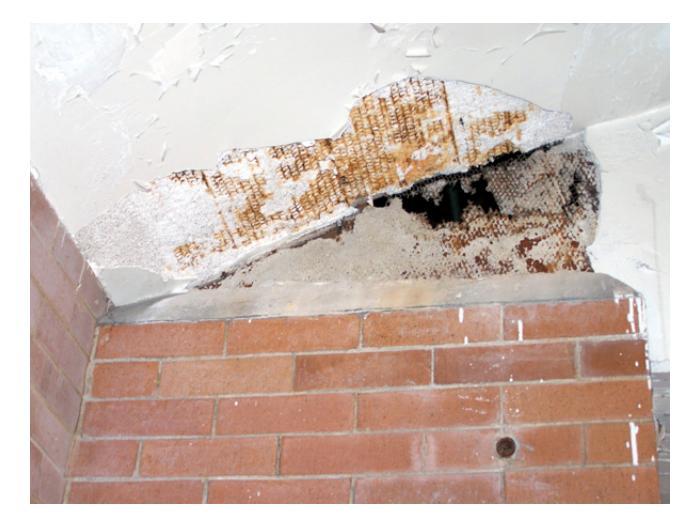
Damaged lath and plaster ceiling in Room 104

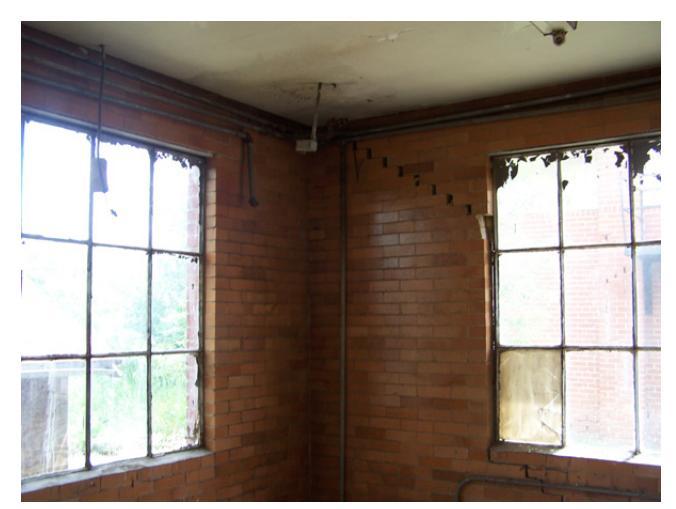
Stair-step crack at the northeast corner of interior Room 102

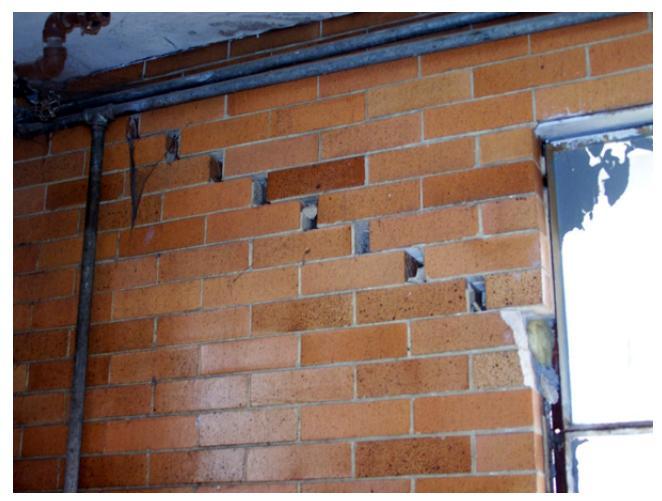
Stair-step crack at northeast corner of Room 102

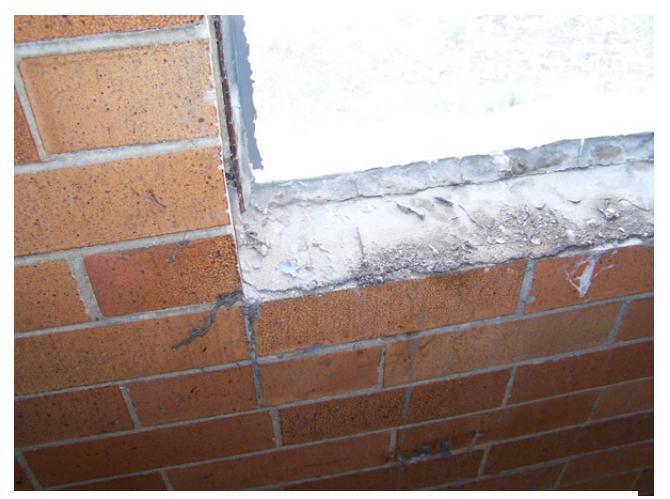
Stair-step crack at bump out wall in Room 104

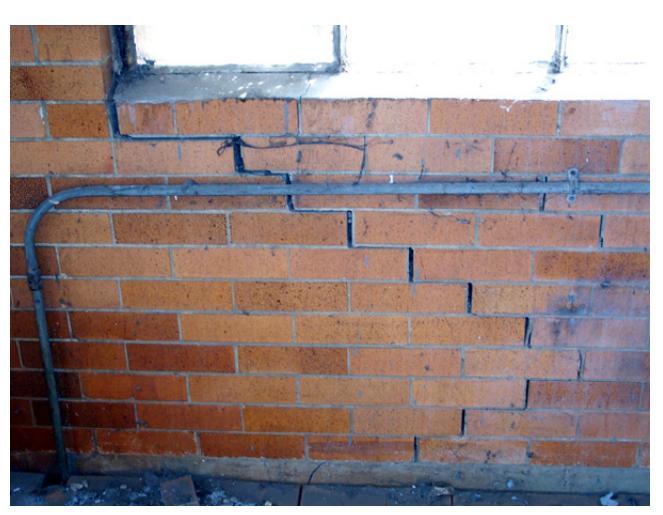
Crack below east window Room 102

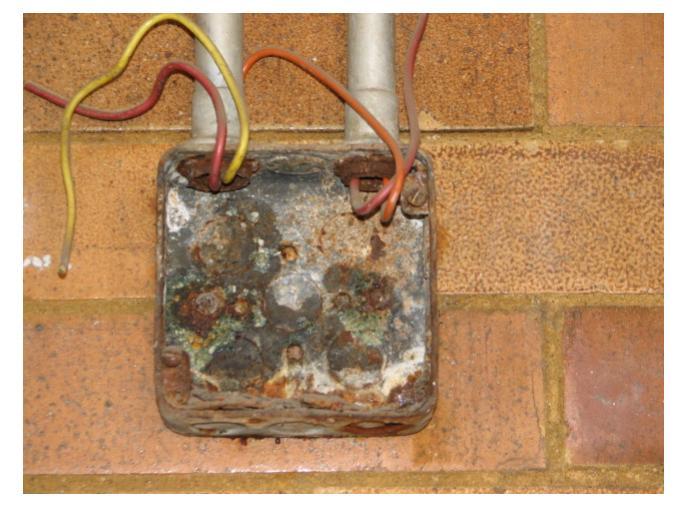
CATEGORY:	3.9 Electrical Systems
DESCRIPTION:	The electrical distribution within this building is run in conduit from fuse panels. Lighting is predominantly strip fluorescent.
EVALUATION:	The electrical system is not code-compliant. Lighting ballasts are corroded.
RECOMMENDED TREATMENT:	Replace the building's entire electrical system with a new code-compliant system. It may be possible to reuse conduit (surface-mounted is most feasible and in keeping with the building's historic character.) New fluorescent lighting should resemble existing and would be in keeping with the building's utilitarian nature.

Corroded junction box

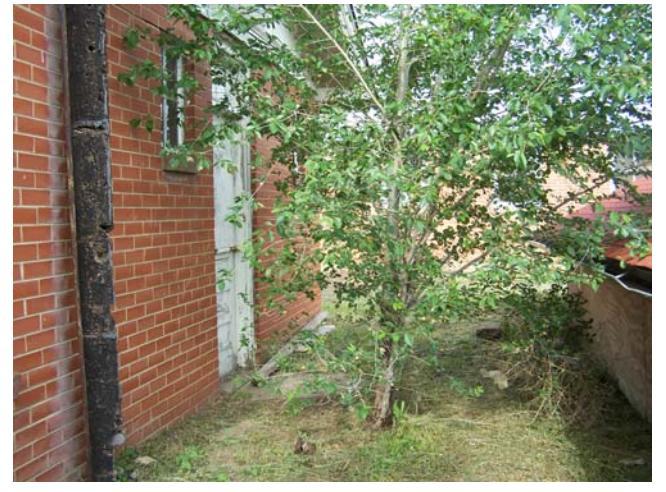
Volunteer tree between Brick Milk and Ice House and Brick Pump House

CATEGORY:	3.1 Site
DESCRIPTION:	The site at the Brick Pump House is flat with a moderate rise to the north. Recent activity by the current tenant has disturbed the site and obstructed access to the northwest corner.
	Vegetation is sparse around the building with only one volunteer tree at the south elevation. It is located between the Pump House and the Brick Milk and Ice House. Shrubbery around the structure is all volunteer grasses and plants.
	The site appears to have negative slope toward the building where water and soil pressure from the south is causing damage to the south perimeter wall of the structure.
EVALUATION:	The site is in poor condition. Vegetation has been allowed to overgrow and is damaging the structure. Volunteer grasses on all sides are unkempt and overgrown. There is inadequate slope away from the structure to allow for proper water drainage.
RECOMMENDED TREATMENT:	Remove the tree between the Pump House and the Brick Milk and Ice House. All volunteer grasses and shrubbery should be cut and maintained so as not to

allow overgrowth. Re-grade the site to provide a minimum slope of one quarter inch per foot to six feet out from the building perimeter.
