Shoenberg Farm

Historic Structures Assessment Project #2007-M2-011 March 14, 2008

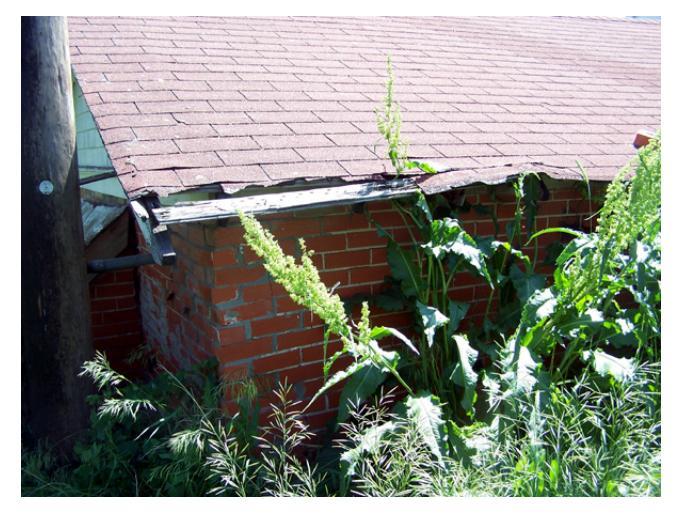
Overgrown shrubbery at north elevation of Pump House

CATEGORY:	3.1 Site
DESCRIPTION:	The site at the Brick Pump House is flat with a moderate rise to the north. Recent activity by the current tenant has disturbed the site and obstructed access to the northwest corner.
	Vegetation is sparse around the building with only one volunteer tree at the south elevation. It is located between the Pump House and the Brick Milk and Ice House. Shrubbery around the structure is all volunteer grasses and plants.
	The site appears to have negative slope toward the building where water and soil pressure from the south is causing damage to the south perimeter wall of the structure.
EVALUATION:	The site is in poor condition. Vegetation has been allowed to overgrow and is damaging the structure. Volunteer grasses on all sides are unkempt and overgrown. There is inadequate slope away from the structure to allow for proper water drainage.
RECOMMENDED TREATMENT:	Remove the tree between the Pump House and the Brick Milk and Ice House. All volunteer grasses and shrubbery should be cut and maintained so as not to

allow overgrowth. Re-grade the site to provide a minimum slope of one quarter inch per foot to six feet out from the building perimeter.

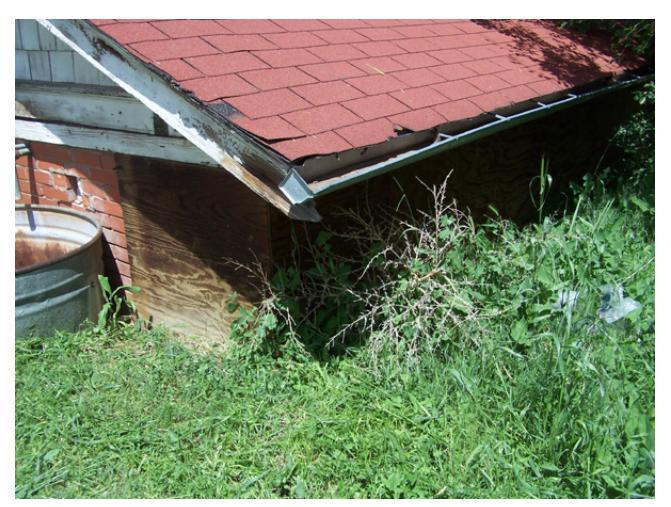
Volunteer grasses against Pump House structure

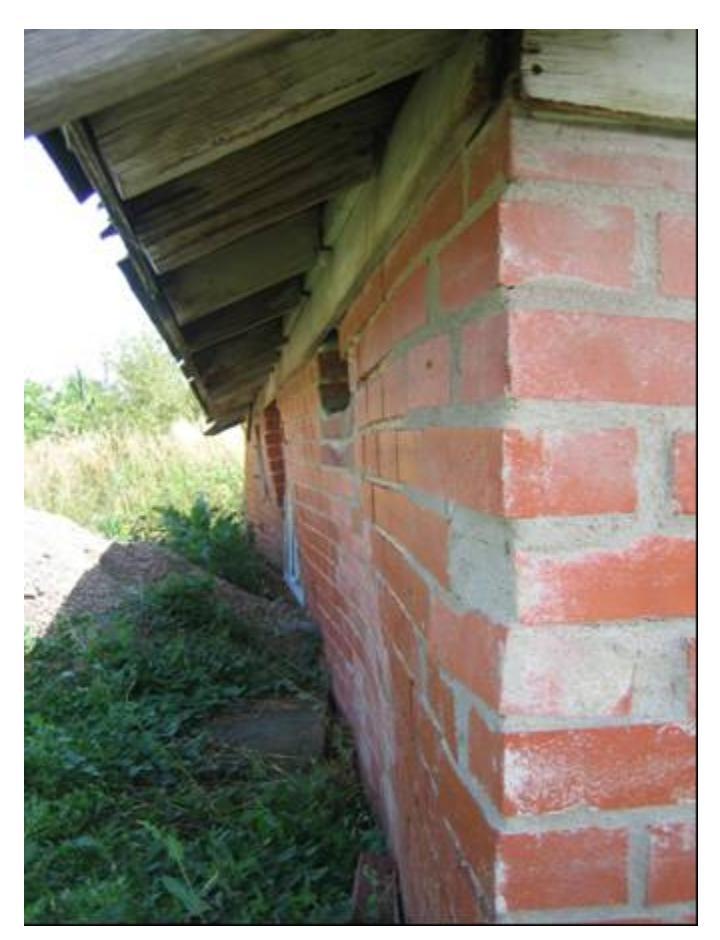
Distressed and deflected north wall from exterior

The original south wall has largely been removed and replaced with pressure-treated 2x6 studs at 16" and plywood sheathing. The north wall has been shored with a continuous 2x12 plate approximately 3' above the slab and five equally spaced 4x6 kickers.

Shoenberg Farm	
1911 Brick Pump House	Efflorescence is evident along the middle-third portions of the walls. Both the bricks and the mortar are
	step cracking near the two windows and the door opening.
	The floor is a slab-on-grade with hairline spider web cracking. Various concrete equipment pedestals rest on the slab.
EVALUATION:	The exterior walls are in poor condition. Exterior soil pressures exerted on these walls have caused significant distress and deflection. At the worst condition, the north wall has deflected inward by approximately 1 foot. This wall's capacity to resist loads is effectively gone. The shoring is the only thing preventing complete collapse of the wall. Furthermore, the shoring assembly does not have the calculated capacity to resist the lateral earth pressure. The remaining brick walls are not as severely deflected but have also lost much of their capacity.
	The wood-framed south wall is currently plumb, but not a good long-term solution to resist soil pressures because of the loss of historic fabric. Also, even pressure-treated wood can deteriorate when in direct contact with moisture without a protective membrane.

RECOMMENDED TREATMENT:	In the current condition the Pump House is not safe for occupancy. It is recommended that the soil around the perimeter be removed immediately to prevent collapse. A pump or drain system will need to be provided to prevent the excavated area from filling with water.
	If the Pump House is to become occupied in the future, it is recommended that concrete retaining walls and footings be introduced up to the grade elevation and that all of the brick walls be removed and rebuilt. The brick walls can be rebuilt utilizing the salvaged bricks, and be built off the top of or just inside the new concrete retaining walls. But, severely deteriorated bricks are not considered salvageable so some new bricks will need to be introduced. A perimeter drain is also recommended in conjunction with this repair.
	The slab-on-grade is in serviceable condition, but will likely need to be removed in order to rebuild the walls and install competent foundation elements.

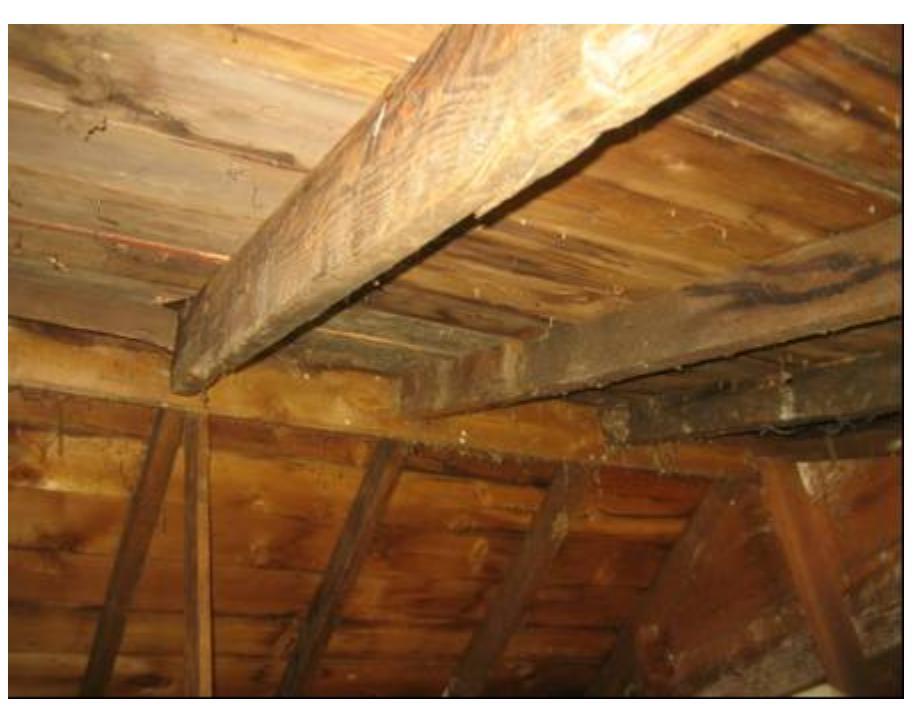
Pump House roof framing

Water damage to the roof and ceiling framing is evident on the northern half of the Pump House. Some of the framing members are merely water-stained while other members have deteriorated.

SHOENBERG FARM	
1911 Brick Pump House	The east and west gable end-walls above the brick are constructed of vertical 2x4s at 24".
EVALUATION:	The roof framing is in poor condition. The roof rafters are inadequately sized and spaced to support the current design snow load. The ceiling joists are inadequate to support any additional dead load besides the self-weight of the plaster and lath ceiling. Also, the ceiling joists are distressed due to the compression induced by the tops of the brick retaining walls pushing inward, hence the line of shoring.
RECOMMENDED TREATMENT:	The roof framing requires further investigation to survey the extent of the water-damaged members. Severely damaged members will require replacement. Moderately damaged members will need to be replaced or reinforced. Stained members can be retained.
	The overstressed members require reinforcing to bring the roof and ceiling framing assemblies into compliance with current Code-prescribed loads. The roof rafters can be either sistered or collar ties can be introduced to each rafter pair. The ceiling joists can be sistered to resist both gravity loads and to provide restraint for the tops of the retaining walls.

The wood member connections will need to be analyzed and will likely require strengthening. Anchorage of the sill plate to the brick wall requires bolstering to transfer lateral earth pressures from the brick wall to the ceiling diaphragm.

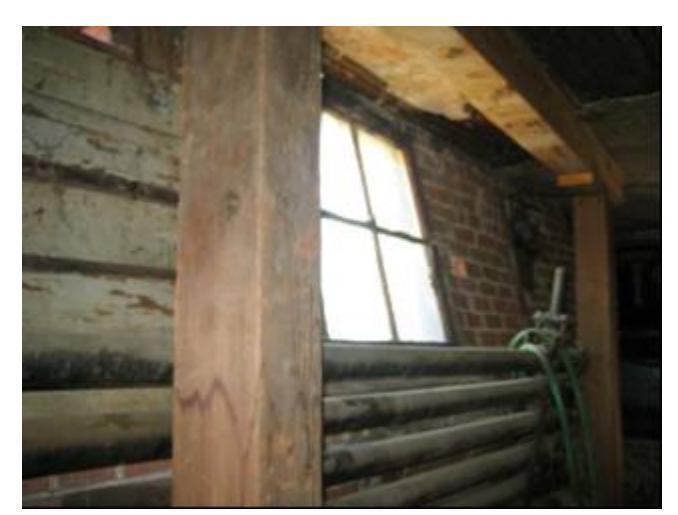
Ceiling joist shoring along north wall

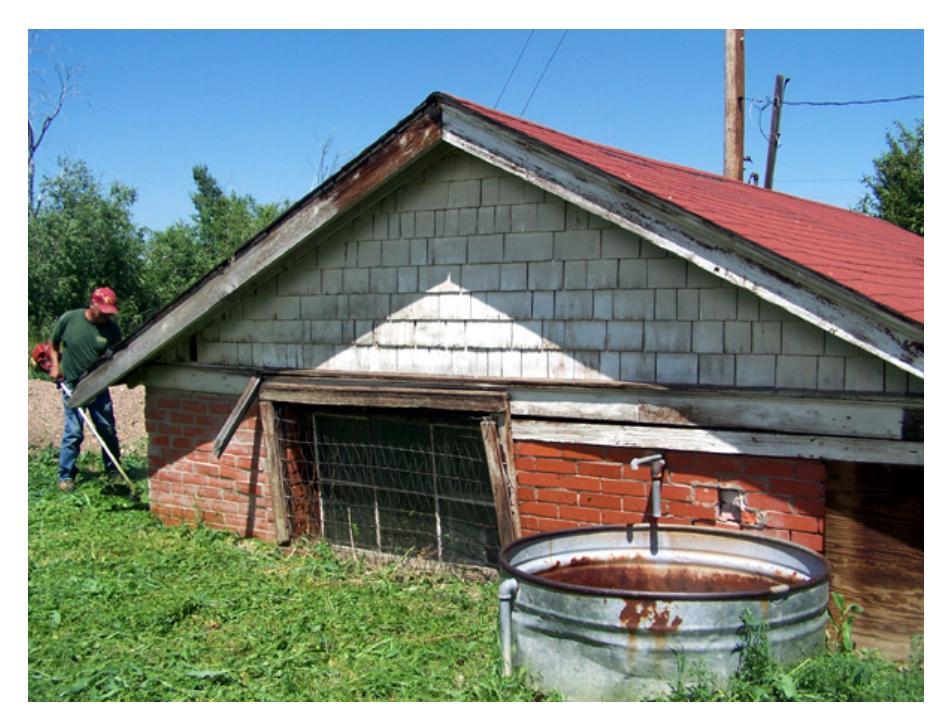
West elevation of subterranean Brick Pump House

SHOENBERG FARM **1911 Brick Pump House EVALUATION:** The Brick Pump House is in poor condition. The southern most wall is failing and deteriorating. Recent stabilization efforts have temporarily arrested further damage by stabilizing the wall with plywood sheathing on the exterior and wood studs on the interior (see 3.2 Foundations). Due to the shifting of the structure as a whole, the north elevation is showing signs of buckling. Several areas show critical stair-step cracks in the masonry walls, leaving large gaps and holes. Previous stabilization and repair attempts are evident in multiple locations, specifically on the north elevation. Past repairs include multiple locations of mortar patching and repairs with non-historic cementitious mortar throughout the structure. Brick elements have begun to dislodge on the north elevation, exposing the interior of the pump house to the elements. The masonry steps are in fair condition. Two of the steps appear to have been reconstructed with concrete risers. Some cracking is evident at the juncture of the brick and sandstone. **RECOMMENDED TREATMENT:** The north and south walls should be re-built and the structure stabilized (see 3.2 Foundations). The east and west wing walls should be assessed as the north and south walls are re-built. The wing walls have suffered from previous patching attempts and may need to be reconstructed if the existing brick cannot be salvaged due to the cementitious mortar used to patch the mortar ioints.

The cementitious mortar used previously may be difficult to remove in the rehabilitation process and therefore a higher percentage or replacement brick should be anticipated. It is assumed approximately 75% of the existing brick needs to be replaced. New replacement brick and mortar should match original, including compressive strength.

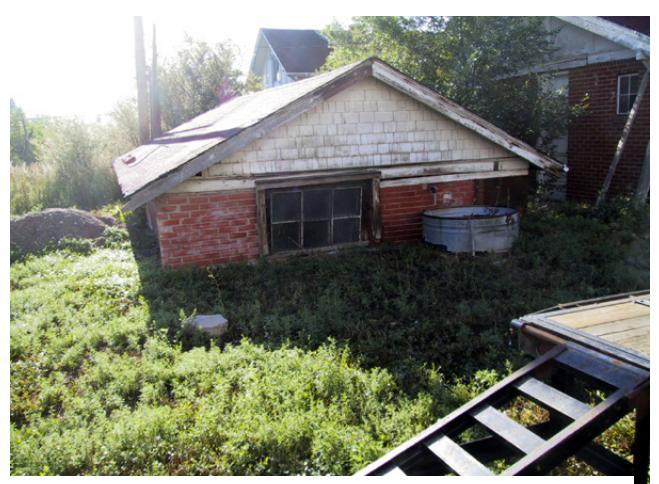
West elevation of Brick Pump House

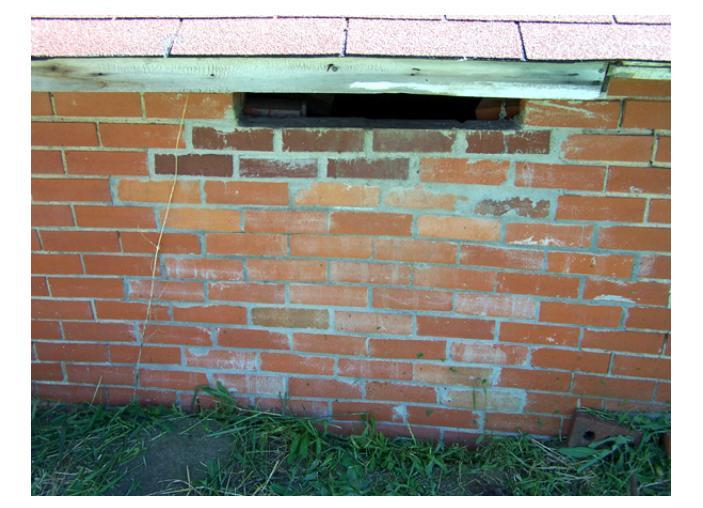
Brick repair at the north perimeter wall, using cementitious mortar

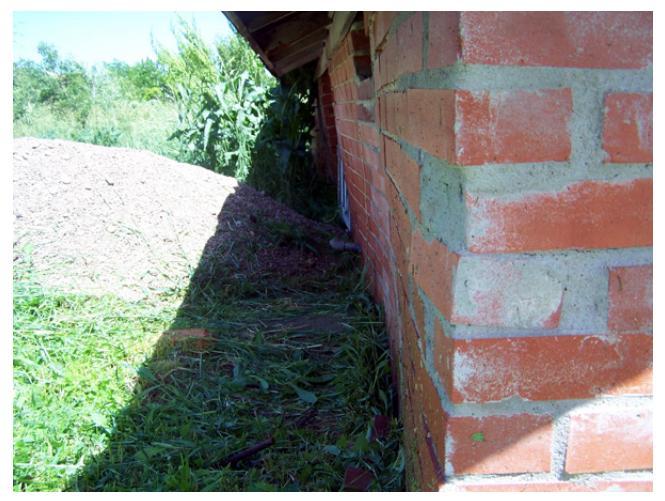
Distortion of the north wall from soil movement

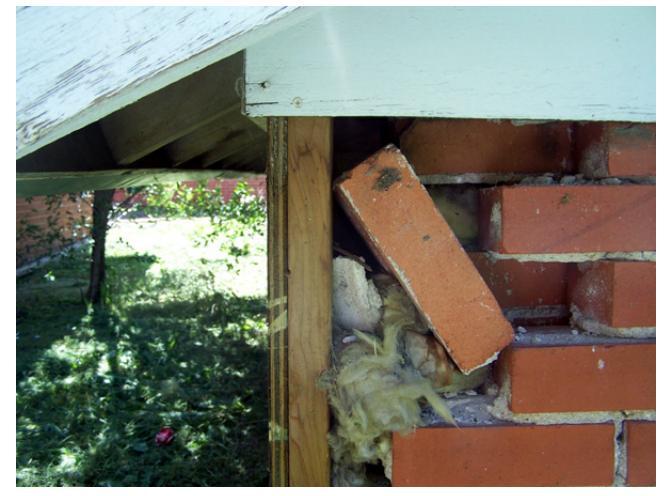
Southeast corner of south wall with wood bracing

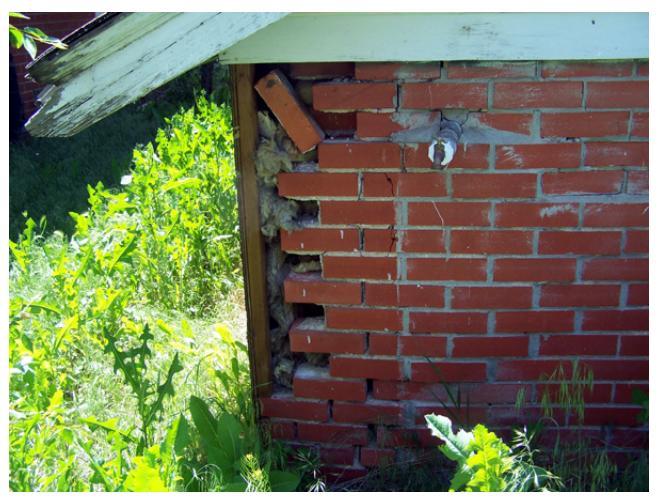
Missing south wall at the southwest corner of wall

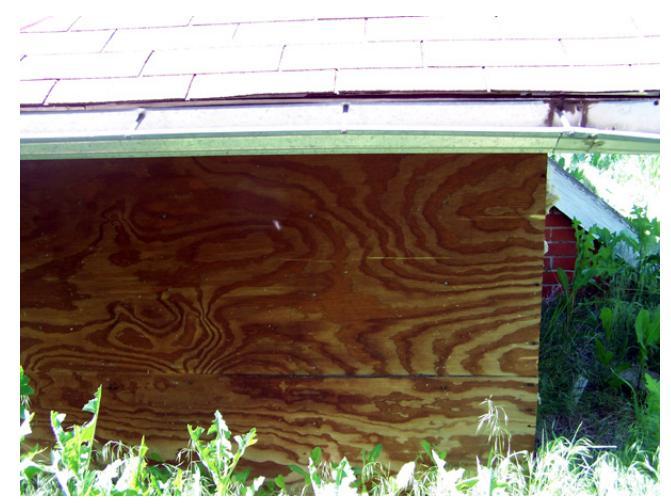
Temporarily stabilized south wall of Pump House

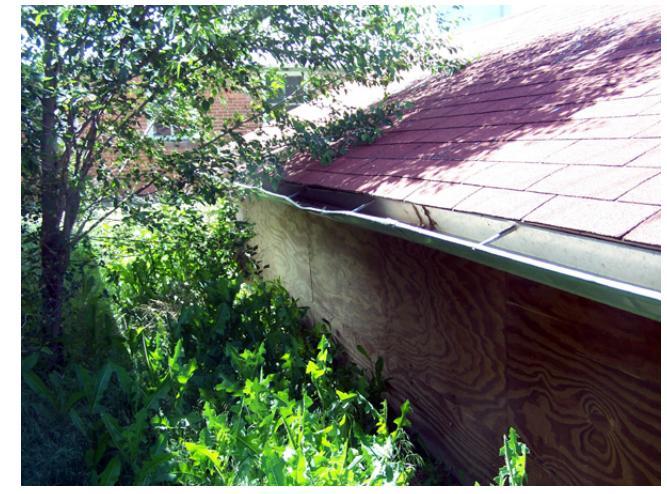
Bent gutter at south elevation of Pump House

Remove existing metal gutters and install new gutters and downspouts to match original.

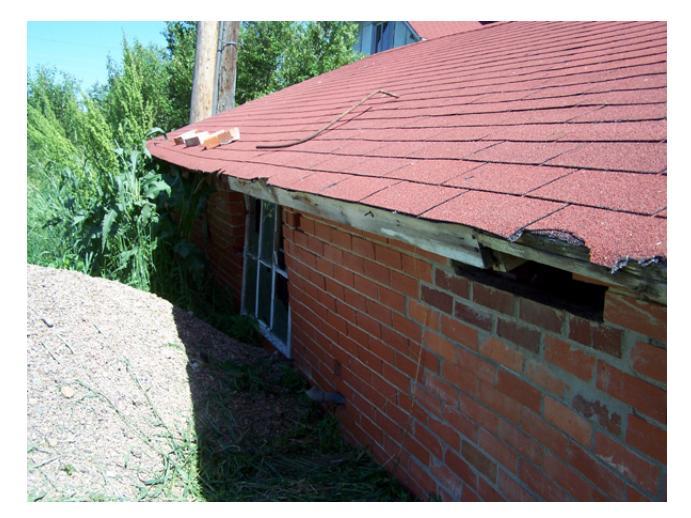
Damaged asphalt shingles, fascia and missing gutter at the north elevation

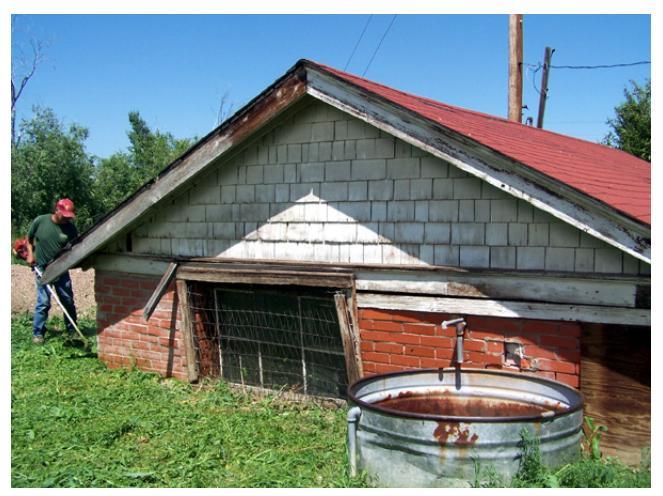
Broken and missing glass lites at north awning window

Replace broken glass at both windows, both interior and exterior panes. Sand and paint the wood sash and muntins. Remove the chain link fence and 2x boards on the west window. Reconstruct the wood frame and trim when the exterior walls are rebuilt.

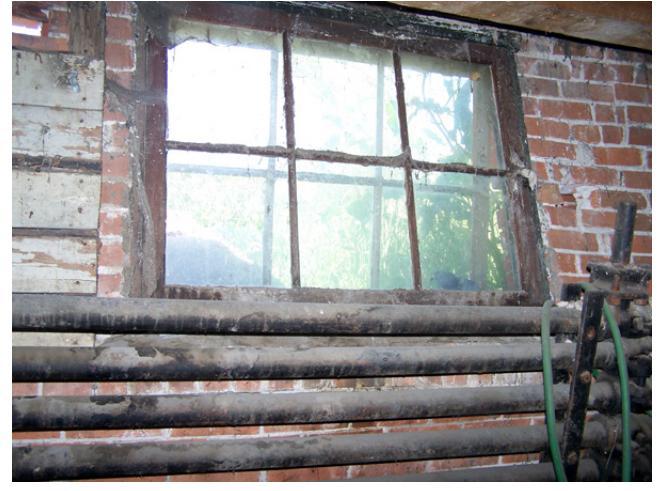
Broken glass in north window

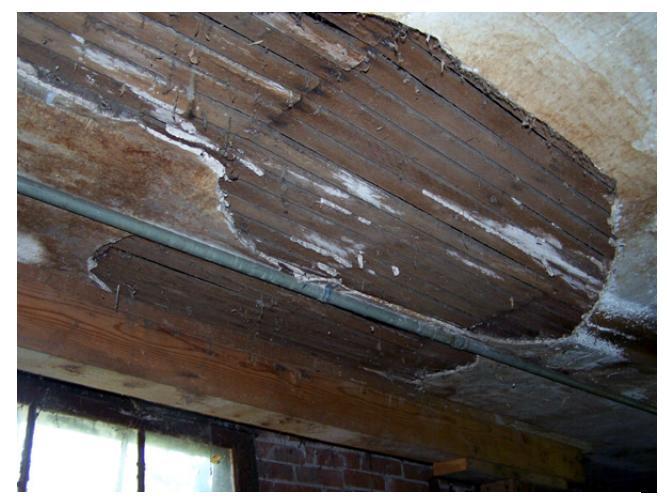
1911 Brick Pump House	
	The plaster ceiling is in poor condition with several areas missing plaster entirely. The concrete floor is in fair condition.
RECOMMENDED TREATMENT:	Once the future use of the Pump House is determined, the interior should be cleaned and restored for future ventures. As mentioned in previous sections, the exterior masonry walls need to be stabilized and reconstructed, thus stabilizing the interior space of the Pump House.
	The plaster ceiling treatment should be removed to better assess the existing rafter system and roof damage. This will allow further assessment of the undersized roofing members and to evaluate and stabilize the structural members. Once the structural members of the roof are evaluated and stabilized, the interior ceiling should be replaced with gypsum board, finished to match the historic plaster ceiling.

Damage at Pump House ceiling

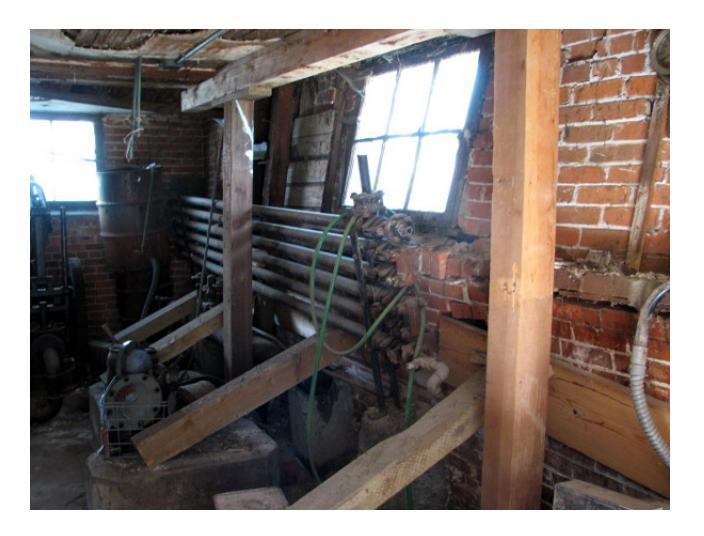
Crumbling bricks and mortar residue on floor of Pump House

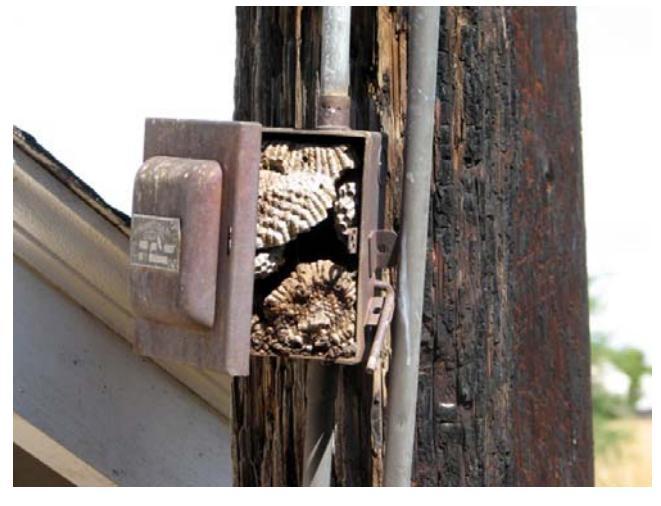
Electrical panel with hornets' nest

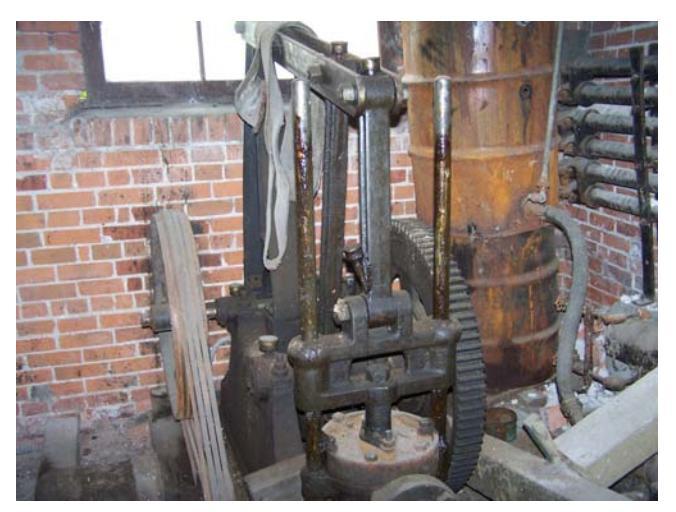
Motorized pump

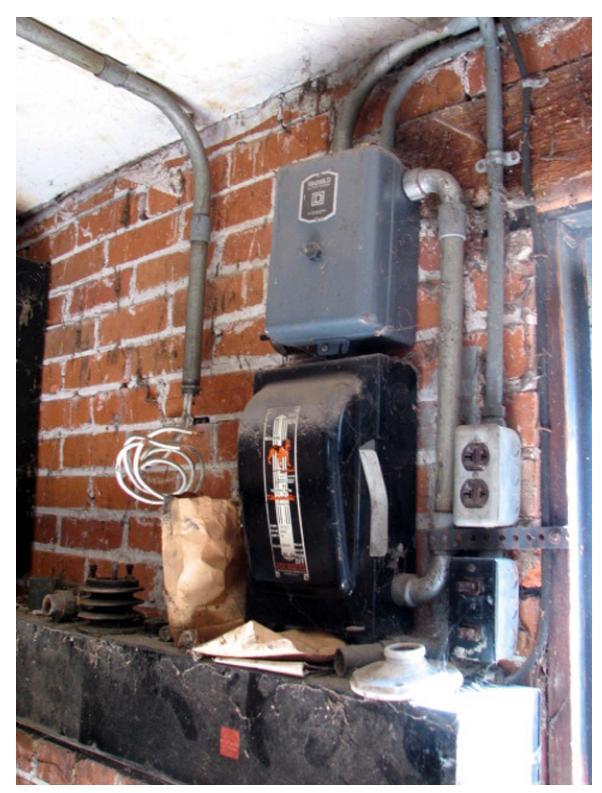
Equipment panel switches

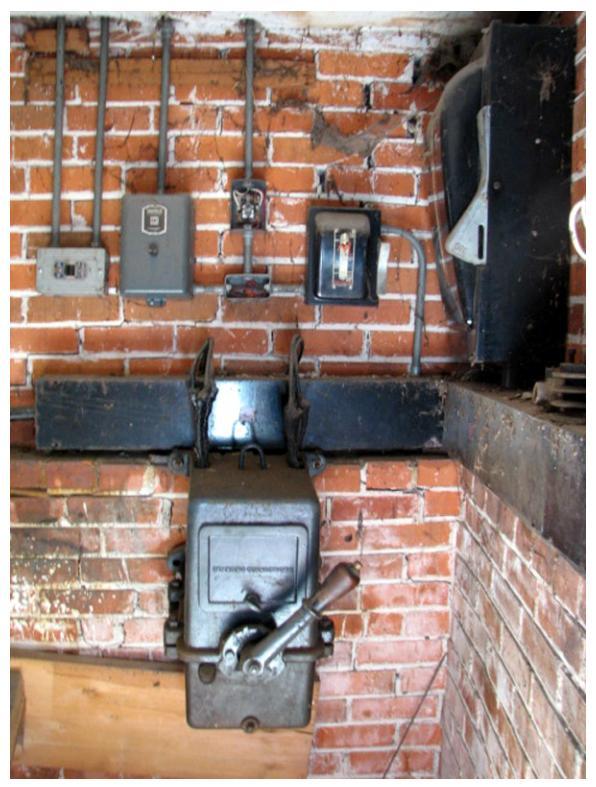
Equipment panel switches

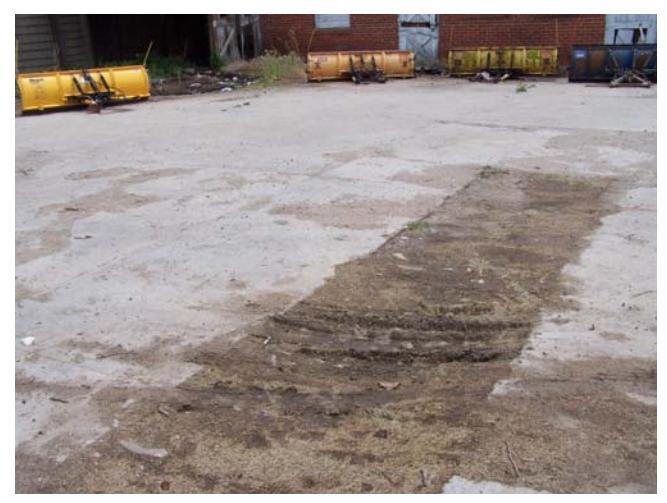
Concrete driveway looking east towards Wood Stave Silo location

Replace the concrete driveway. Evaluation of the leaching ground water needs to be addressed. If the silo is to be adaptively re-used by a future tenant, the foundation of the demolished silo needs to be secured or removed so as not to infringe on access to the site.

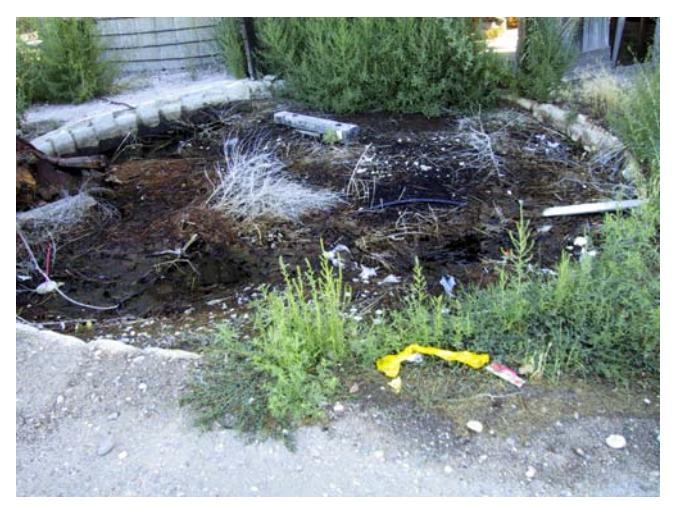
foundations of the demolished hay feeder's silos currently pose a hazard as metal elements; loose rocks and concrete are visible.

Foundation remains southwest of 1911 Wood Stave Silo filled with standing water and debris.

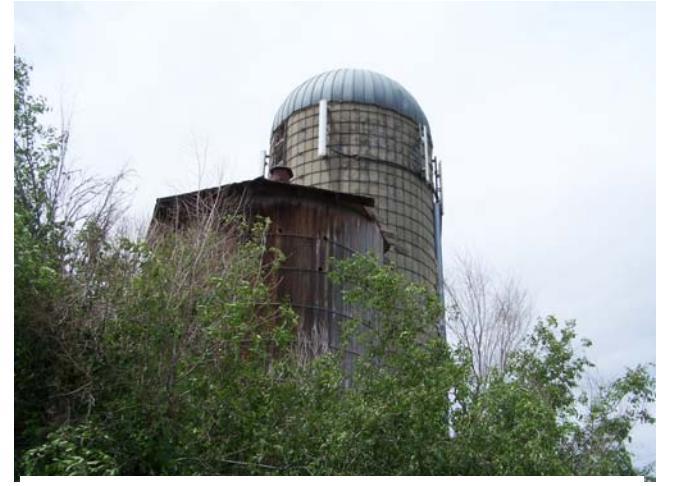
North elevation of wood silo with overgrown trees. Concrete silo is directly adjacent.

Trim the overgrown grasses and shrubbery surrounding the silo. Remove the volunteer groves of trees at the north corner so as to provide clear access and to diminish further damage to the foundations.

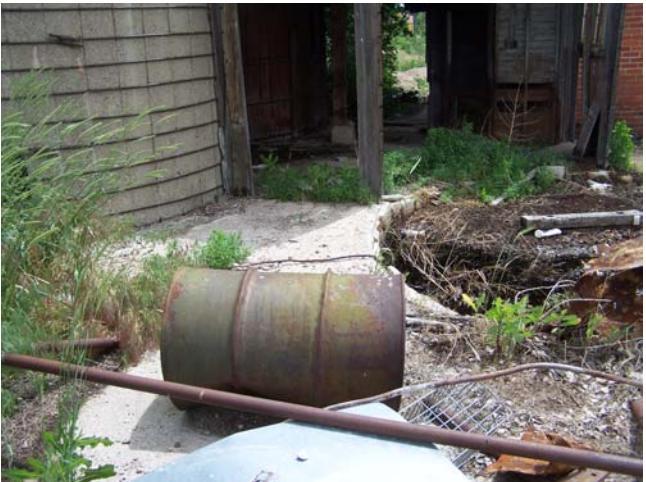
Trash and debris blocking entrance to Wood Stave Silo. Note foundation remains filled with standing water and debris at right.

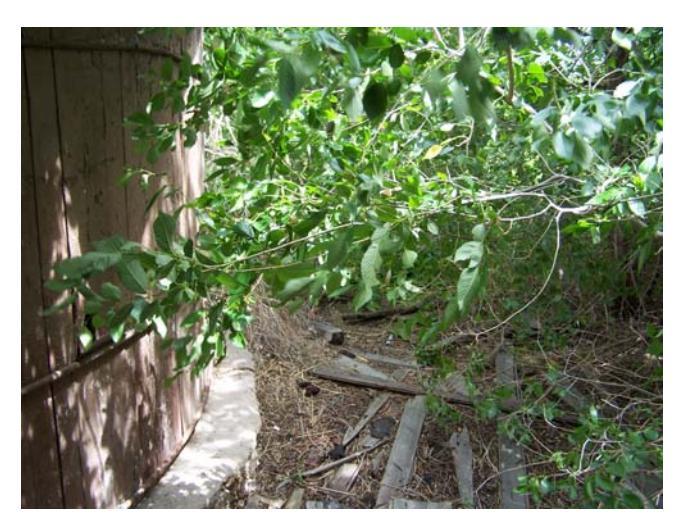
Overgrown trees at north corner of wood silo foundation

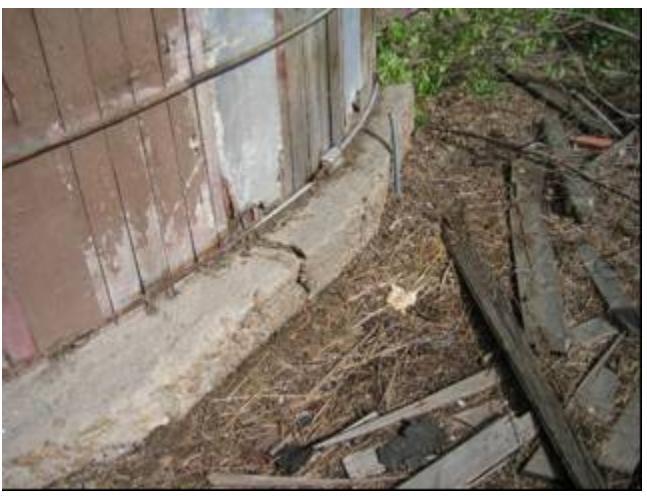
Crack in foundation along east side

to remain unoccupied no repairs are anticipated other than repairing the cracks and the surfaces.

A perimeter drain should be installed to limit water infiltration around the foundation. This will help prevent future foundation movement.

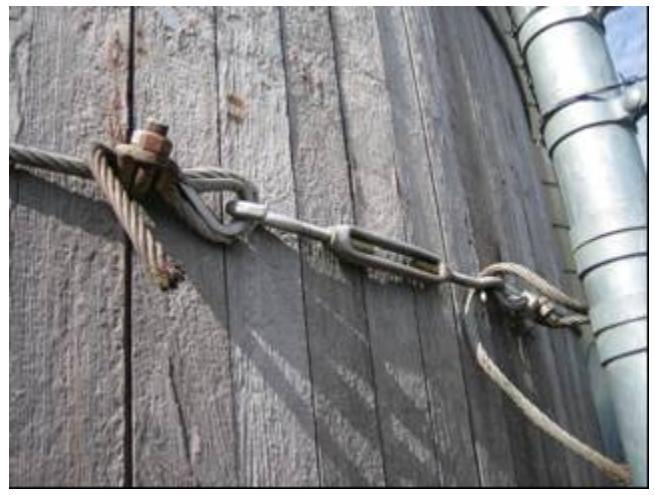
Horizontal cable tie and coupler

The hoop ties should be straightened where sagging and tightened where not in direct contact with the exterior sheathing. One additional tie should be introduced to the top of the wall to counteract the thrust induced by the roof rafters to the top plate. It is assumed that the structure originally had a cable tie in this location.

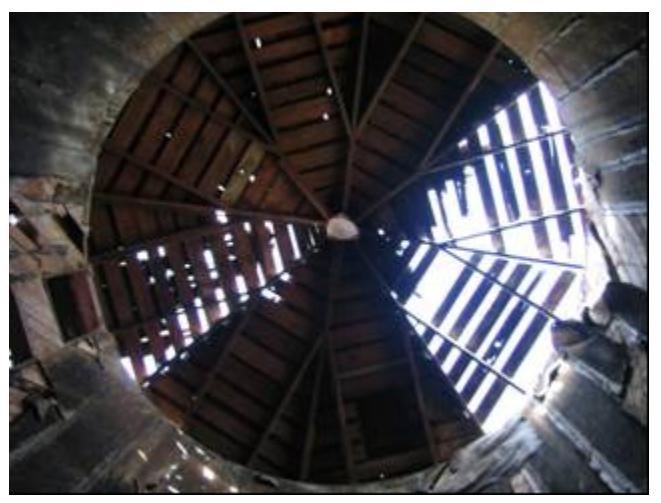
The hoop ties are in good condition, but some of the ties are not snug to the exterior sheathing.
	The general condition of the roof structure is poor. In some locations the roof rafters have thrust outward as much as 2 to 3 inches. Also, many of the roof framing elements are either severely deteriorated or missing.
RECOMMENDED TREATMENT:	After the silage is removed, the wall assemblies should be thoroughly inspected for deterioration as only a limited area was observable for preparation of this report. Sheathing or studs that are deteriorated should be removed and replaced. In-place strengthening may also be possible depending on the extent of deterioration. The hoop ties can be temporarily loosened or removed selectively (a few at a time) so that the exterior wood sheathing can be repaired or replaced.
	The Silo's anchorage should be uncovered so that the existing system can be observed and analyzed. Supplemental anchorage of the stud walls to the foundation may be required to resist the overturning induced by Code-prescribed lateral loads.

Silo roof framing from below

It would be advisable to either remove the roof structure and replace it with new material of a similar kind replicating the original system or to sister the existing inplace framing and replace the missing elements.

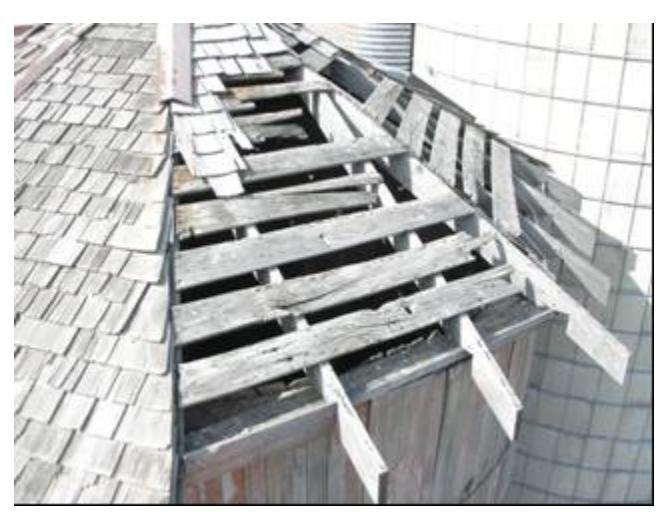
The roof is a segmented octagonal roof form with hip members that intersect near the ridge at a rusted metal ventilation cap. Wood shingles are visible on several facets of the roof. The shingles are missing from the north facing facet, so the 1x6 horizontal sheathing is visible. The horizontal sheathing has approximately 2.5" gaps between the boards. Those boards are supported on 2x6 rafters. The rafters have a birds-mouth cut where they bear on the 2x6 horizontal wood plate. That plate in turn is supported by the circular wood walls of the silo.
EVALUATION:	Overall, the wood stud wall assembly is in fair condition. Where observed, the studs appeared competent. The interior and exterior sheathing has undergone some deterioration due to age, exposure to weather and silage, and woodpeckers. Tar paper attached to the interior sheathing appears to have slowed the deterioration process. But, the condition of the wall studs and interior sheathing may be in poor condition below the silage elevation. Many of the interior sheathing boards are missing.

North-facing facet of Silo roof framing

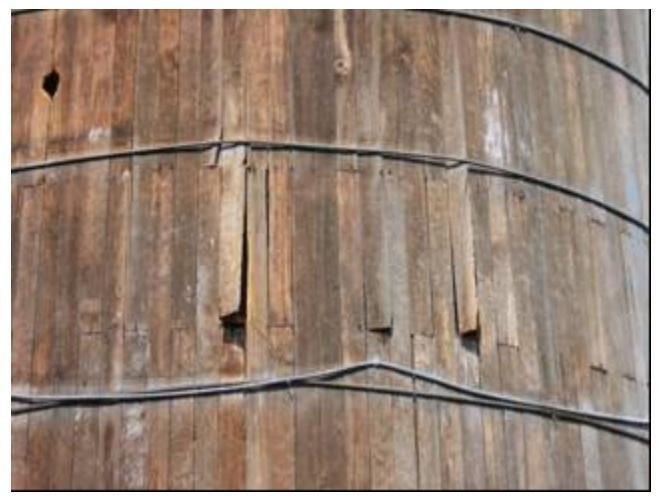
Wood Silo cable ties

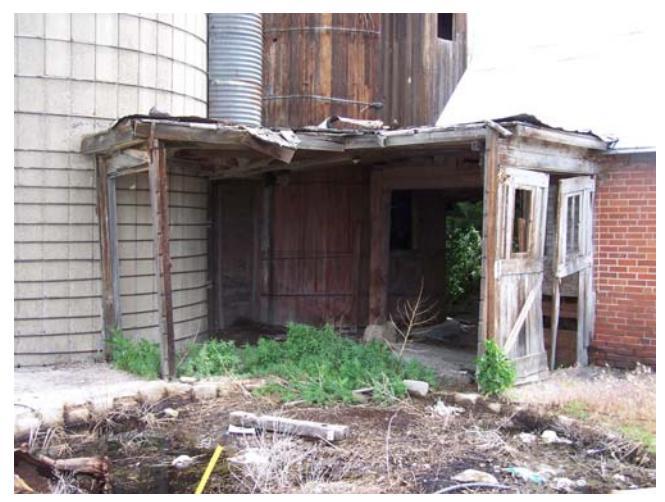
The shed attachment is in poor condition. A door and possible window in 'skeleton form' are all that remain intact on the south side of the shed. The flat sheet metal roof above the wood entrance structure is in poor condition with areas that are bent and dented.

Wood structure at the entrance between the Wood and Concrete Silos

The wood framed shed is a safety hazard in its current deteriorated state. It is recommended the shed be documented, dismantled and any material salvaged for future reconstruction purposes, based on historic photographs and documentation.

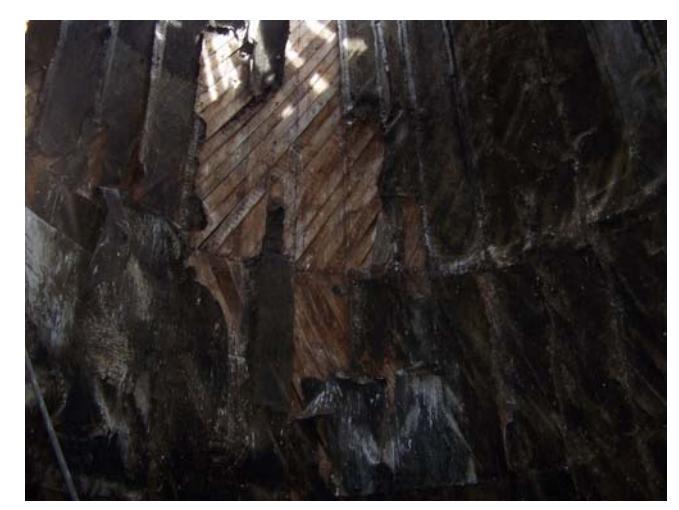
EVALUATION:	The Wood Stave Silo is in poor condition. The exterior wood tongue-and-groove boards are in fair condition, but the interior skin of the silo is in various states of deterioration. At the interior, the building paper that once covered the wood cross-bracing has deteriorated.

Interior view of Wood Silo showing cross-bracing and deteriorated building paper.

The interior sheathing should be removed and replaced with an in-kind material to match the original diagonal cross-bracing. The interior building paper should be removed so the new cross sheathing is visible.

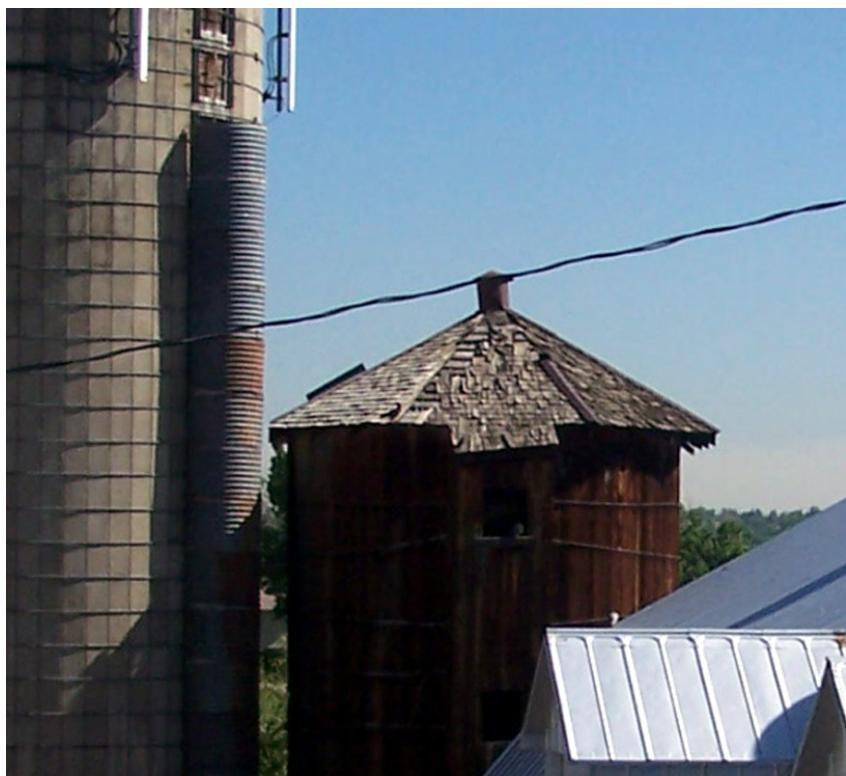
Segmented wood shingle roof of the Wood Stave Silo

CATEGORY:	3.5 Envelope – Roofing & Waterproofing
DESCRIPTION:	The roof shape is segmented with eight pie-shaped segments, covered with wood shingles. Eight primary framing members make up the roof structure with spaced sheathing. A round ventilator is located at the peak of the roof.
EVALUATION:	The roof is in poor condition. Wood shingles are missing and the spaced sheathing has deteriorated.
RECOMMENDED TREATMENT:	Once the roof structure has been repaired of replaced, install new, spaced 1x sheathing members to match the original. Install No. 1 cedar shingles over the new sheathing and replace the ventilator with a new galvanized vent of the same design (coordinate venting requirements with the current building code).

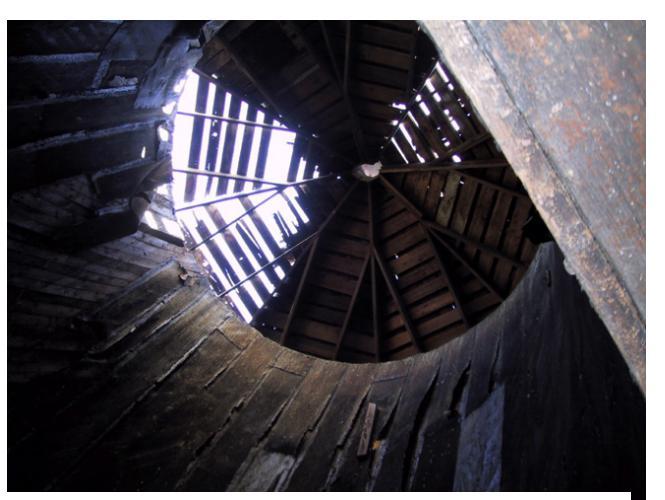
Underside of wood roof

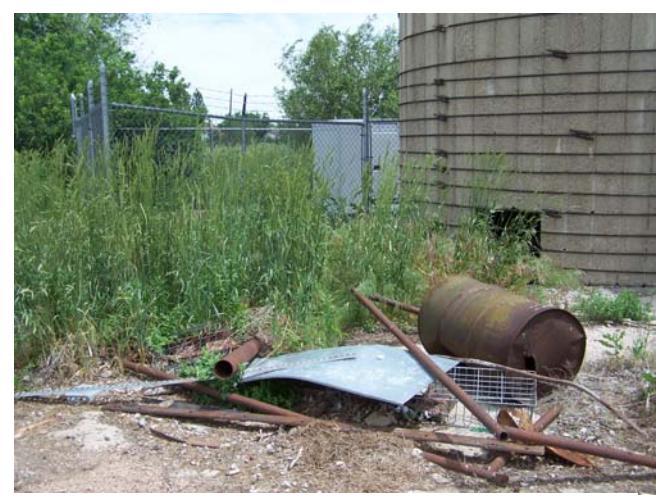
1950s Concrete Silo west elevation. Trash and debris blocking entrance path.

RECOMMENDED TREATMENT: Trim the overgrown grasses and shrubbery to the north of the silo. Replace the concrete driveway and slope it away from the structures to allow for proper water drainage. If the Concrete Silo is to be adaptively re-used by a future tenant, the two foundations of the demolished hay feeders need to be enclosed or removed so as not to infringe on access to the site.

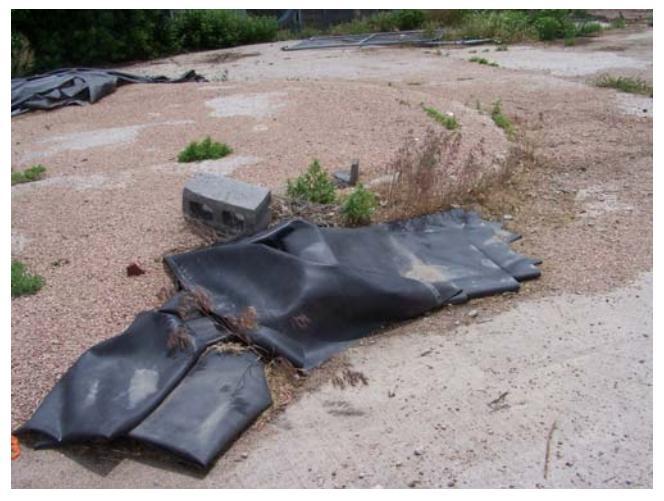
The exposed foundations of the demolished hay feeder's silos currently pose a hazard as metal elements; loose rocks and concrete still protrude.

Foundation remains of hay feeders west of Concrete silo

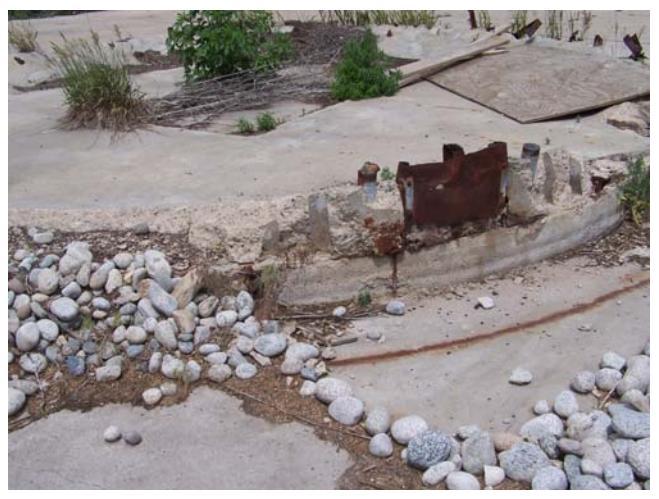
Foundation remains of hay feeders west of existing silo

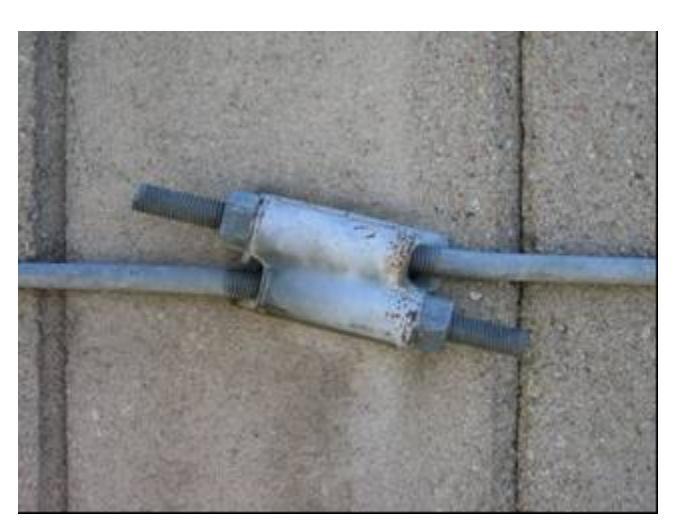
Hoop rod coupler

Since it was not possible to inspect every hoop tie in this limited investigation, all hoop ties should be inspected for damage and tight contact with the concrete panels should be confirmed.

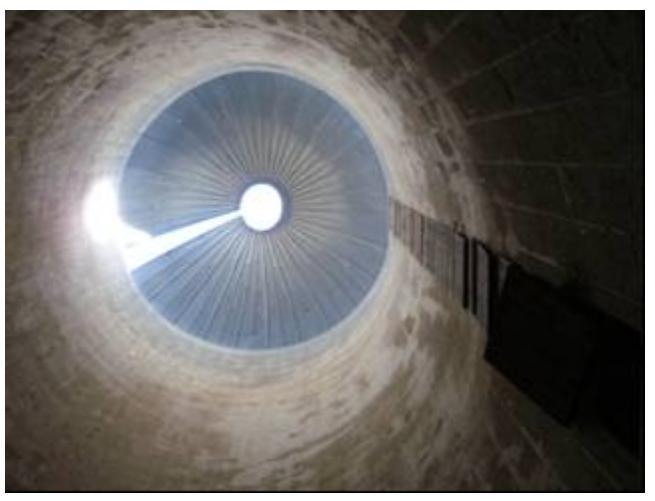
The general condition of the roof structure is good. No signs of distress or deterioration are visible to the sheet metal or to the roof's connection with the wall and hoop assembly.

Roof structure from below

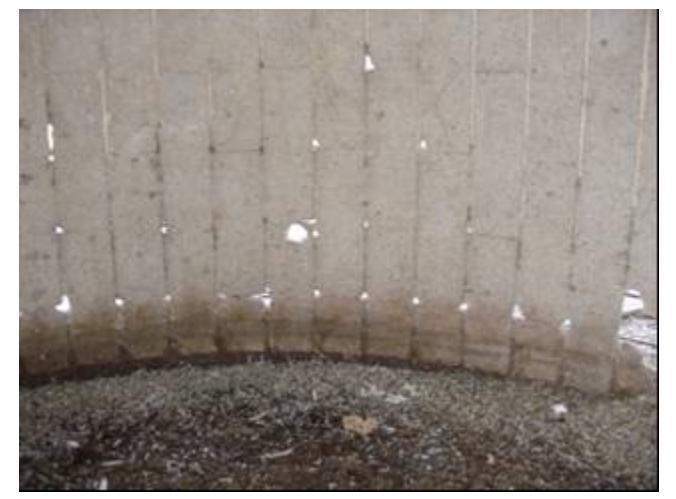
Base of Silo from interior

Concrete Silo	
RECOMMENDED TREATMENT:	In its current condition, because of the bottom wall portion's severe concrete loss, the Silo could collapse in a severe seismic or wind event. Therefore, repairing the concrete walls is essential.
	It is doubtful that replacement panels are procurable. Because of the panel's complex geometry at their edges it is also doubtful that the panels can be custom-made economically. The simplest and most economical way to restore the wall's integrity may be to add a layer of concrete to the interior of the damaged walls. This can be achieved by spraying a 3" to 4" thick coat of 'shotcrete' on the wall reinforced with a mat of welded wire mesh reinforcing placed at mid-depth. Limiting the reinforcing to the interior will leave the exterior look largely unchanged. These repairs should be performed in conjunction with the probable foundation repairs (pending further investigation and analysis) so that the Silo walls can be properly anchored to the foundation.

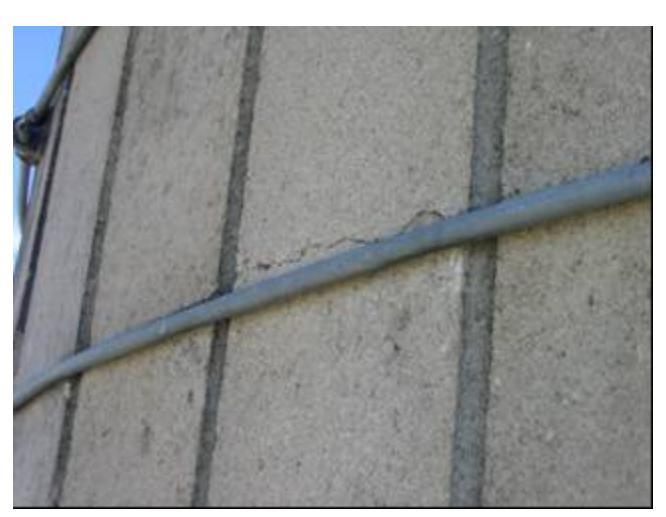
The middle 50 percent of the pre-cast panels is in good condition. Cracking of the panels is minimal and little deterioration is visible. This portion of the silo has apparently remained relatively dry over the life of the structure.
	The upper 25 percent of the pre-cast panels is in poor condition. Spider web cracking and discoloration of the panels is pronounced. Some of the panels have bowed outward midway between the hoops. It is assumed that the cracking is the result of surface moisture, from roof runoff, undergoing freeze-thaw cycles over the course of the winter months.
	As there are no vertical tension elements the Silo has little resistance to overturning or bending forces from wind loading.
	The hoop ties are in good condition. Where checked the ties were in contact with the concrete panels and the coupler nuts were tight. Intermittent rusting of the rods and couplers is evident and the amount of rusting increases towards the bottom of the structure. The rusting can be characterized as superficial discoloration; no deterioration of the metal is visible.

Middle portion of Silo along west elevation

Where observed, the panels at mid-height were in good condition, but each panel should be inspected for cracks or deterioration. Cracks should be patched with a compatible concrete/epoxy filler to prevent further moisture intrusion.
	The panels at the upper portion also require repair. At a minimum, cracks should be patched with a compatible concrete/epoxy filler to prevent further water infiltration and deterioration. Also, a gutter or similar system should

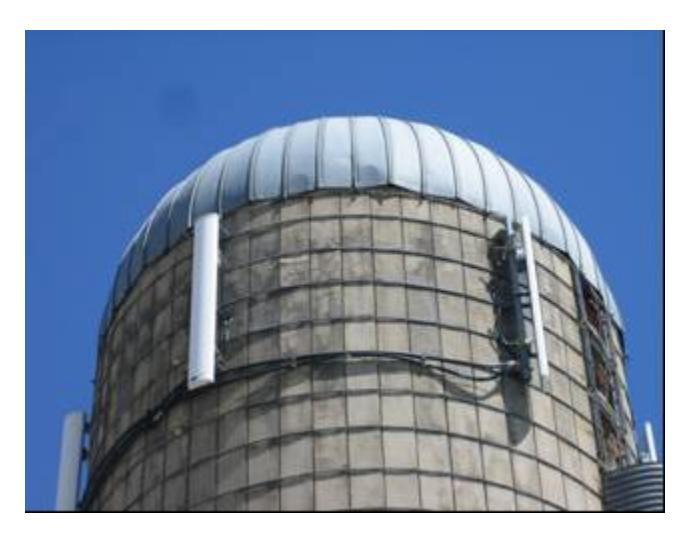
Upper portion of Silo along southwest elevation

concrete/epoxy filler to prevent further water infiltration and deterioration. Also, a gutter or similar system should be installed around the roof edge to stop the cyclical wetting, freezing, and thawing of the pre-cast panels.

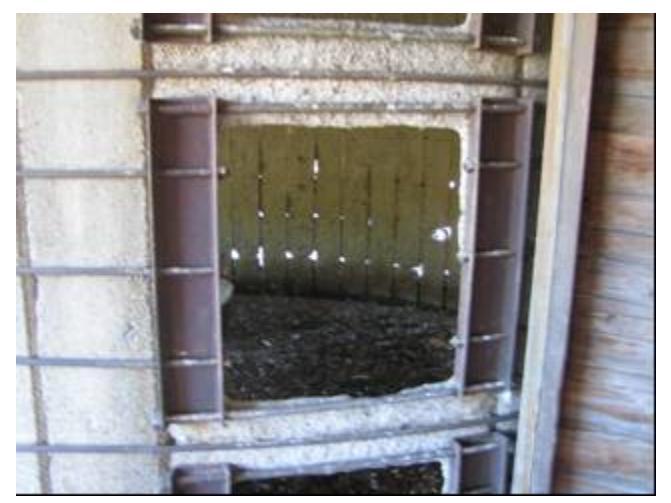
Unique panels along south elevation

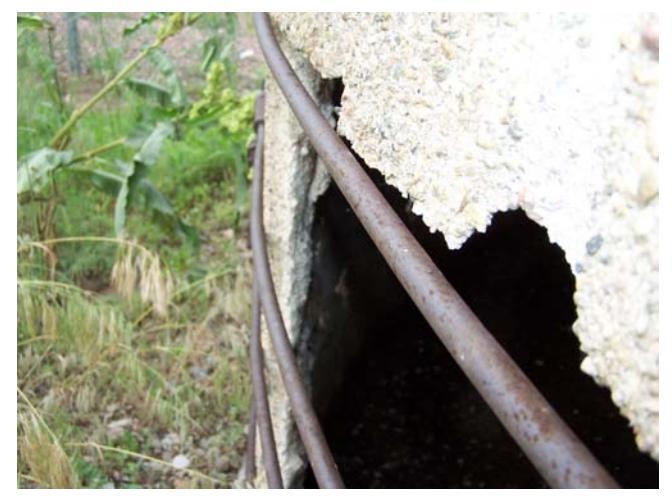
Close-up view of thinning concrete sections at western side of Concrete Silo
