Shoenberg Farm

Historic Structures Assessment Project #2007-M2-011 March 14, 2008

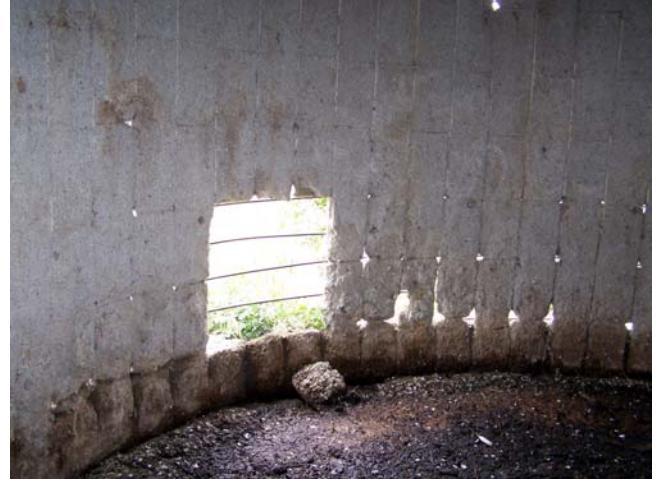
Interior view of damaged concrete panels at west side of Concrete Silo

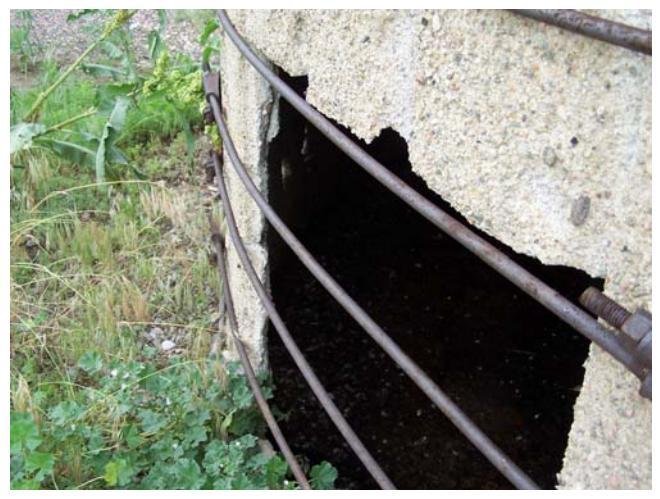
Area of removed concrete at west side of silo

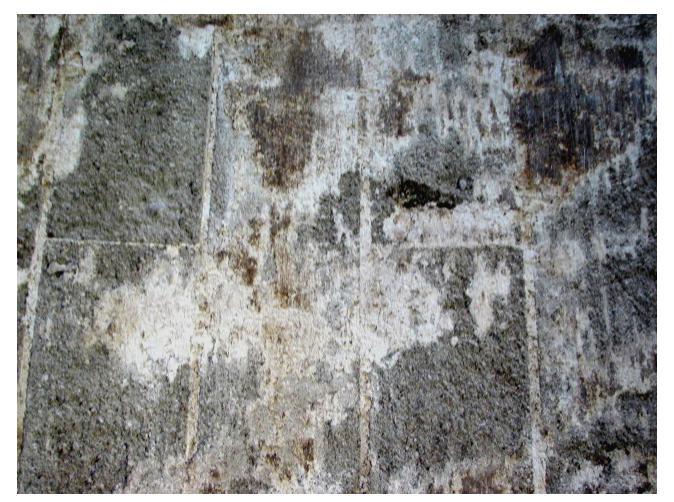
Damage to interior of Concrete Silo

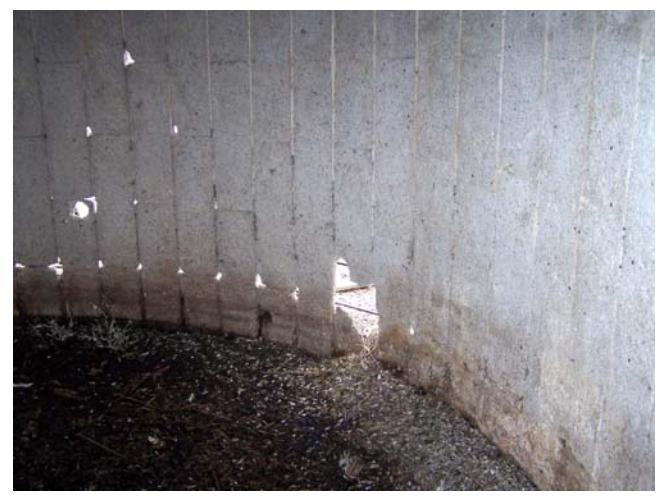
Interior view of damaged concrete panels at northeast corner

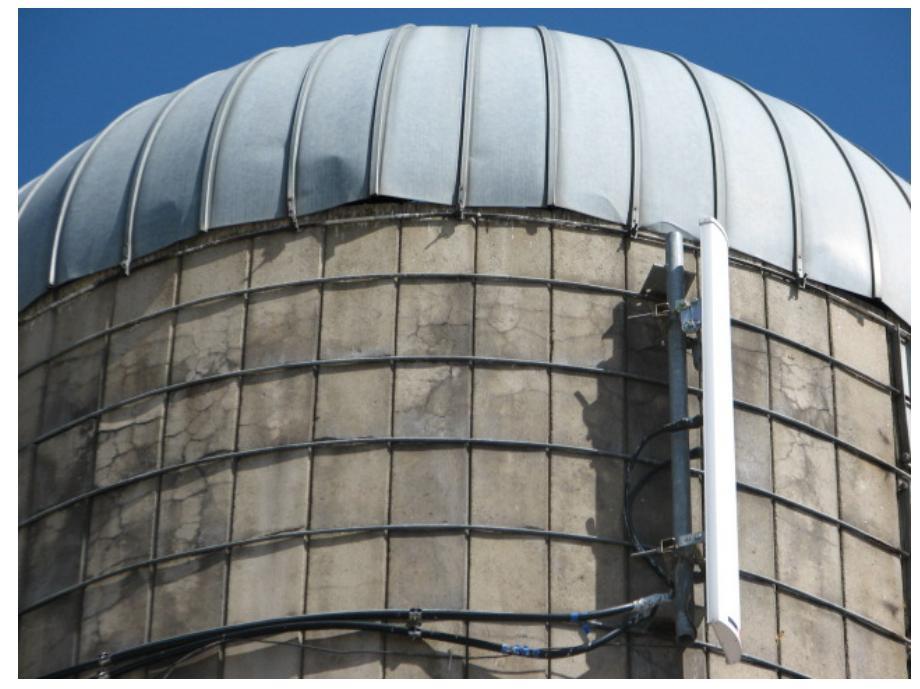
View of rounded metal roof. Cell phone equipment is visible on the right.

CATEGORY:	3.5 Roofing & Waterproofing
DESCRIPTION:	The roof of the silo is a dome-shaped metal roof constructed of heavy-gauge galvanized sheet metal. It is comprised of 50 individual panels joined together with a flat interlocking seam. There is a center hole, approximately five feet in diameter at the top of the metal roof. The metal panels are self supporting from the base to the peak. Individual panels taper from approximately one inch at the peak to approximately 18" at the base of dome. The base of the metal panels is attached to the top tension ring at every other panel joint.
	The owner currently has a lease with a cell phone company. There is equipment installed on the ground level and attached to the silo just below the roofline.
EVALUATION:	The metal roof appears to be in good condition. Minor dents are visible from the ground at the base of the metal panels. A pie shaped section is missing at the northern corner of the roof.

RECOMMENDED TREATMENT:	Install missing metal pie shaped section in roof to match original. Install a translucent plexi-glass

skylight at the center circle of the roof to allow light infiltration and deter moisture inside the silo.

Although the cell phone lease provides an estimated \$1,500 a month in income to the owner, the ground level equipment and all equipment installed on the silo should be removed in order to restore the historical integrity of the Concrete Silo.

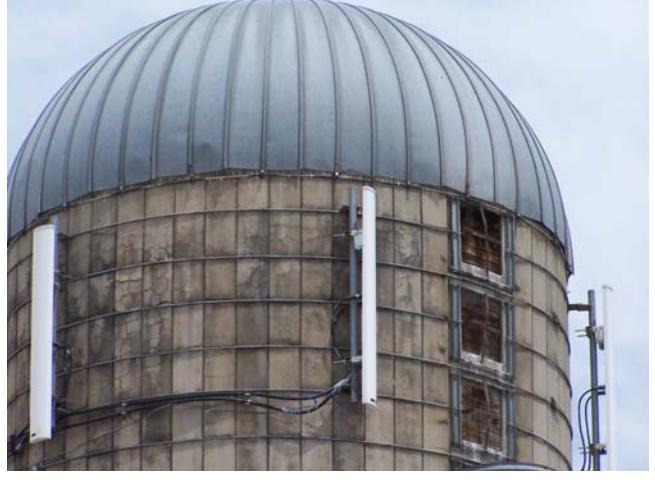
Visible dents at roof base.

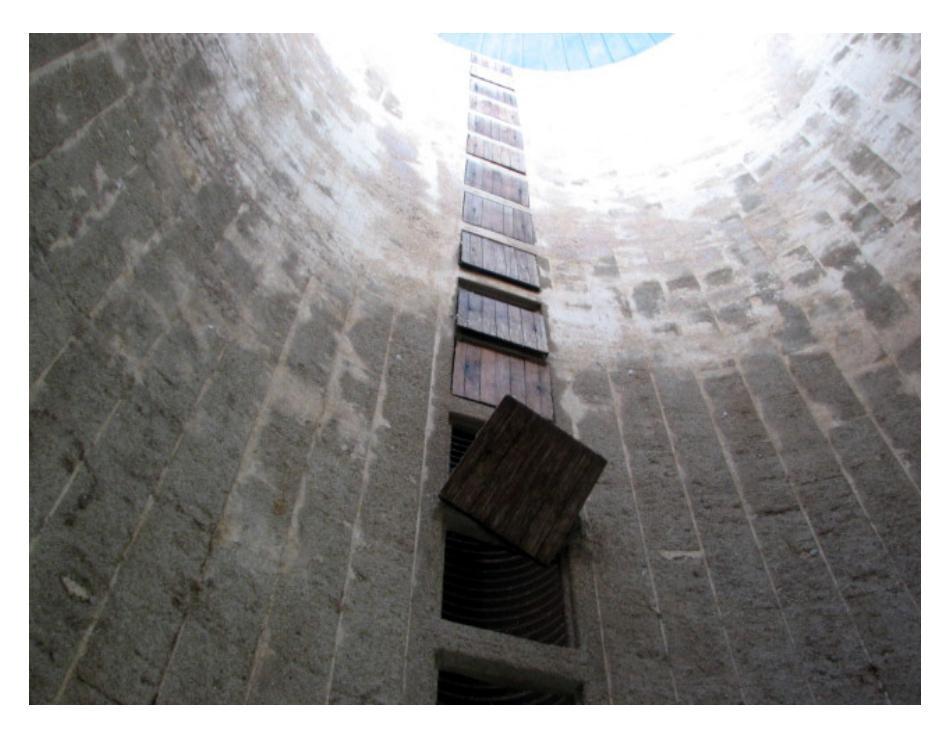
1950s Concrete Silo. Interior view of access openings at southwest side

CATEGORY:	3.6b Windows (Openings)
DESCRIPTION:	Access to the concrete silo from the ground level is through a series of openings located at the southwest corner of the structure. The openings are protected by a corrugated metal chute on the exterior and by removable plank panels on the interior.
EVALUATION:	The access openings are intact and in fair condition. Two wood panels are missing at the lower level.
RECOMMENDED TREATMENT:	Replace missing wood panels at opening locations to match original.

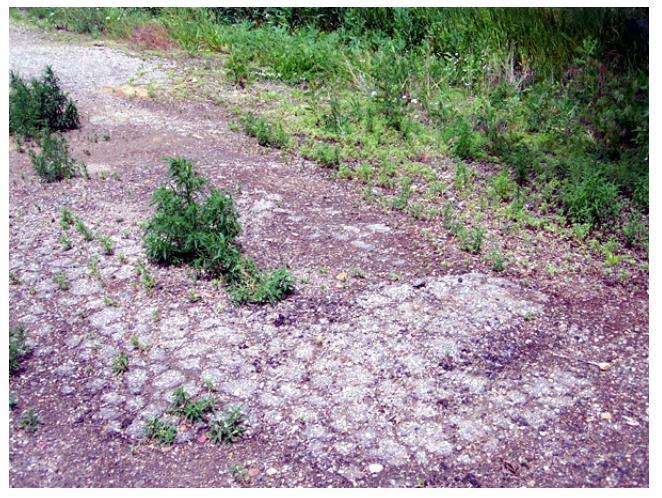
Deteriorated section of sidewalk on the south side of Quonset

Replace the concrete sidewalks and driveway as necessary for future tenant use. Slope the sidewalks away from the structures to allow for proper water drainage.

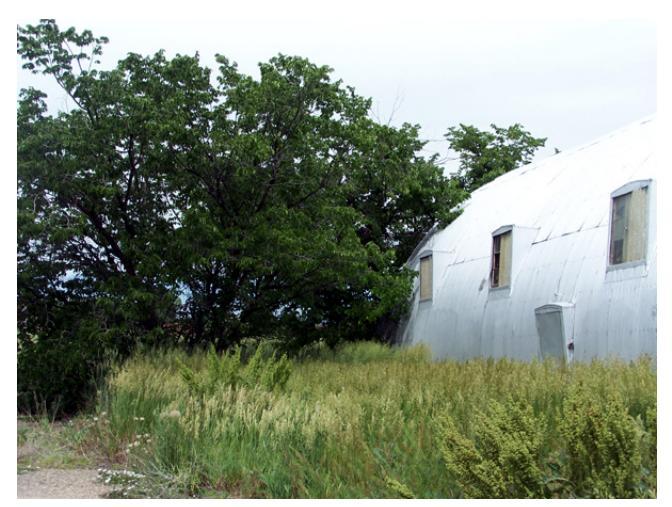
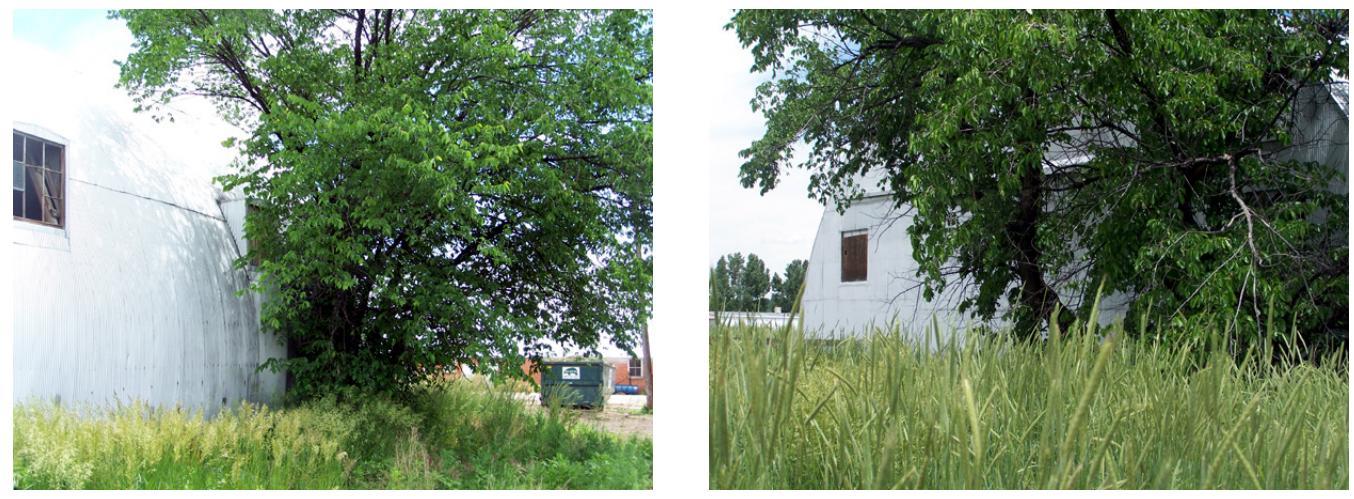
Grove of trees at southwest corner of Quonset

RECOMMENDED TREATMENT: Trim the overgrown grasses and shrubbery surrounding the Quonset. Trim the dead branches on the trees at the southwest corner.

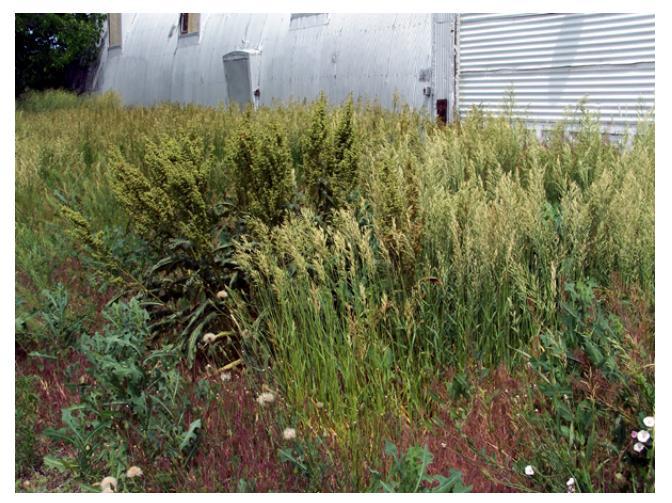
Overgrown grasses surrounding Quonset

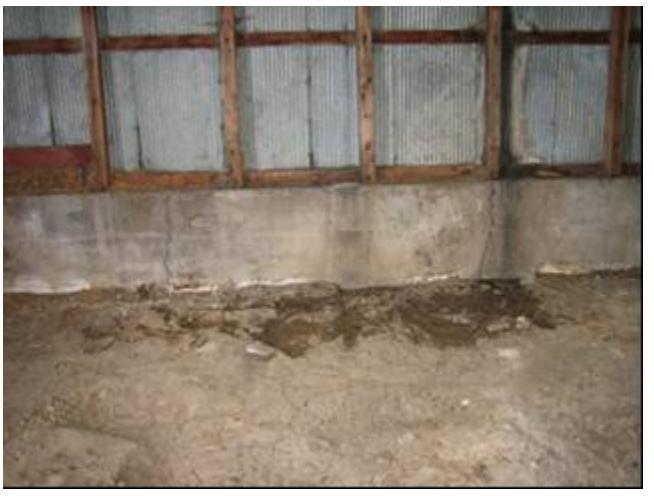
1. There are numerous small cracks in the foundation walls around the perimeter. These do not appear to have compromised the structural integrity of the foundation.

Typical minor cracks in foundation wall

- 3. Representative areas of the footings should be excavated and evaluated. Some foundation underpinning should be anticipated.
- 4. Seal the cracks between the drain pan and stem wall with a suitable flexible caulk to prevent water infiltration and further deterioration.

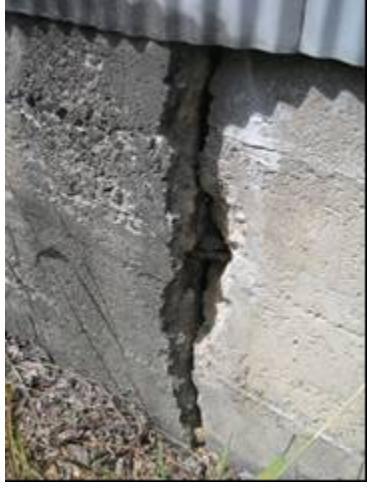
Quonset Structure 2. There are two large cracks in the south wall near the east end. The sections of stem wall on either side of one crack have displaced approximately 2" from each other. One of the cracks appears to be a result of root invasion by a previously removed tree. 3. Footings were not visible for evaluation. 4. The concrete drain pan is cracked and displaced from the stem wall providing a path for water entry. **RECOMMENDED TREATMENT:** The following treatments correspond to the evaluation items listed above: 1. Seal the smaller cracks in the foundation walls with a suitable flexible caulk to prevent water infiltration and further deterioration. 2. Tie the stem wall together across the crack in the south wall using a new steel tie plate to prevent further differential movement.

Crack in southeast foundation wall

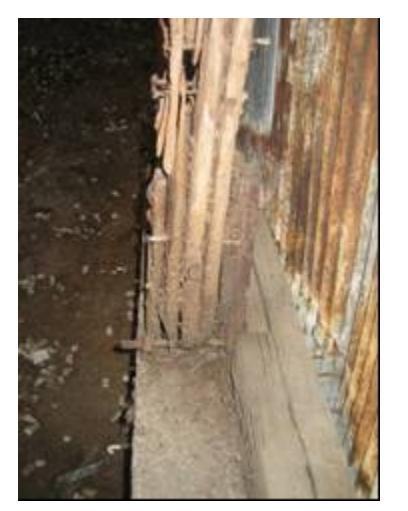
About 5% of the arches are also deteriorated at their bases. In some cases, there is little sound material left. Considering that the arches transfer their entire load to

the foundation through the base connection, this leaves these arches with little usable capacity.

Severely deteriorated arch

The new arches and purlins would be visible, but they would also leave the unique structural system intact and in full view. There would also be no loss of historic fabric with this approach.
	New concrete pilasters and footings would be required to support the ends of the new steel arches.
	The header over the garage door will require strengthening. The addition of a horizontal steel tube adjacent to the header and spanning to the new steel arches will likely be the best solution.
	The interior and end walls should be strengthened. End wall studs should be sistered with new 2x8 material. Headers over the doors will require sistering. The interior of the walls should be sheathed with plywood to resist lateral forces. Additional anchors will be required to tie the wall to the foundation.
	Deteriorated wood arches will require partial replacement where the damage is significant. It is anticipated that deteriorated plies can be unbolted and replaced.

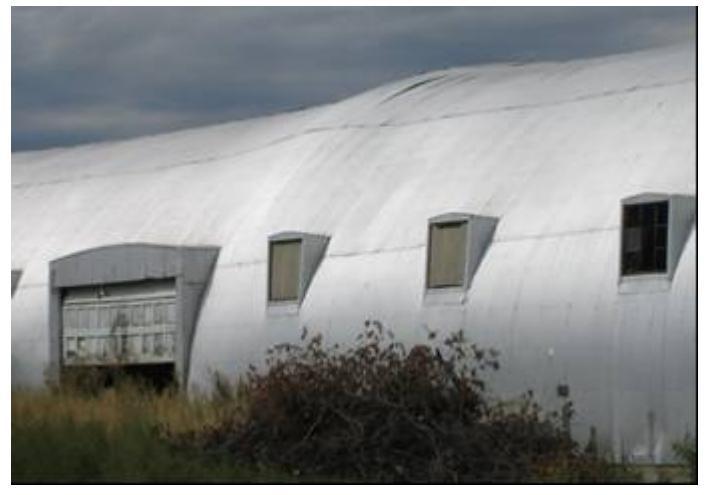
The garage door opening on the south side of the building has interrupted several of the arches. A header was installed above the opening to carry the arches but it is inadequate to meet Code prescribed loading. The header carries the load from these arches into the two un-reinforced arches on either side of the opening. These arches are severely overloaded. Not surprisingly, this area of the roof has experienced the greatest deformation. The interior partition wall just to the east of the opening is now holding up most of the roof in this area.

South elevation: note deformation at east side of door around interior partition wall

Historic Structures Assessment Andrews & Anderson Architects, PC
SHOENBERG FARM	
Quonset Structure RECOMMENDED TREATMENT:	Strengthening the arch system is urgent to prevent further damage and possible collapse of this structure. If the building is to be used for public occupancy in the future, the necessity for a strengthening system that is Code-compliant will be particularly important.
	We investigated a number of methods for reinforcing the arches. Although economical, there is no simple method for achieving the increase in capacity necessary via sistering or adding cables to the arches. Thus a more involved solution is required.
	We feel that a new system of structural steel arches installed inside of the building is the best solution. These arches could be pre-bent at the fabricator's shop and installed relatively quickly in the space between the existing wood arches. The use of steel would allow the new arches to be spaced reasonably far apart, say 9 feet. Horizontal steel tubes could then be installed between the steel arches on the inside of the building mirroring the purlin system on the outside of the existing arches. These steel purlins would support the existing wood arches and would also allow the contractor to carefully push the wood arches back into their original un-deformed shape.

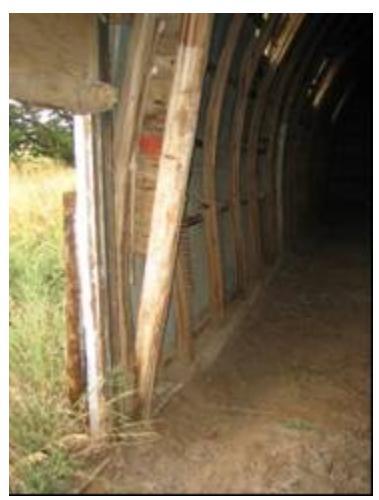
Deformed arches west of garage door

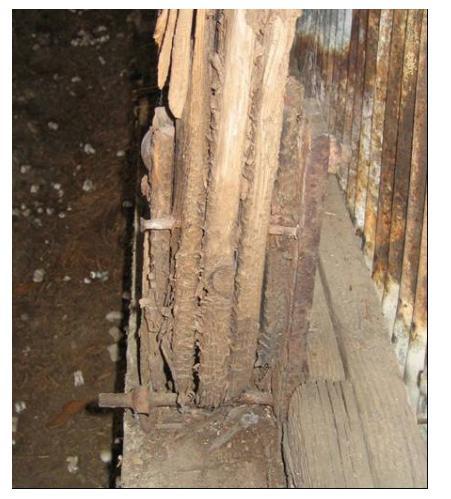
Arch connection to foundation from side

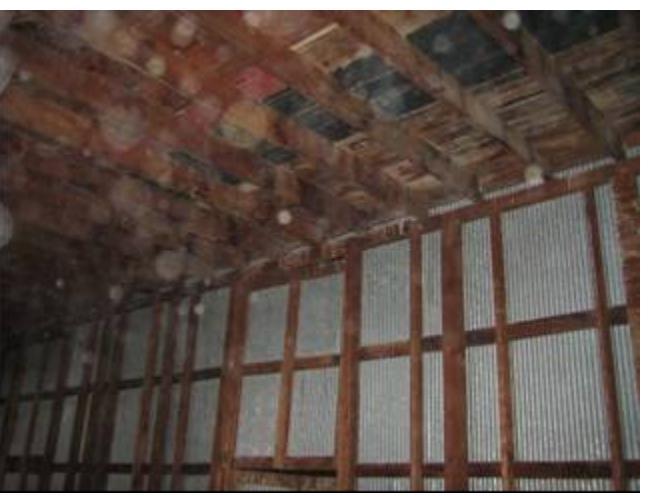
Loft framing at south wall

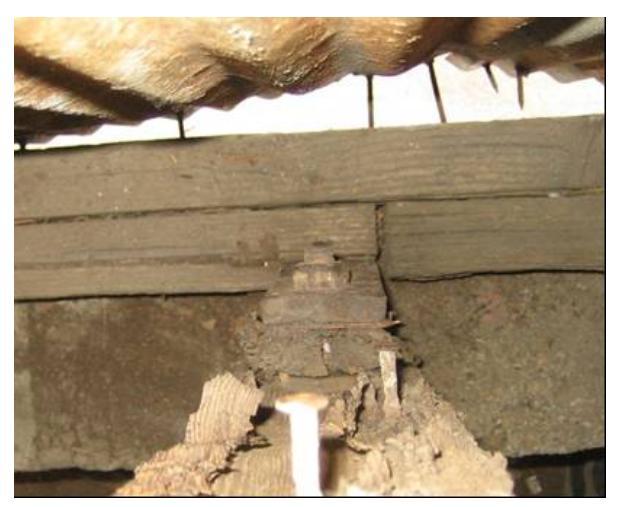
Arch connection to foundation from above

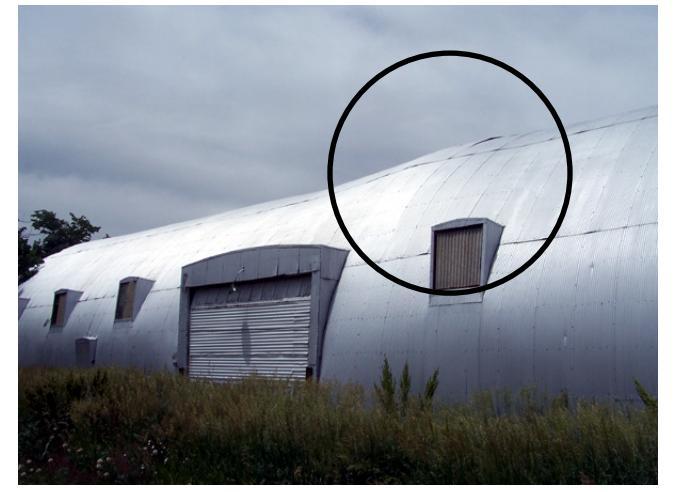
CATEGORY:	3.5 Envelope – Roofing & Waterproofing
DESCRIPTION:	The roofing elements are continuous sheets of lightweight corrugated steel that connect to the vertical corrugated steel walls below. The arc of the structure is formed by the continuous corrugated walls, which rest on bent arched wooden "ribs" running parallel to each other throughout the structure. Wood longitudinal purlins support the curved roofline.
EVALUATION:	The roof at the Quonset structure is in fair to poor condition. The corrugated metal roof is in poor condition with areas of damage throughout. One area of the roofline is visibly bowing above the vertical door entrance.
RECOMMENDED TREATMENT:	Further investigation needs to be done to determine if the west end of the structure is settling and causing the bowing at the roofline. See Section 3.2 Building Structural Systems for additional recommended treatments.

Area of bowing at roofline

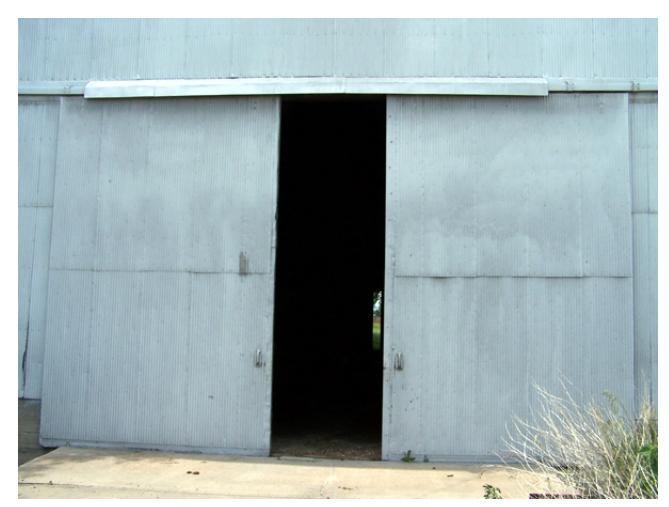
The two horizontal sliding doors at the east and west ends are in fair condition. They are operable, but require effort to move along the track and do not close completely, leaving a gap of several inches.

Horizontal sliding doors at east entrance to Quonset

Recondition or replace the track hardware on the two horizontal entrance doors. Replace the track for the south overhead door. Restore and repaint the door itself. Recondition or replace the track hardware on the interior dividing door.

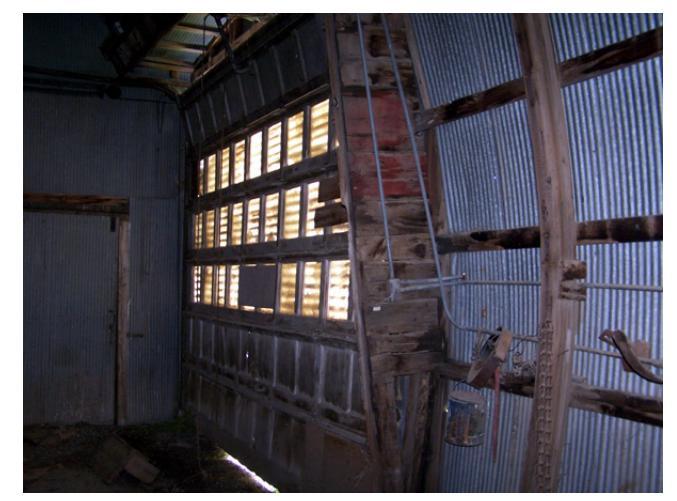
The vertical overhead door at the south elevation is in poor condition. The door itself has buckled and does not open or close without considerable effort. It is evident the bent wood structure at the door location on the

interior of the Quonset is failing and bowing, affecting the door operations.

Interior view of vertical overhead door

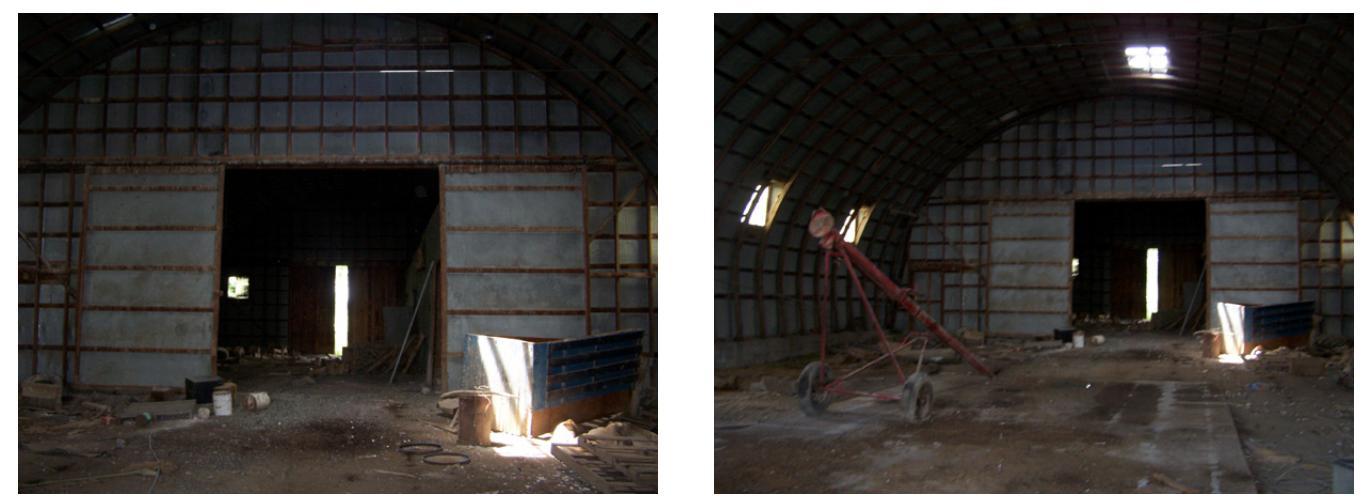
At the time of assessment, the interior dividing doors were blocked by farm equipment, dirt and debris. It is not known if the doors are operable. It is assumed the track system is either not functional or is damaged.

Interior door separating the east and west ends of the Quonset

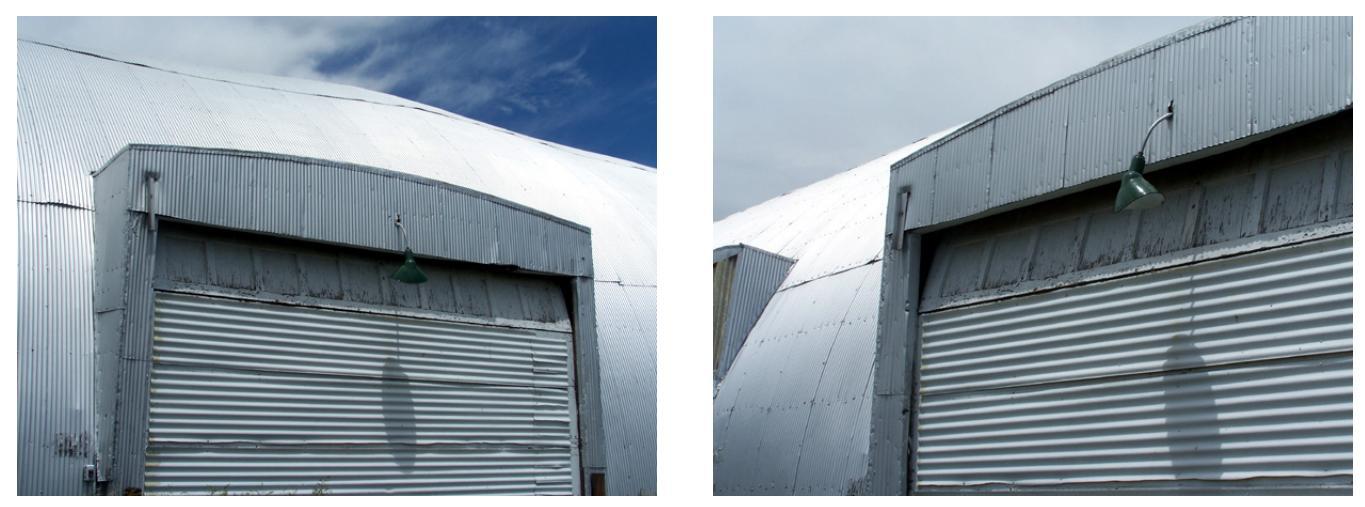
Vertical door at south elevation of Quonset. Note the upper segment of the door is dislodged from the vertical plane

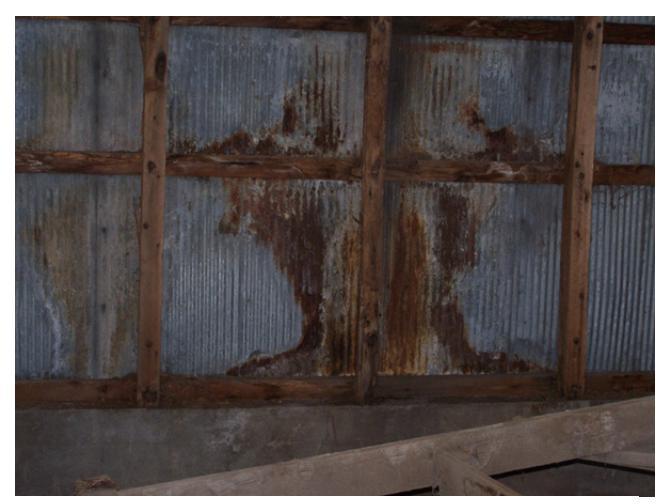
Rusted corrugated metal panels at interior of Quonset

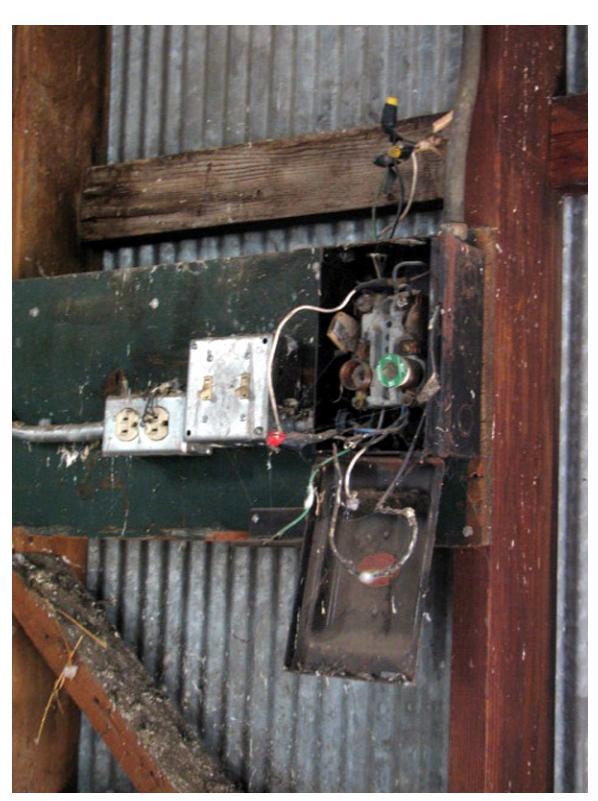
Distribution panel in the Quonset Structure

The electrical distribution system does not meet code.

Future adaptive re-use of this structure will need to take electrical systems needs into account and will need to address code requirements. Adaptive re-use of this building should factor in a code-compliant electrical and lighting system.
